BOARD OF DIRECTOR'S MEETING

Gary Paxton Industrial Park – Board of Directors Meeting
April 27, 2020 3:00pm – Zoom Meeting
DRAFT Meeting Minutes

II.A. Site Description & Initial Conditions

FIGURE IV:
APC-SITKA SOLID WASTE DISPOSAL FACILITY - 11/24/98 CONDITIONS
 Located along Sawmill Creek near Sitka, Alaska

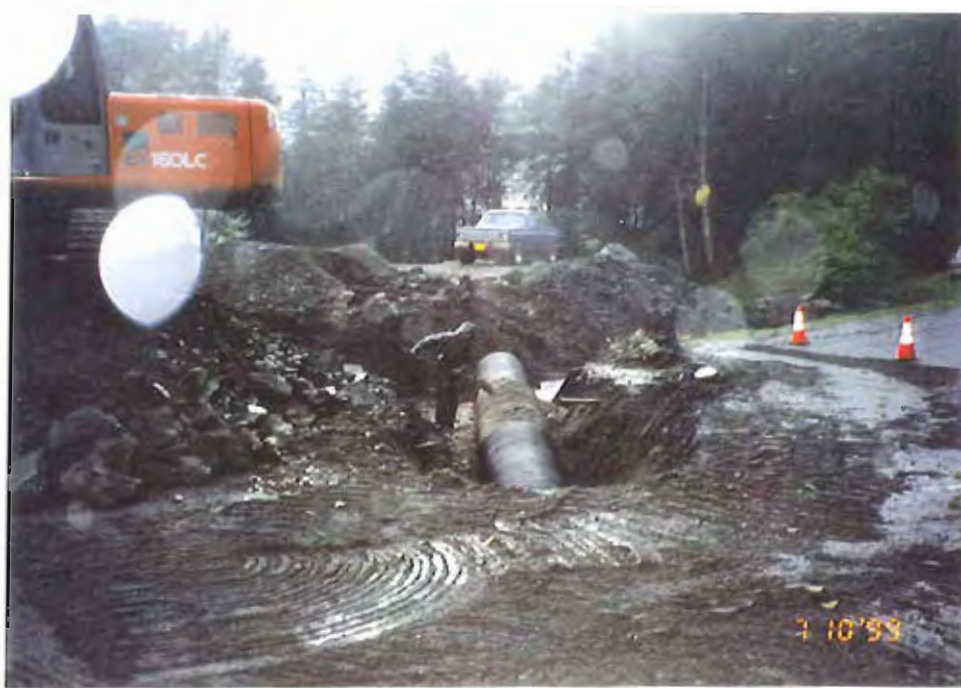
Photo #1: 10/7/99 view of the initial section of new 3'-dia. culvert being installed across the Sawmill Creek Roadway near Sta. 6+50' of the APC/Sitka landfill site.

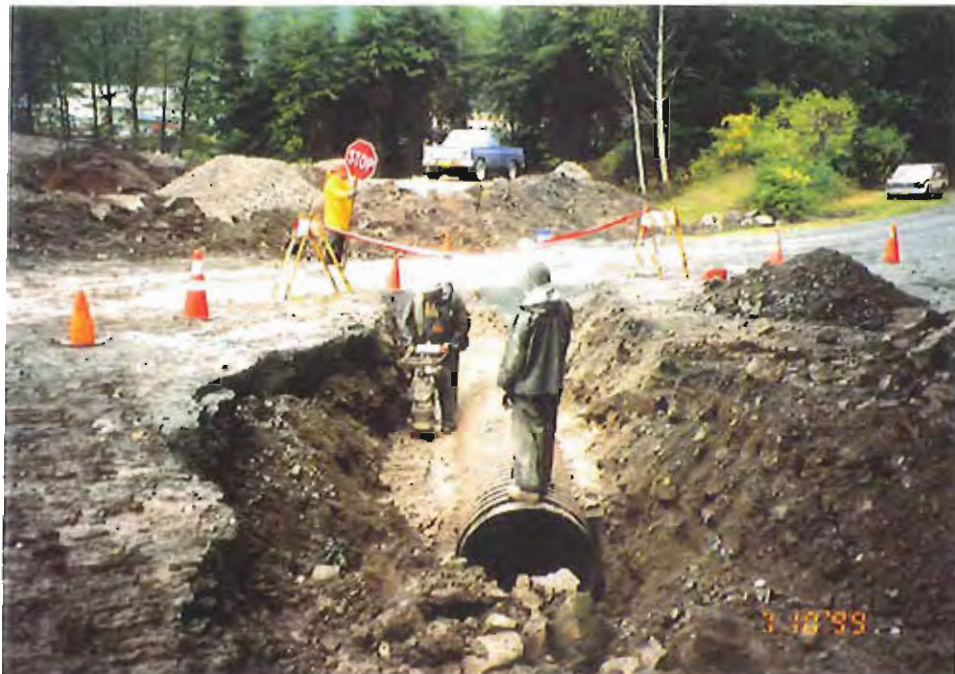
Photo #2: 10/7/99 view looking southwest at the inlet to the new 3'-dia. culvert being installed across the Sawmill Creek Road to drain the upslope surface water away from the APC/Sitka landfill deposits.

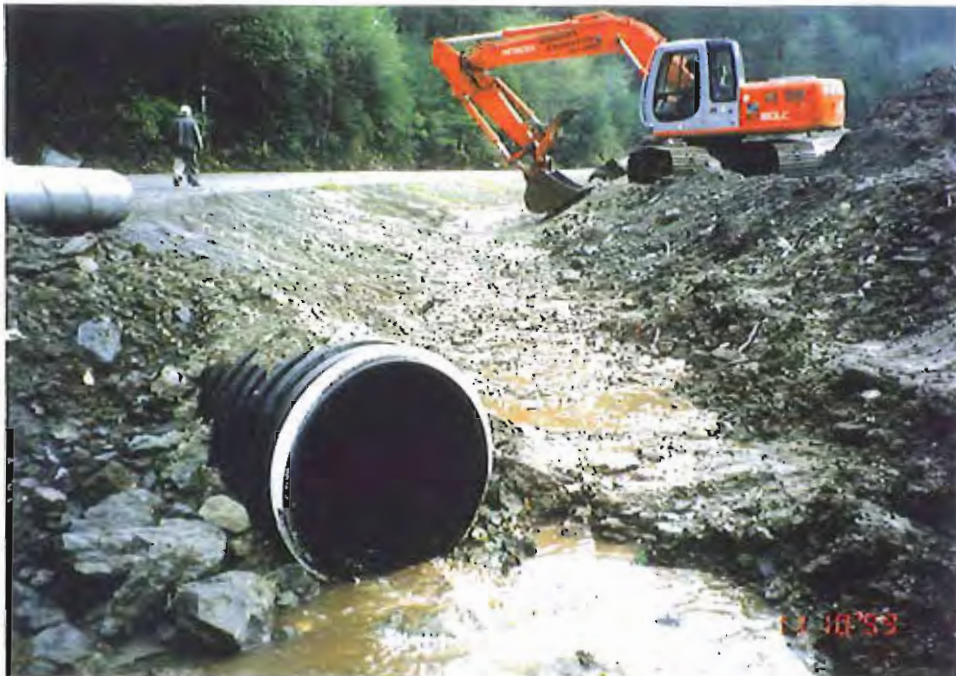
Photo #3: 10/11/99 view of the new 3'-dia. culvert discharge from across the Sawmill Creek Road, looking up the roadside drainage ditch being prepared for placement of the 30-mil membrane (see next photo).

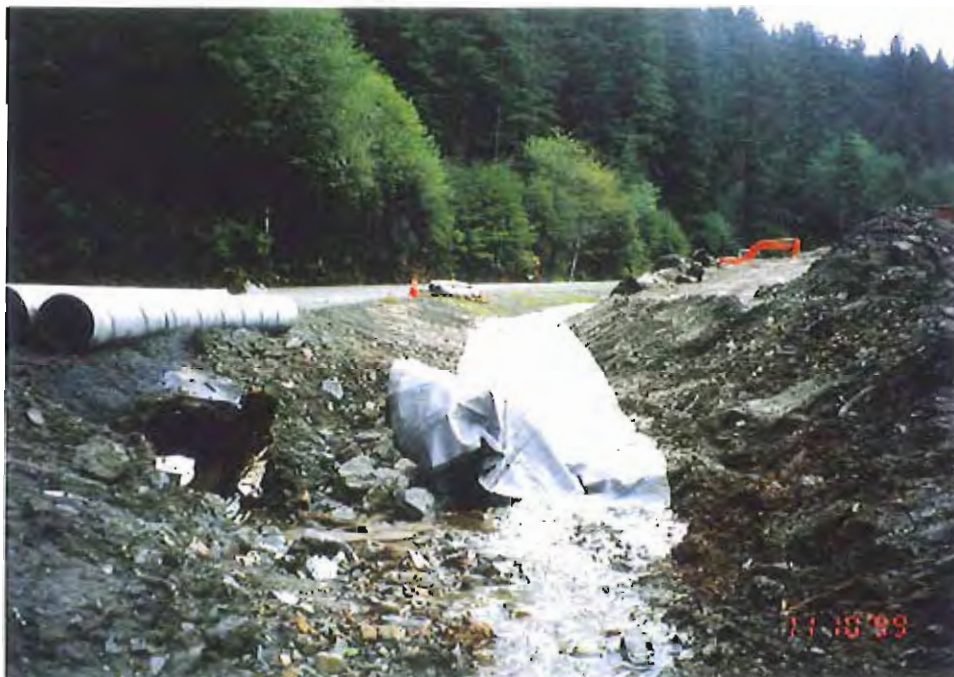
Photo #4: 10/11/99 view of the Sawmill Creek Road's downslope drainage ditch, just after the 10'-wide 30-mil membrane material had been rolled out.

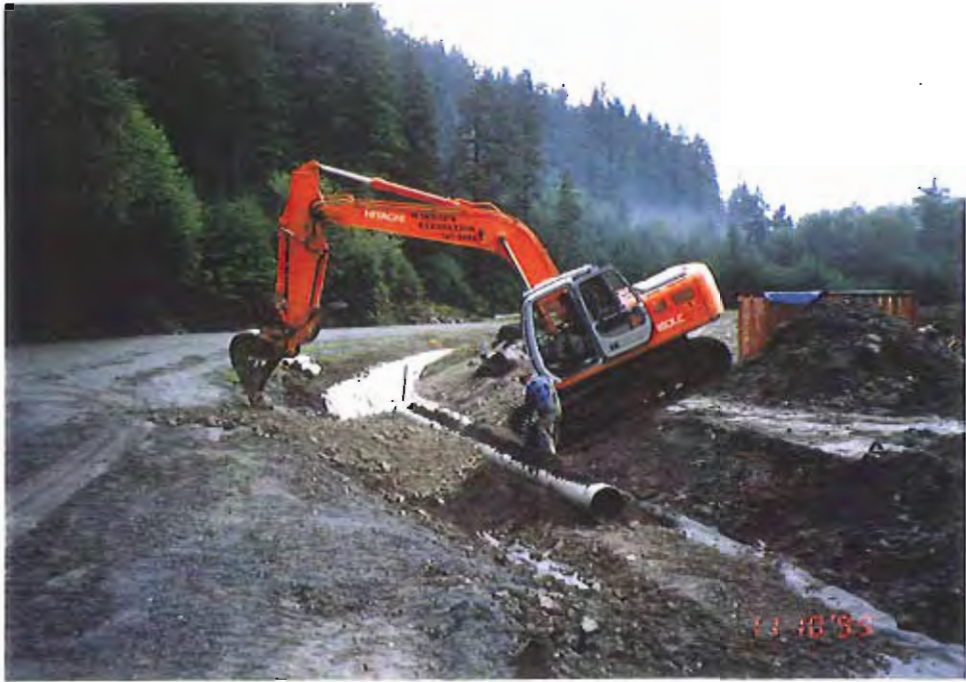
Photo #5: 10/11/99 placement of the 18"-dia culvert at the entrance to the APC/Sitka landfill site, showing the 6" of crushed-concrete fill placed between the membrane and the culvert.

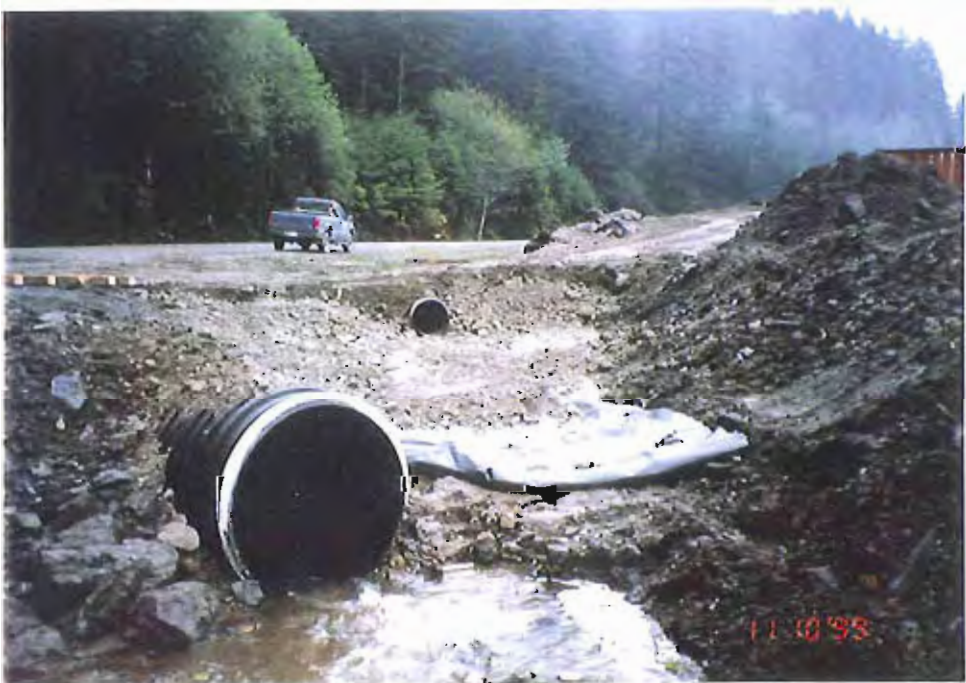
Photo #6: View of the downslope drainage ditch between the Sawmill Creek Roadway and the APC/Sitka landfill on 10/11/99, showing the 6" layer of crushed concrete and the 30-mil membrane below the now-installed 18"-dia culvert under the APC/Sitka landfill's access road.

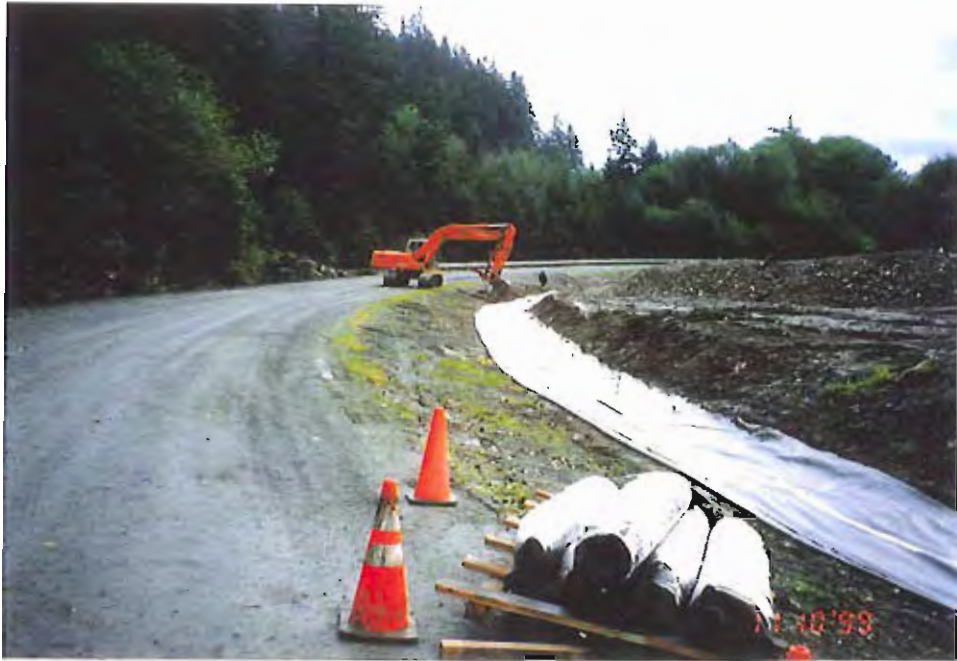
Photo #7: Continued laying and securing of the 10³-wide 30-mil membrane along the downslope water drainage ditch between the Sawmill Creek Road and the APC-Sitka landfill on 10/11/99.

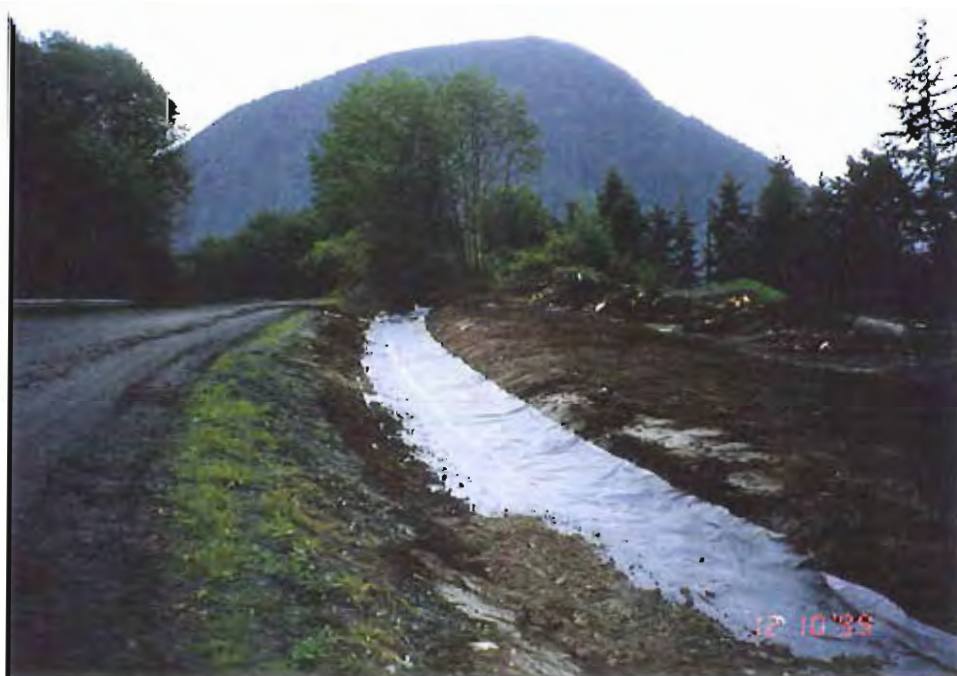
Photo #8: 10/12/99 placement of the 30-mil membrane along the upper end of the of the surface water drainage ditch between the APC/Sitka landfill and the Sawmill Creek Road, showing the careful securing of the membrane's edge within the adjacent roadside soil.

Details of the final ditchline are shown in Cross-Section B-B on page C10. In addition, a 6"-thick layer of soil was added to the roadside bank and extended over the edges of the crushed-concrete layer as shown in Photo #25, page A14, and continued to the upslope end of the ditch (see Photo #51, page A27). As the project neared completion on 11/23/99, the 6"-thick soil layer along the fill embankment had been extended over the crushed-concrete sides of the ditchline as shown in Photo 80 on page A41.

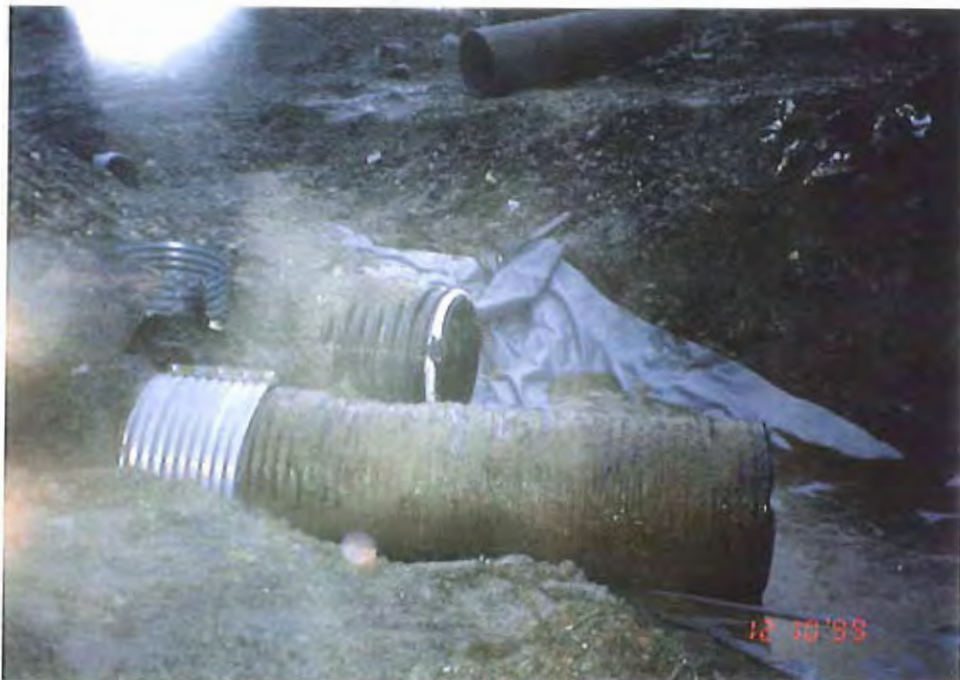
Photo #9: 10/12/99 view of the culvert extension and band placed on the end of the original 3'-dia culvert, to extend it further away from the edge of the Sawmill Creek Roadway.

On 10/12/99 the existing 36"-dia culvert was lengthened about 8' to get its discharge end further away from the roadway's shoulder (refer to Photo #9, page A6). The inlet and outlet ends of the completed new-culvert installation can be seen on page A12, in relation to the existing culvert.

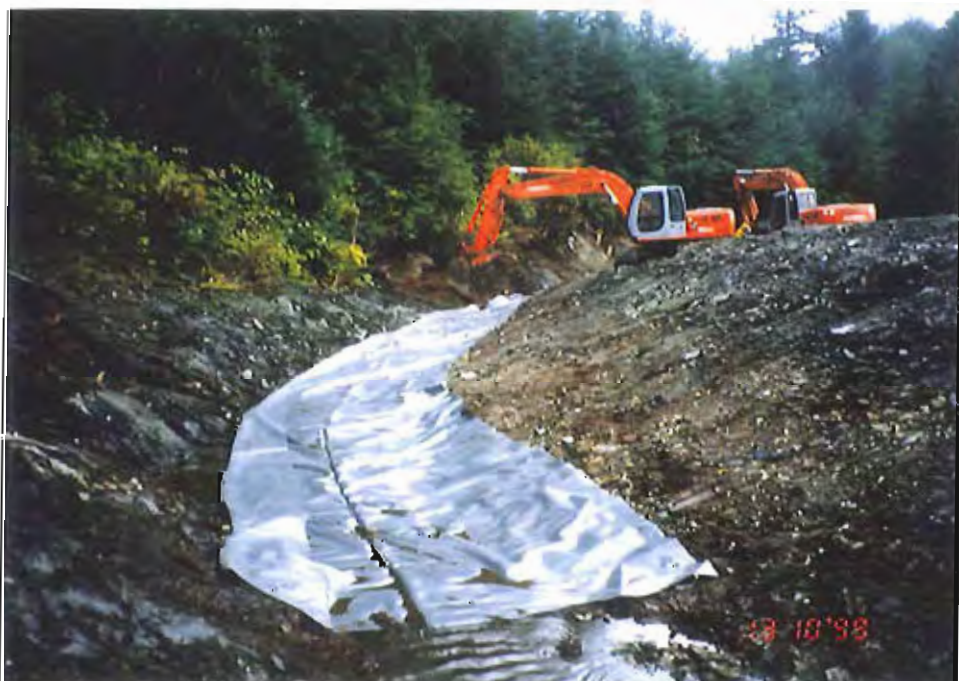
Photo #10: 10/13/99 view of the surface water drainage ditch along the upland side of the APC/Sitka landfill's northeastern area. Note that the left edge of its 30-mil liner is rolled back to allow the backhoe to dig a shallow trench where the liner's edge will be secured within the soil embankment (see next photo).

- A. *Upslope ditchline around the Northeastern Disposal Area.* As shown on Figure IV, page 3d, the original surface water ditch around the site's Northeastern Waste Disposal Area was ineffective at intercepting any surface waters. An initial ditchline was excavated around its southern end on 7/1/99, and by 8/18/99 the entire ditchline had been excavated (refer to the 9/17/99 Status Report photos on pages A24 and A33-A34 of that document). By 10/13/99 the northwest-draining portion of the ditch had been lined with the 30-mil membrane liner (refer to Photo #10, page A6).

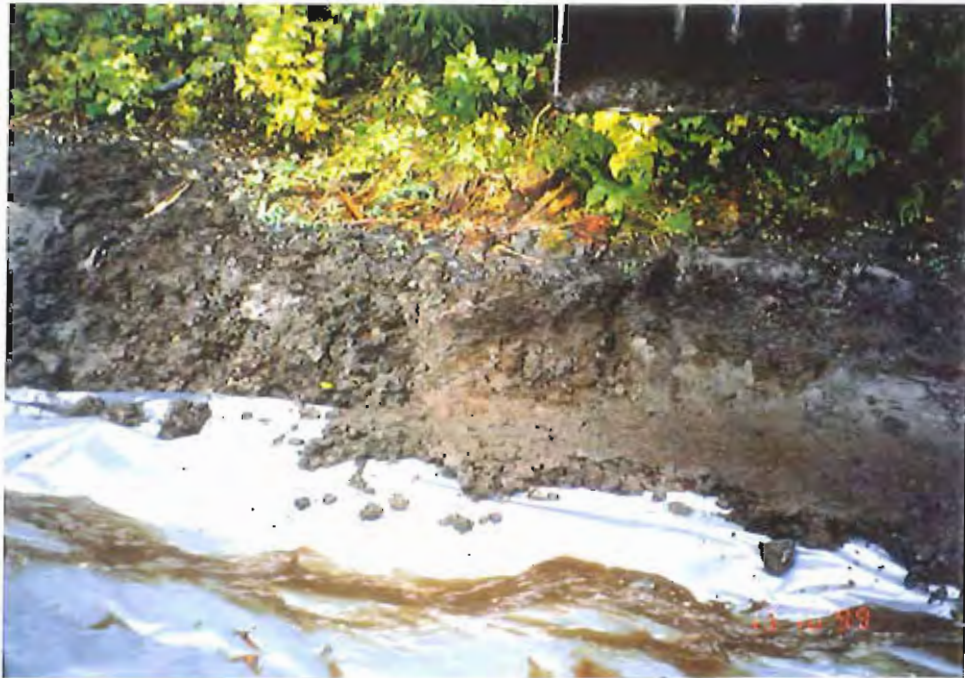
Photo #11: 10/12/99 close-up view of the 30-mil membrane edge being secured into the soil embankment, to assure positive drainage of all upslope water from the APC/Sitka landfill's northeastern area.

Photo #11, page A7, shows the care taken to make certain that the upper edges of the 30-mil membrane were definitely sealed into the ditchline's upper soil embankments. By 10/13/99 a 6"-thick layer of crushed-concrete fines were being placed over the membrane, and by 10/20/99 the entire membrane was covered with crushed-concrete (refer to Photo #12 on page A7, and Photo #18 on page A10). To help insure the crushed-concrete fines would not wash away, the entire ditchline then was covered with 4"-minus crushed-concrete to complete the ditch as shown in Photos #61 & #63, pages A32-A33.

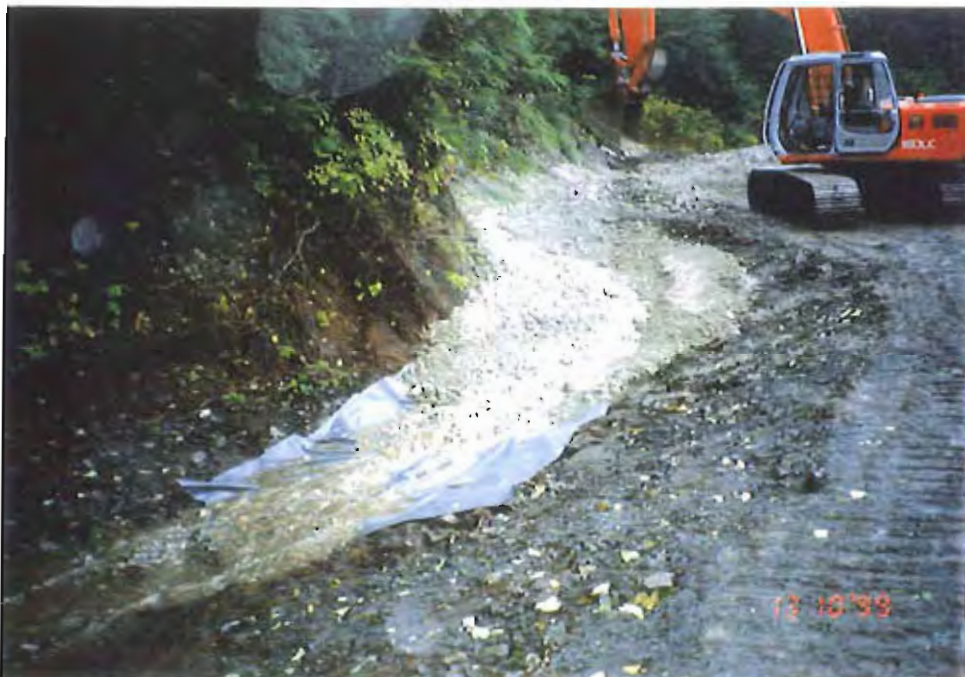
Photo #12: Continuing work on the APC/Sitka landfill's upslope ditch along the northeastern area, showing the 30-mil membrane and 6" of overlying crushed concrete cover, 10/13/99. Note the substantial water runoff.

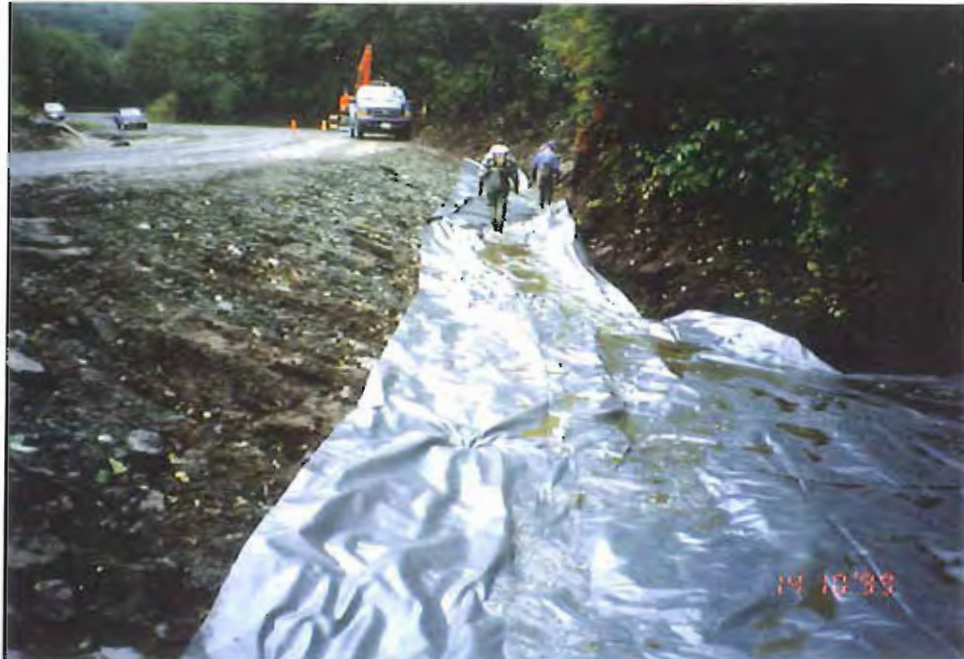
Photo #13: Laying of the 30-mil membrane liner along the Sawmill Creek Roadway's upland surface water drainage ditch on 10/14/99.

- C. Upslope ditchline along Sawmill Creek Road. Photos #13-#16, pages A8-A9, show the placement and extension on 10/14/99 of the 30-mil membrane from the Northeastern Disposal Area, for a distance of 310' along the Sawmill Creek Roadside to the cross-road culvert inlet. Prior to placing the membrane, 4 cross-road culverts that had been in the roadway but not serving any useful purpose had at least 10' of their upslope ends excavated and removed.

The 30-mil membrane's 10'-width was extended as necessary to capture the several upslope drainages (see Photos #13-#15, pages A8-A9). The photos also show the initial placements for a 6"-thick cover of crushed-concrete fines, to protect the 30-mil membrane liner from potential erosion. The photos on pages A10-A11 show the crushed-rock covering the entire liner surface by 10/20/99, and the initial placement of larger rock to protect against the water erosion potential along the bottom of the ditchline.

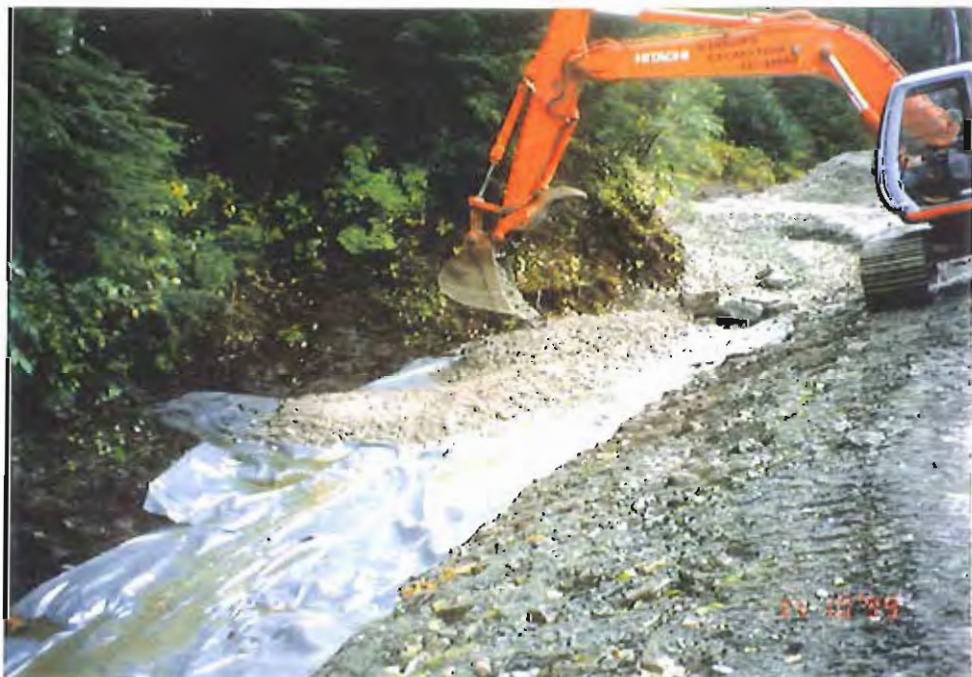
Photo #14: Continued placement of the 6"-layer of crushed concrete over the 30-mil membrane at about Sta. 3+50' in the APC/Sitka Landfill's ditch, along the upland side of Sawmill Creek Road. Note the extension of liner to catch the small stream coming in from the left side of the photo.

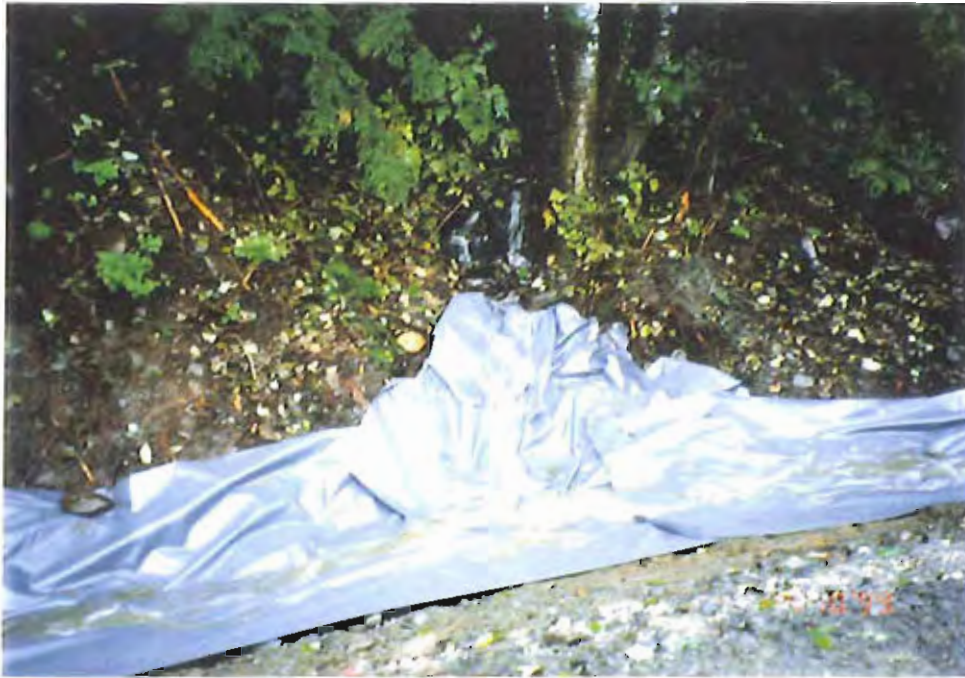
Photo #15: Extension of the 30-mil membrane liner to catch the runoff from a small upland creek at about Sta. 4+70' of the APC/Sitka landfill site, along the upland side of Sawmill Creek Road, 10/14/99.

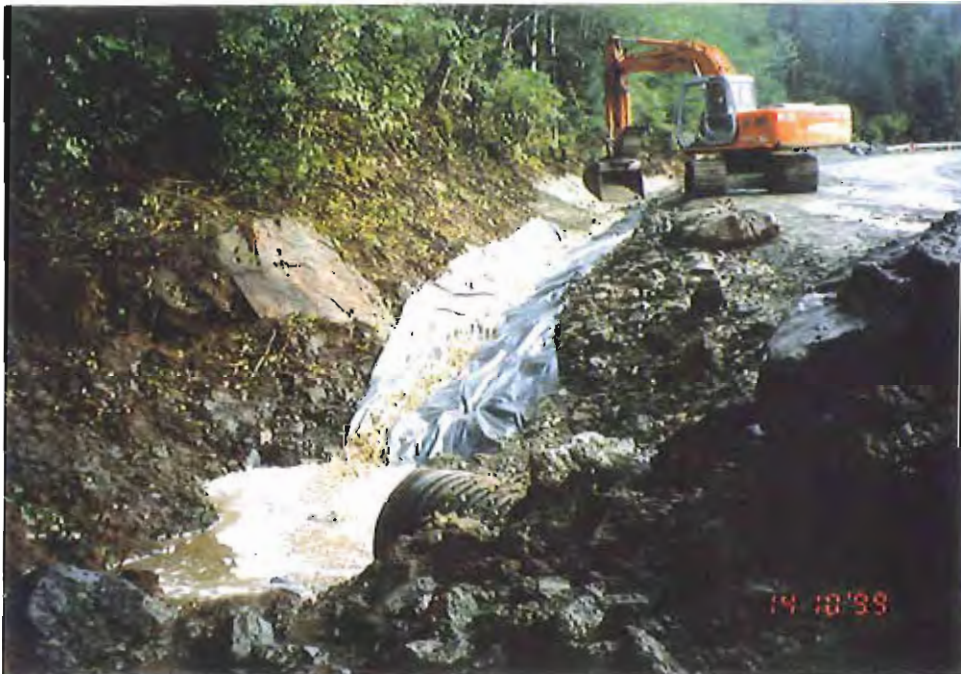
Photo #16: Looking across the inlet of the new 3'-dia. culvert now carrying all of the upland surface water drainage across the Sawmill Creek Road at about Sta. 6+40' of the APC/Sitka landfill site, 10/14/99.

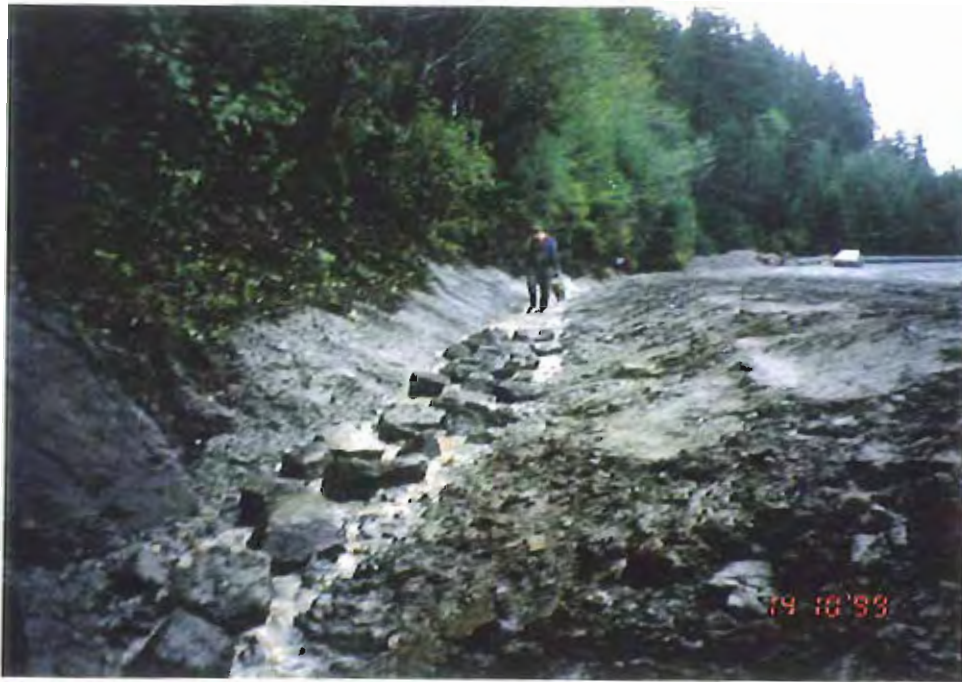
Photo #17: 10/14/99 placement of large rock to protect against erosion in the nearly completed drainage ditch along the Sawmill Creek Road's upland side at the APC/Sitka landfill site.

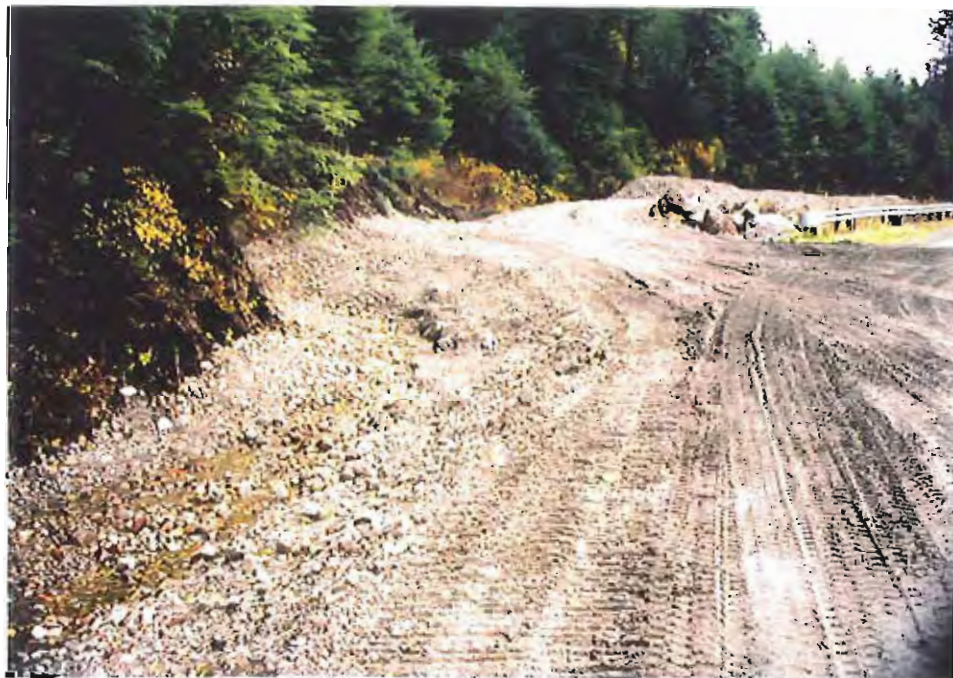
Photo #18: 10/20/99 view at about Sta. 3+20' of the APC/Sitka landfill project site, where the upland drainage ditch flows from the northeastern fill area above the Sawmill Creek Road. Note the considerable volume of water flowing in the ditch, where previously no water had ever flowed.

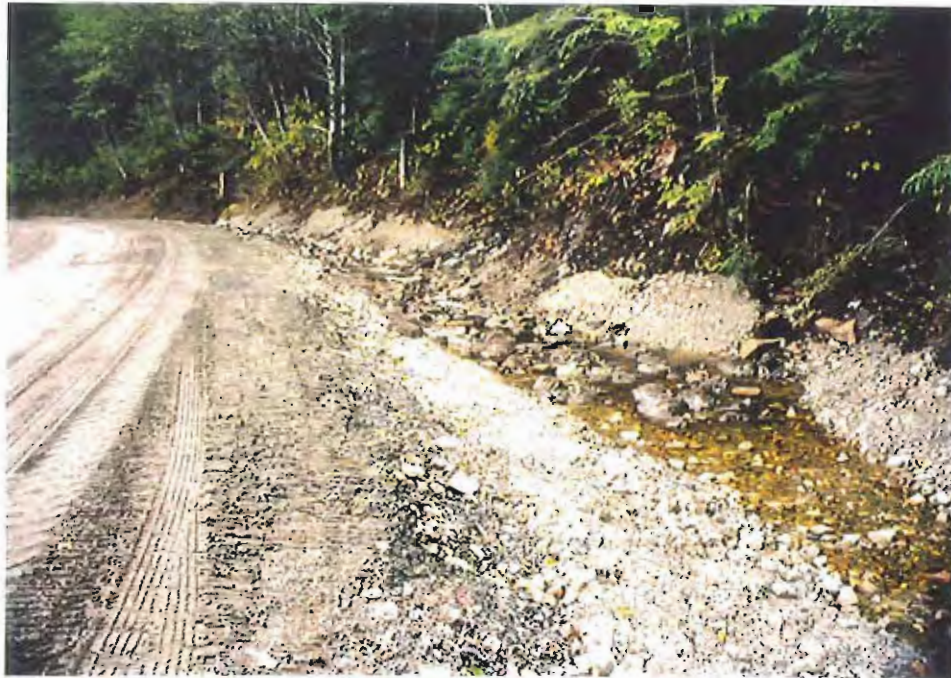
Photo #19: Looking down the nearly completed upland drainage ditch along the Sawmill Creek Road from about Sta. 3+50', showing the substantial water flowing in the ditch, 10/20/99.

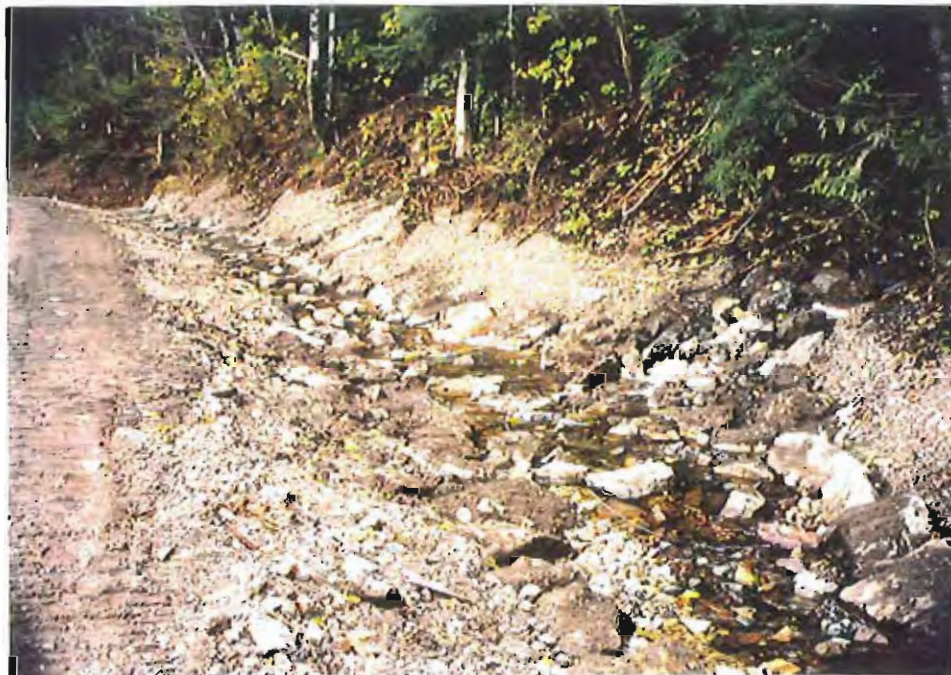
Photo #20: 10/20/99 view of the main creek coming into the drainage ditchline along the upland side of Sawmill Creek Road, showing the large rock placed along its entrance to protect against erosion.

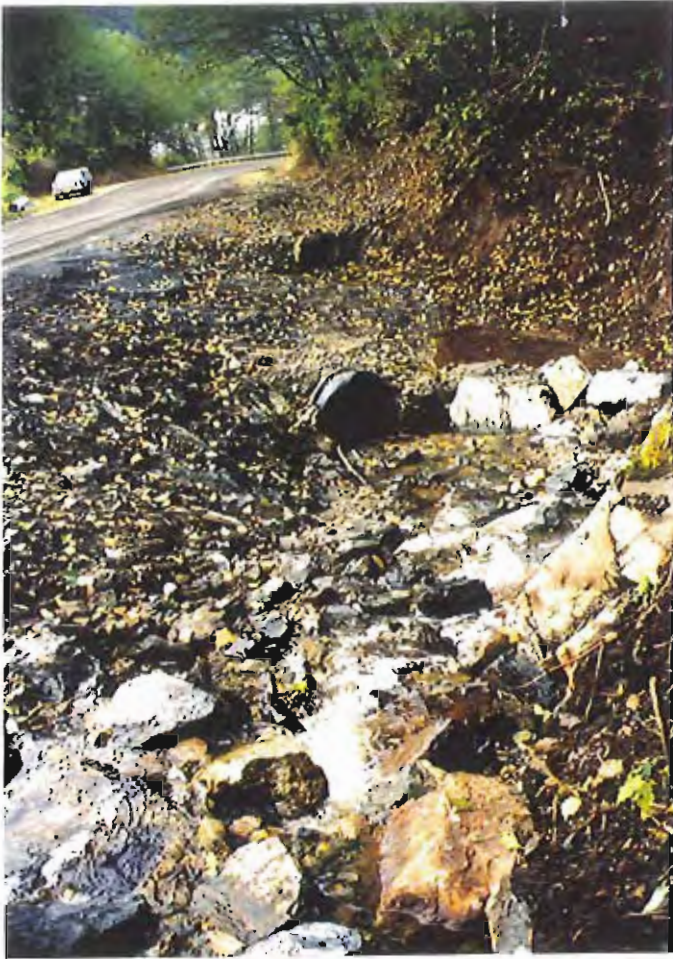
Photo #21: 10/20/99 view of the two 3'-dia culverts now providing positive surface water drainage from along the upland side of Sawmill Creek Road. The new culvert in the foreground is about 4' lower than the old culvert.

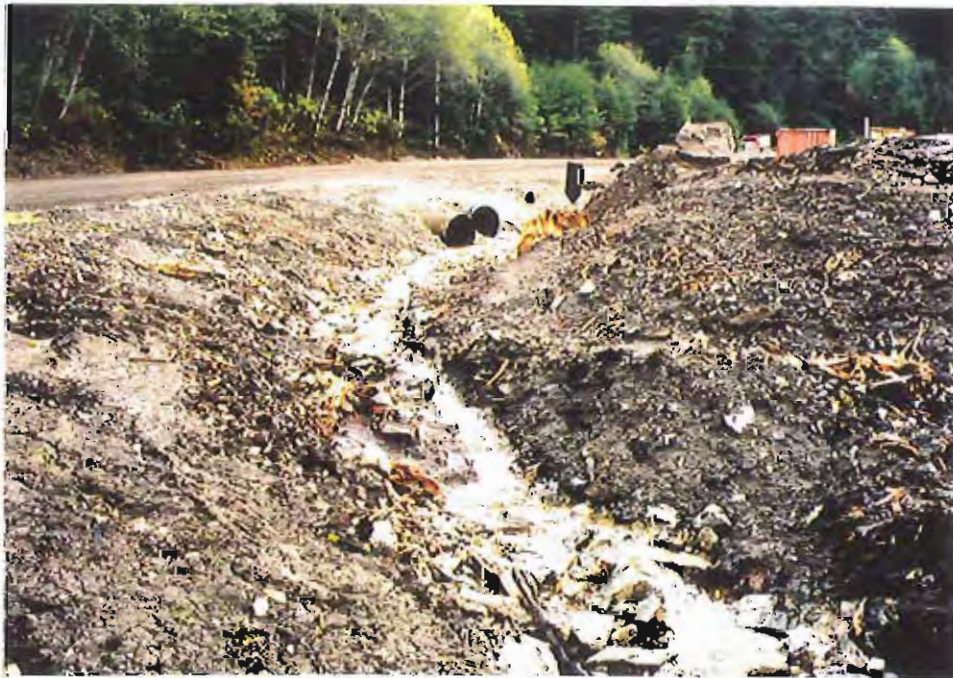
Photo #22: 10/20/99 view looking upstream around the APC/Sitka landfill's northwestern corner, showing the conditions prior to any preparation work for placement of its 30-mil membrane liner. The arrow points to a large stump that was removed the next day, to move the drainage centerline further away from the road.

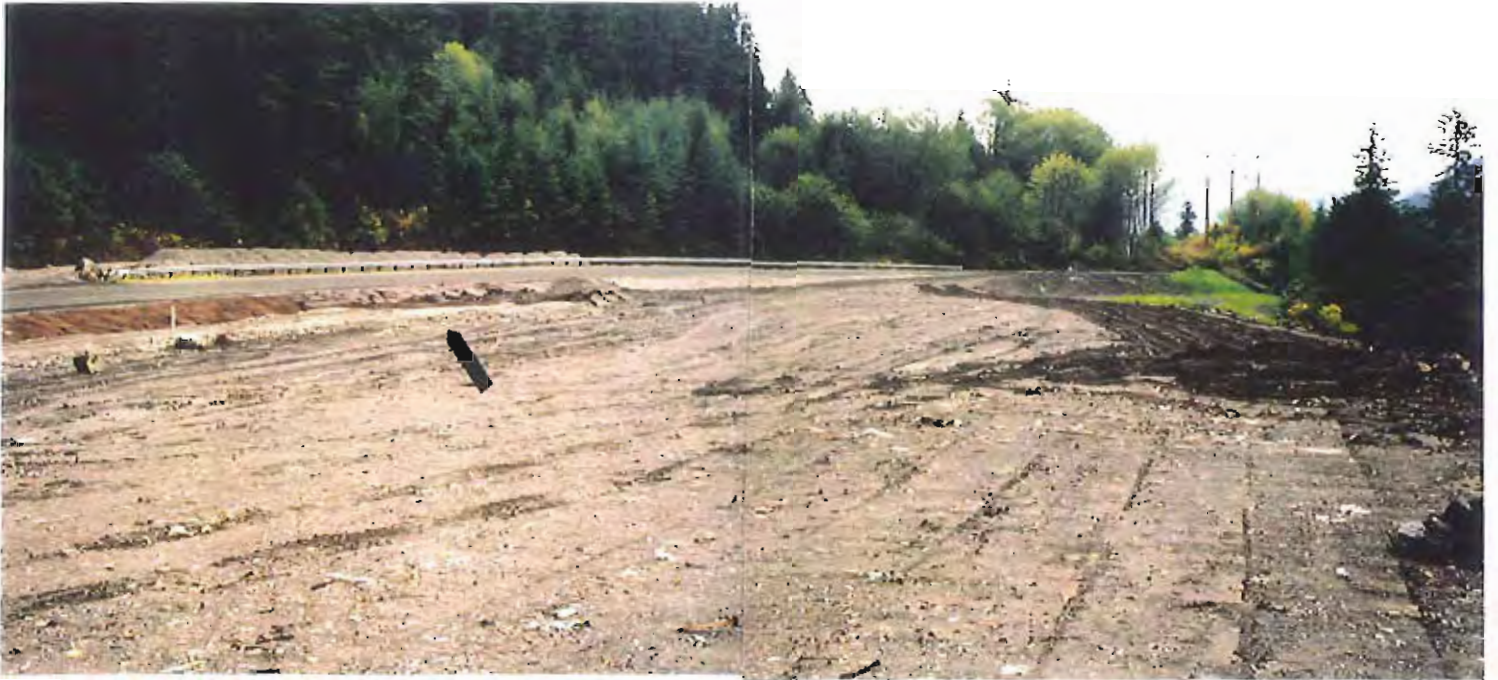
Photo #23: 10/20/99 view looking southeast across the upper surface of the APC/Sitka landfill surface from about Sta. 4+00', showing the well-compacted top surface of the fill. Also shown is the 1.5' lift of new crushed-concrete rock (see arrow) that eventually will cover the entire surface of the landfill.

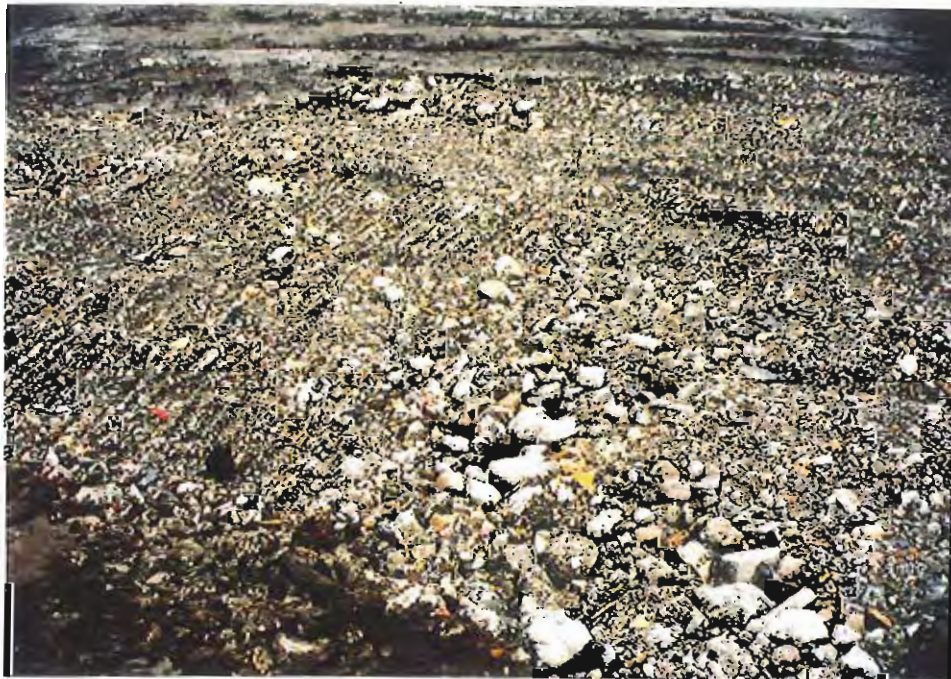
Photo #24: Closer view of the top surface of the 1.5'-thick lift of crushed concrete fill being added to the top of the APC/Sitka landfill surface, showing its clean and porous appearance (10/20/99).

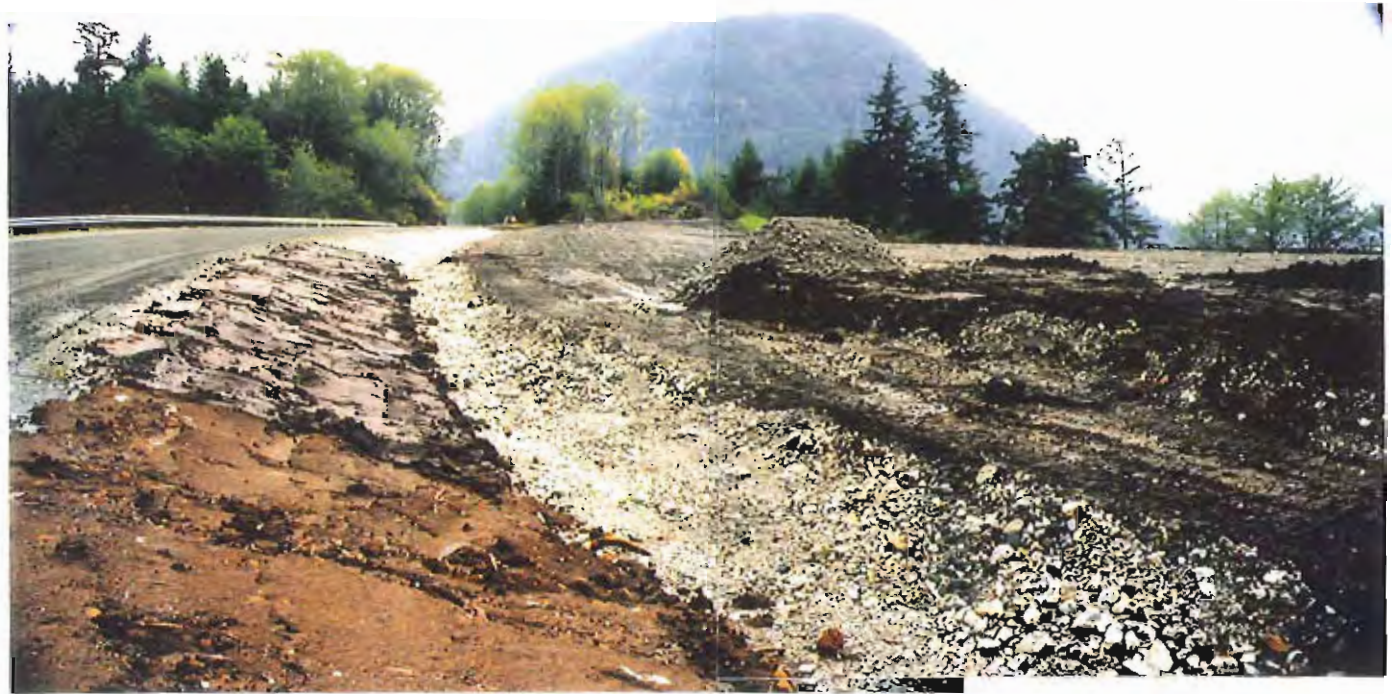
Photo #25: 10/20/99 view looking southeast along the drainage ditchline between the Sawmill Creek Road and the APC/Sitka landfill, showing the initial placement of soil from the roadside to the ditch to insure positive runoff to the membrane-lined ditch.

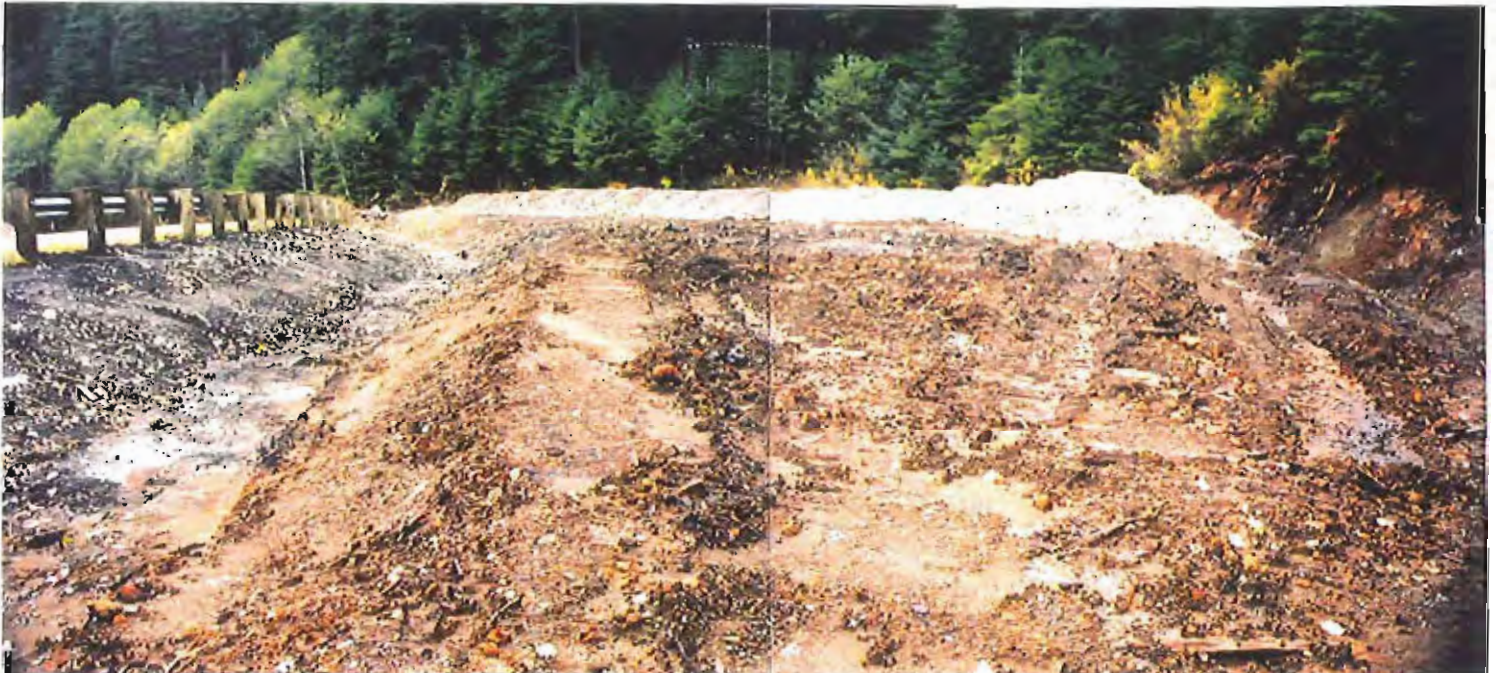
Photo #26: 10/20/99 view looking north across the APC/Sitka landfill's northeastern area, showing the surface water ditchlines along both sides of the fill and the stockpiled loads of crushed-concrete fill (about 200 c.y.) waiting to be spread across the top surface and then covered with 4" of final surface soil.

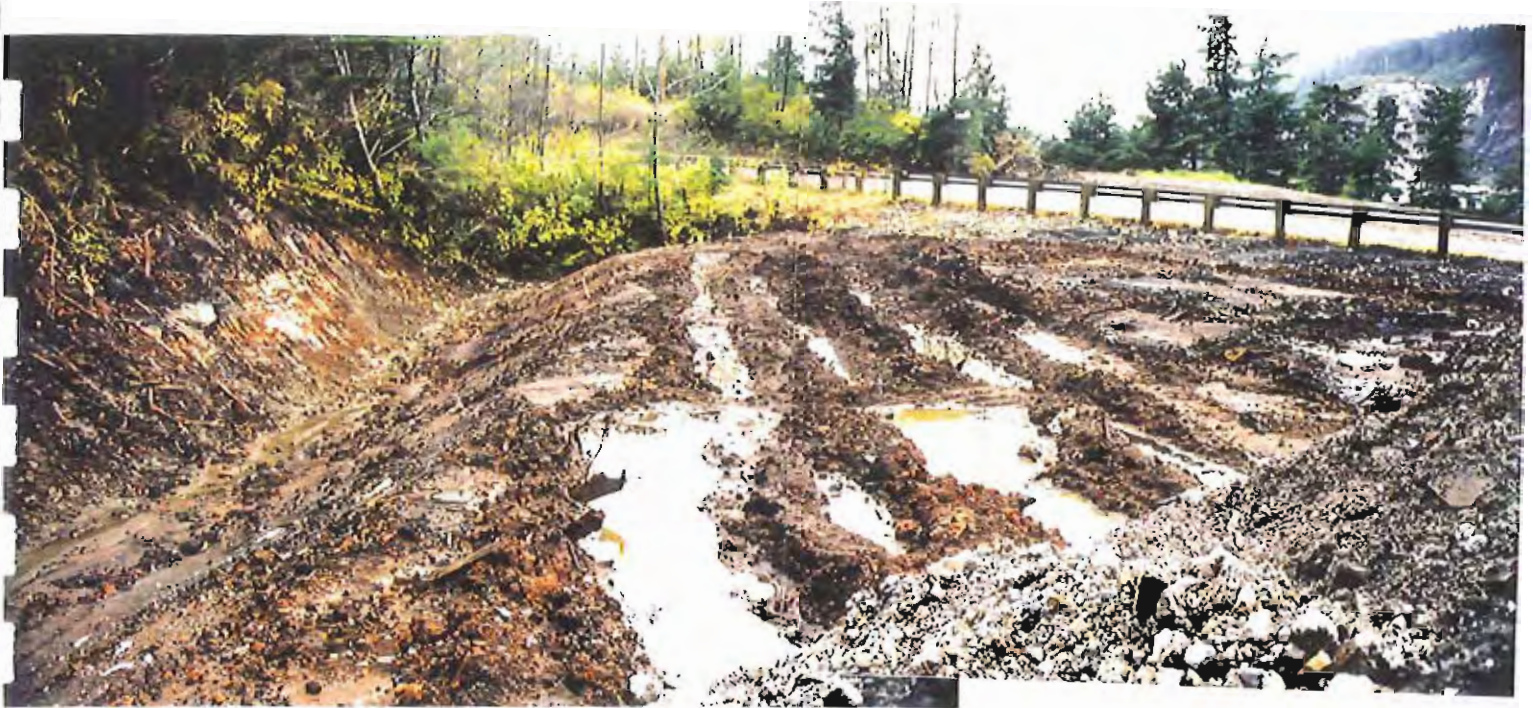
Photo #27: Looking south across the end of the APC/Sitka landfill's northeastern area on 10/20/99, showing the existing volcanic-ash soil cover's ability to provide a good seal for surface water drainage. A 1.5' layer of crushed rock will be placed across the surface, followed by a 4"-thick soil layer, and a 30-mil membrane liner will be placed in the ditch along the left side of the photo.

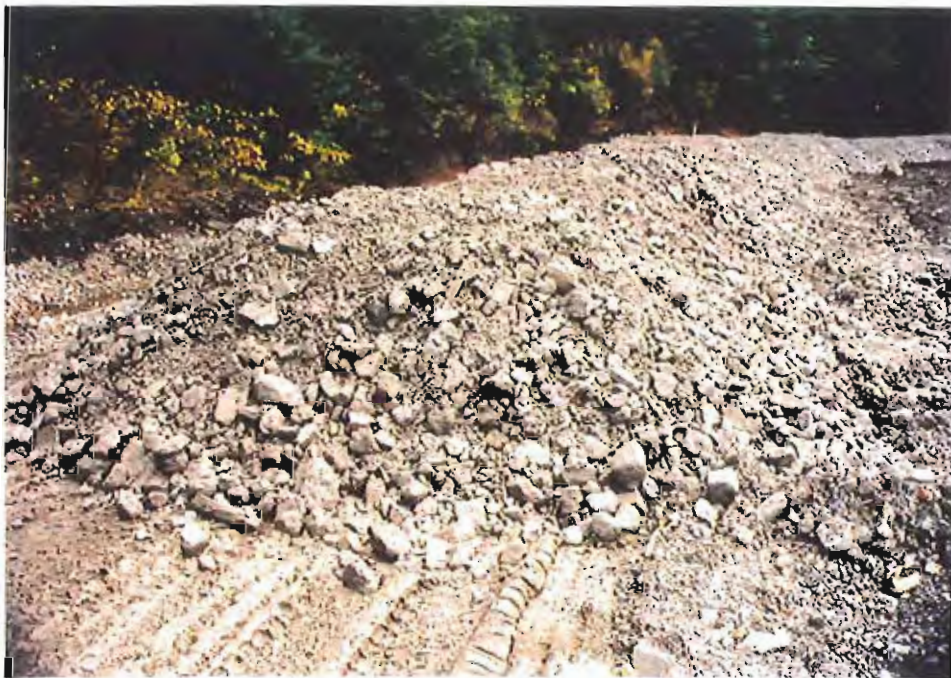
Photo #28: Close-up view of the crushed rock being loaded out for placement over the APC/Sitka landfill's northeastern area, showing its clean and porous appearance.
