BOARD OF DIRECTOR'S MEETING

Gary Paxton Industrial Park – Board of Directors Meeting
April 27, 2020 3:00pm – Zoom Meeting
DRAFT Meeting Minutes

II.A. Site Description & Initial Conditions

FIGURE IV:
APC-SITKA SOLID WASTE DISPOSAL FACILITY - 11/24/98 CONDITIONS
 Located along Sawmill Creek near Sitka, Alaska

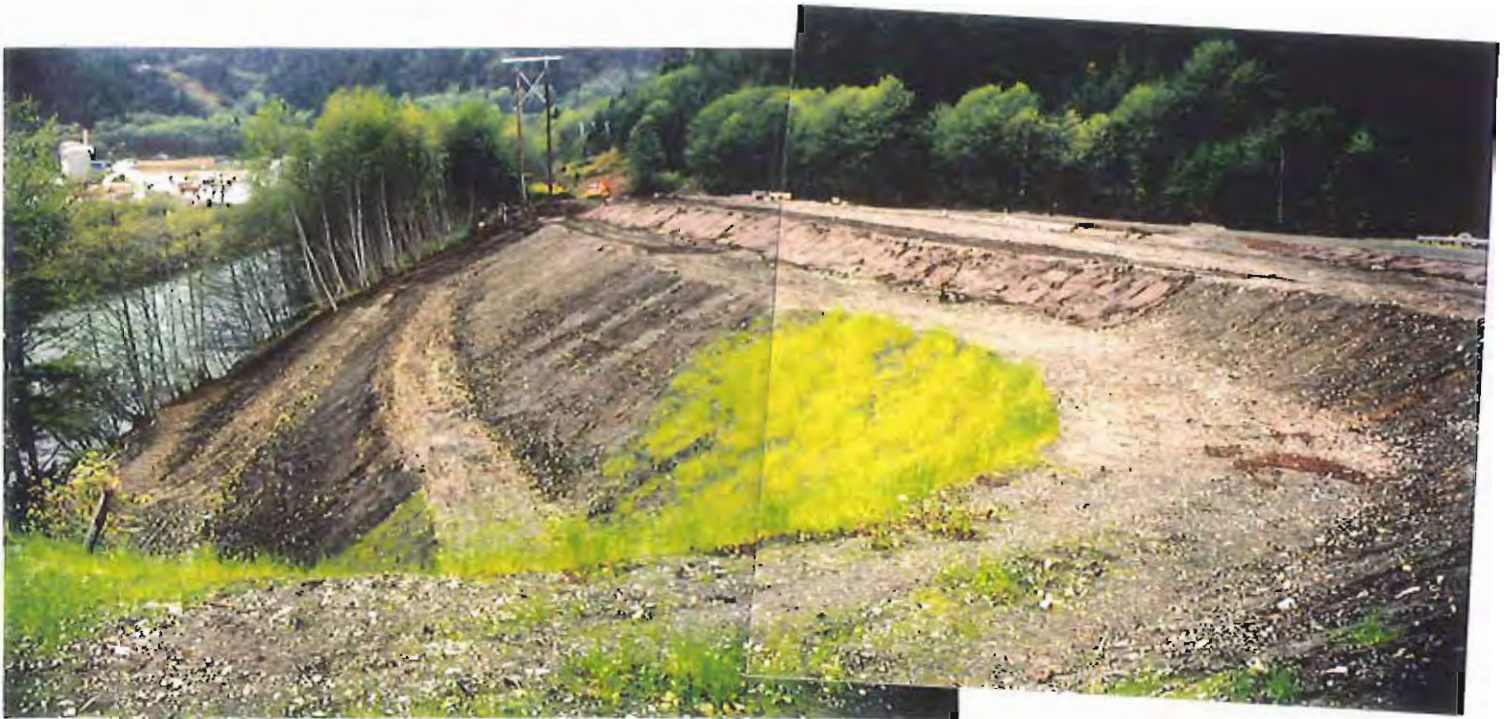
Photo #29: 10/20/99 view looking northwest along the nearly completed embankment area of the APC/Sitka landfill, showing the soil cover that now is in place and ready for grass-seeding.

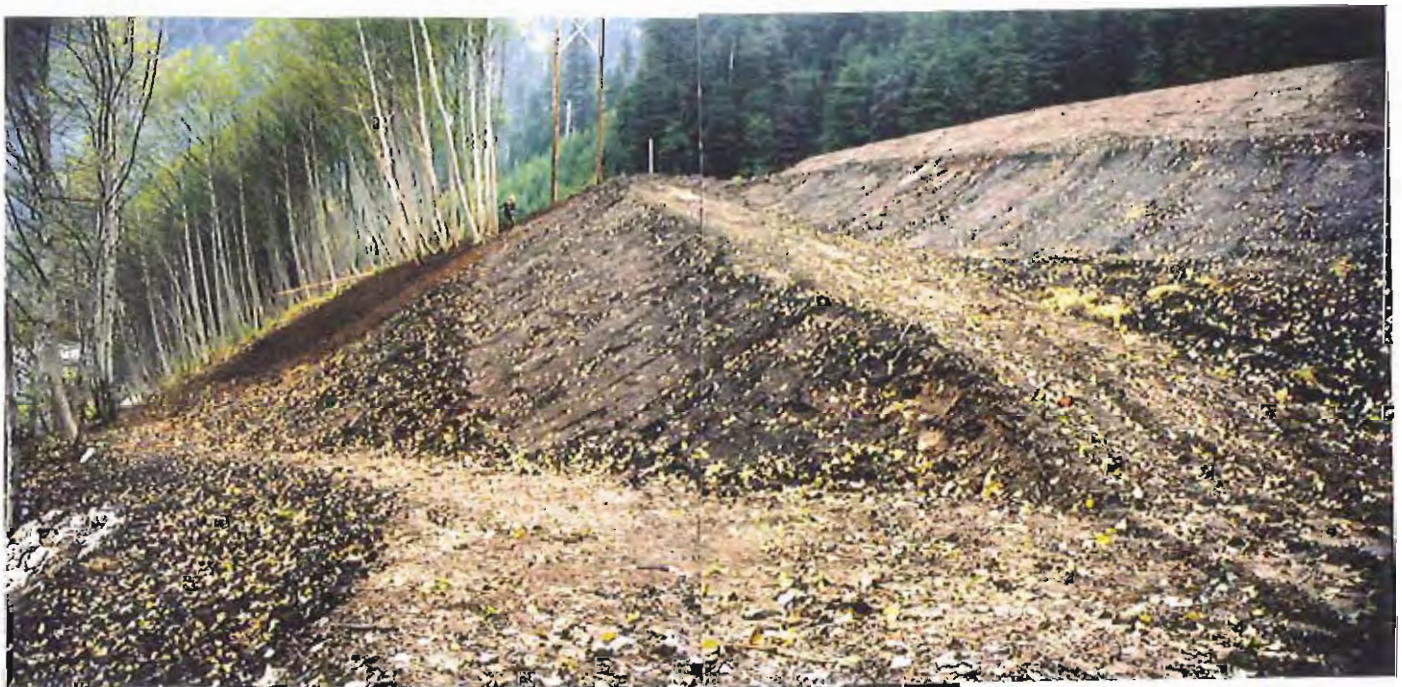
Photo #30: 10/20/99 view of the lower embankment of the APC/Sitka landfill, taken from about Sta. 2+00' and showing the completed placement of soil cover. The fresh-appearing soil along the far end of the embankment has just been hand-raked, to smooth out the soil that had been cast by the backhoe.

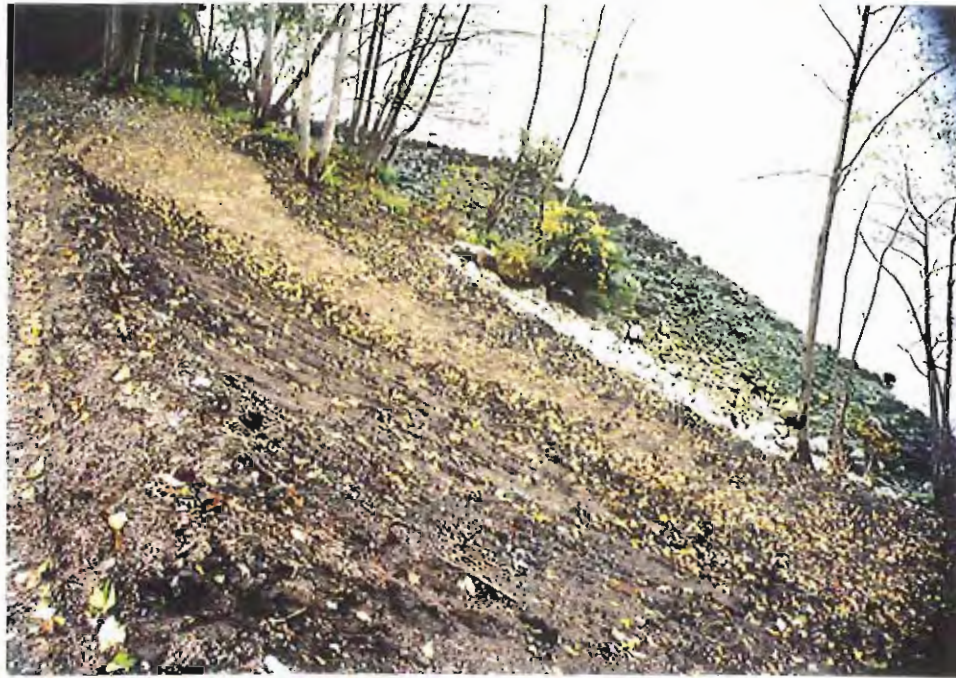
Photo #31: 10/20/99 view looking down the APC/Sitka landfill embankment from about Sta. 3+00', showing the complete covering of soil that extended to the stabilization rock along the tidelands.

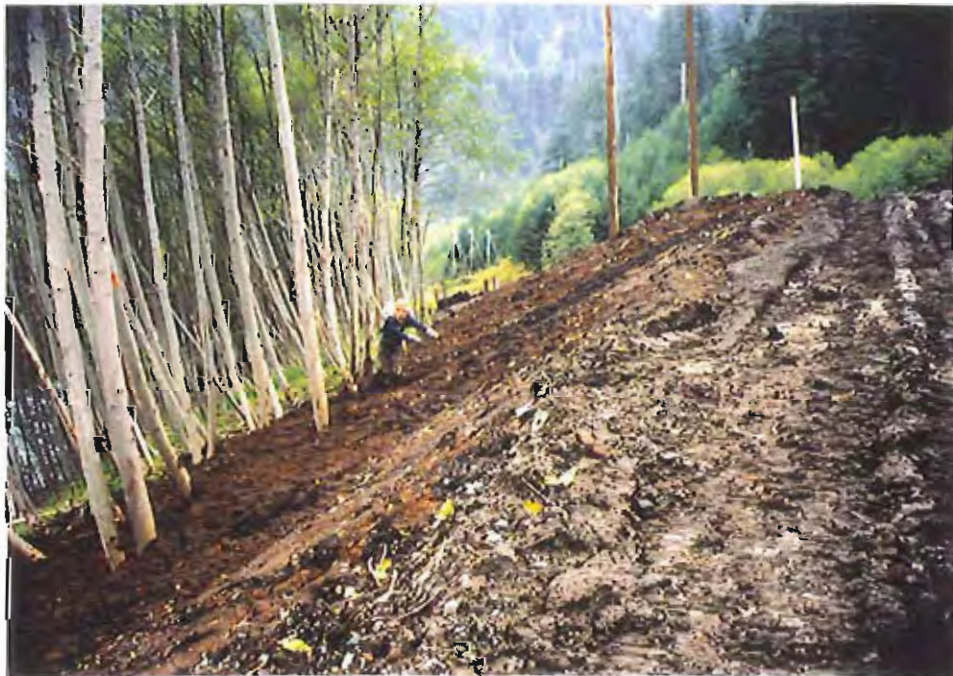
Photo #32: Hand-raking and smoothing out of the embankment soil along about Sta. 3+50', 10/20/99.

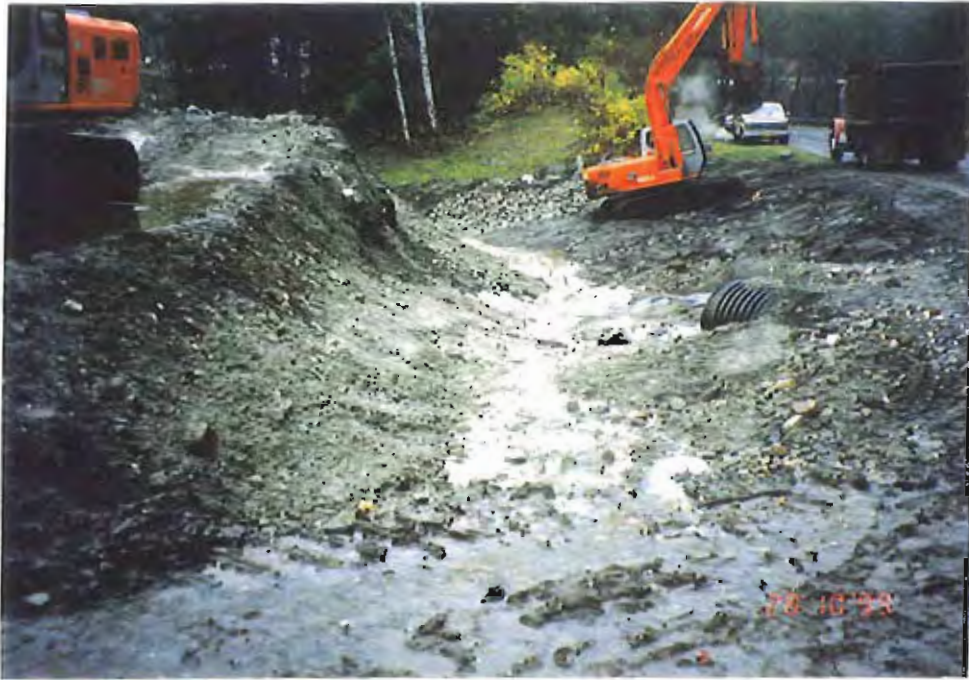
Photo #33: 10/28/99 view of the drainage ditch just below the culvert, with the subbase gravels prepared for placing the 30-mil membrane liner. Note that the ditchline is moved further away from the roadside, and now goes directly over where the large tree stump shown in Photo #22 (see page A12) had been located.

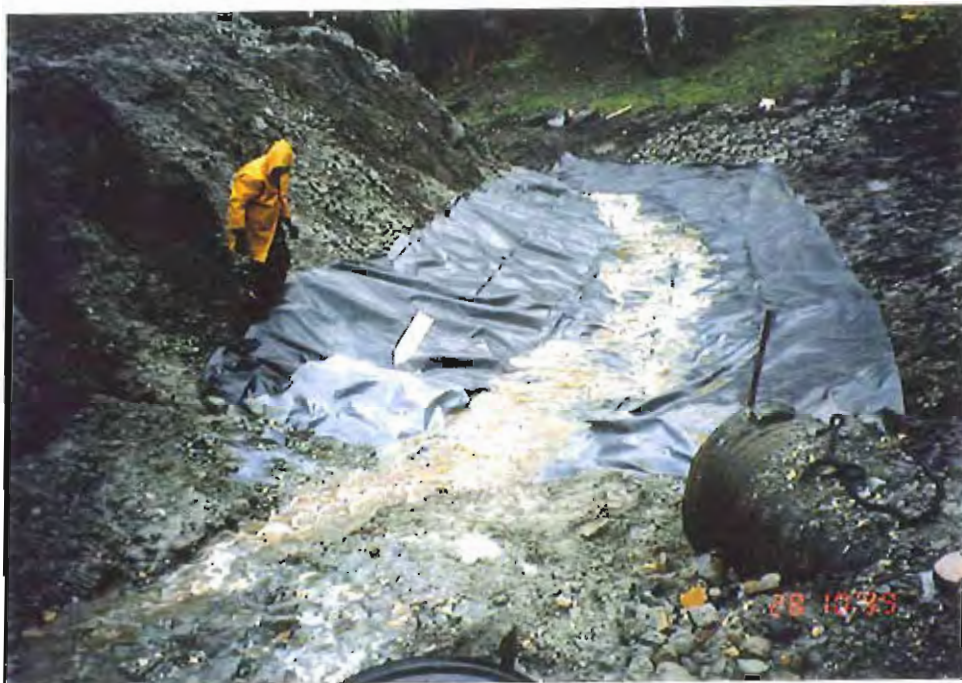
Photo #34: Initial placement of the 20'-wide by 30-mil membrane liner in the APC/Sitka landfill's northwestern ditch on 10/28/99. Arrow points to where the liner section already beneath the culvert discharge has been lapped over the end of the new liner.

On 10/28/99 the area just below the roadside culvert discharge ends was prepared for laying the 30-mil by 20'-wide membrane liner. Photos #33-#36, pages A18-A19, show the process in securing the liner and then methodically covering it with crushed-concrete fines and finally larger rock to hold the fines in place. Armor rock was placed along both sides of the ditchline, and the completed ditchline is shown on pages A20-A21 (refer to Cross-Section D-D on page C11 for installation details).

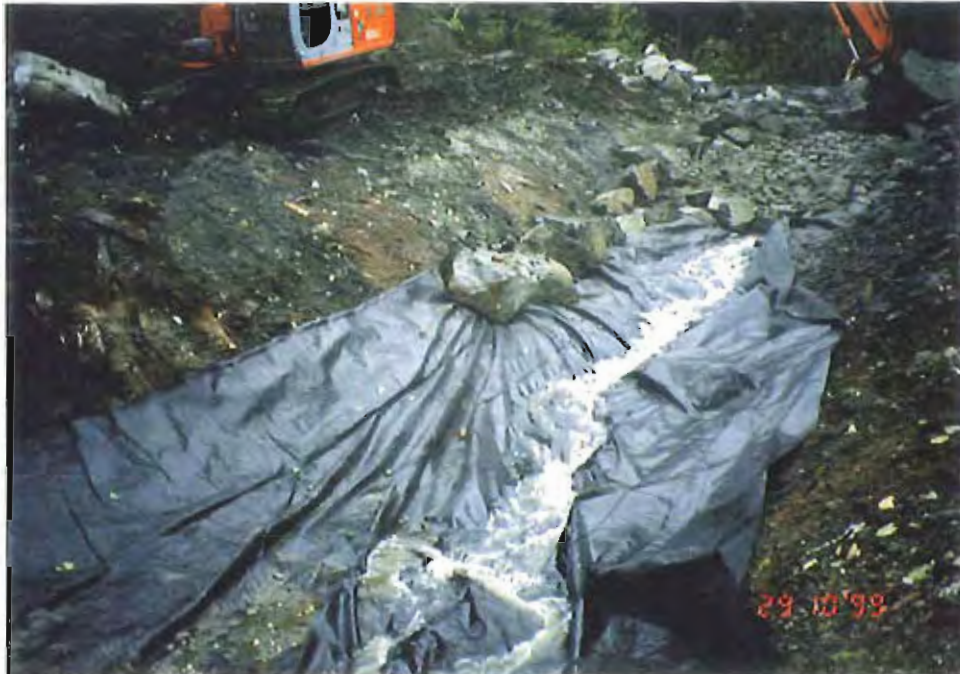
Photo #35: 10/29/99 view of the APC/Sitka landfill's northwestern ditch, showing the protective rock layer being placed over the 20'-wide by 30-mil membrane liner. Large rock is placed along and on the upper edges of the liner, with a 1'-thick layer of smaller rock placed across the inner surface of the liner.

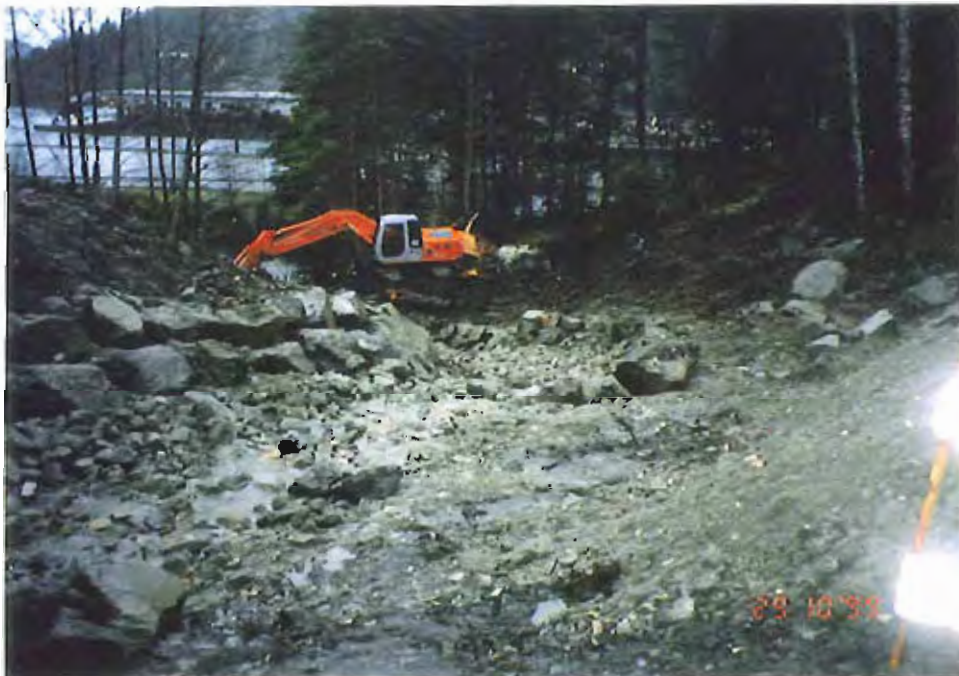
Photo #36: 10/29/99 view looking down the turn in the APC/Sitka landfill's northwestern ditch, showing the 20'-wide by 30-mil membrane liner now completely covered with protective rock (compare with Photo #34, page A18).

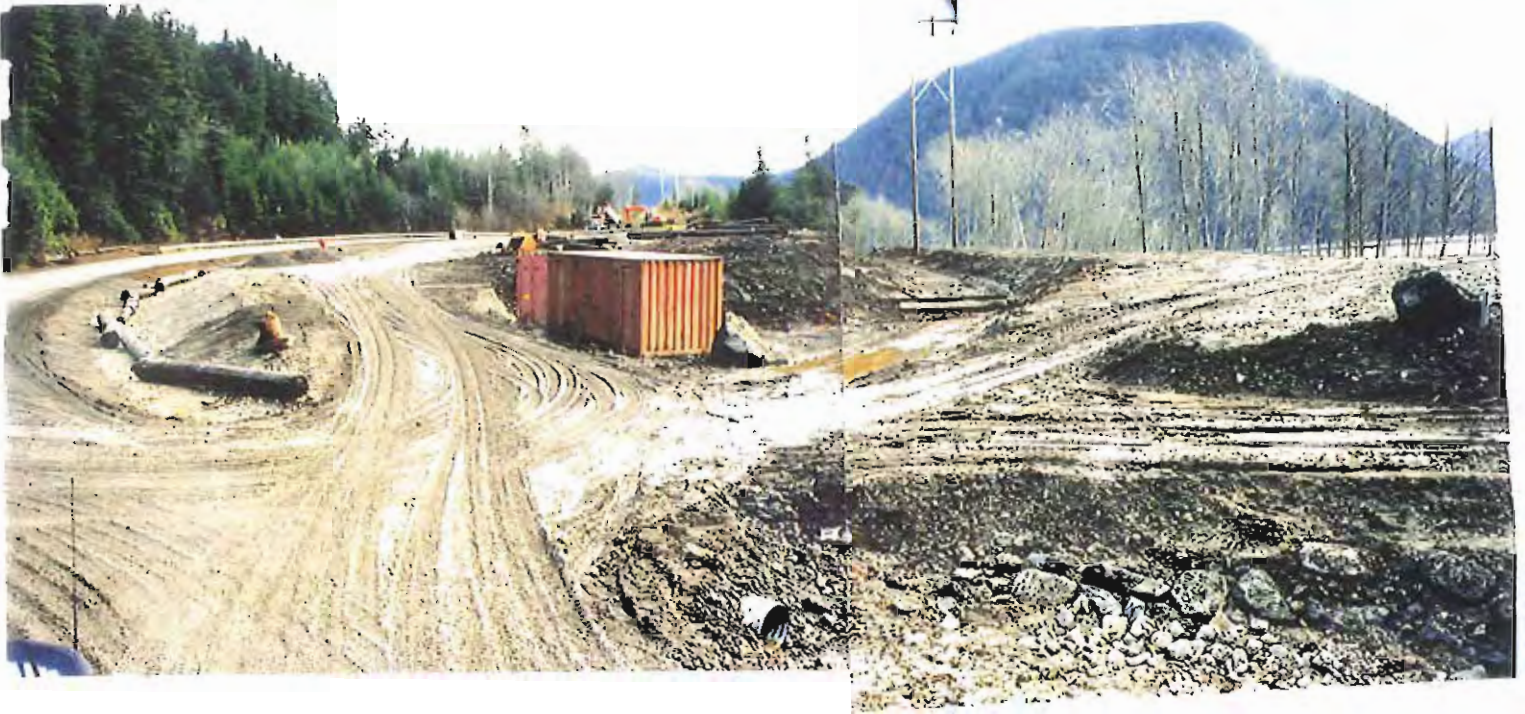
Photo #37: 11/11/99 view of the APC/Sitka landfill's entrance area, showing the completed roadside ditch and logs in the ditch in preparation for final placement along the top outside top of the ditch once the surfacing fill and soil are completed.

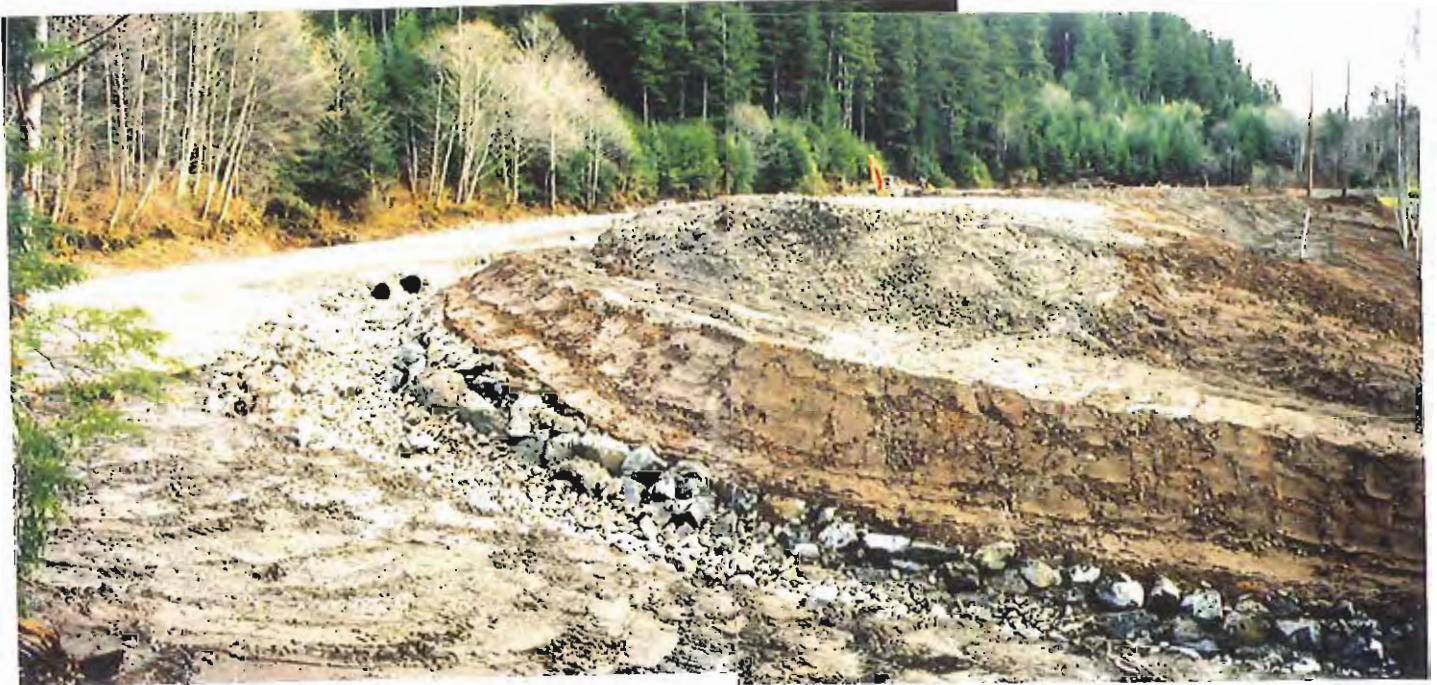
Photo #38: 11/11/99 view of the APC/Sitka landfill's northwestern ditch, now completed.

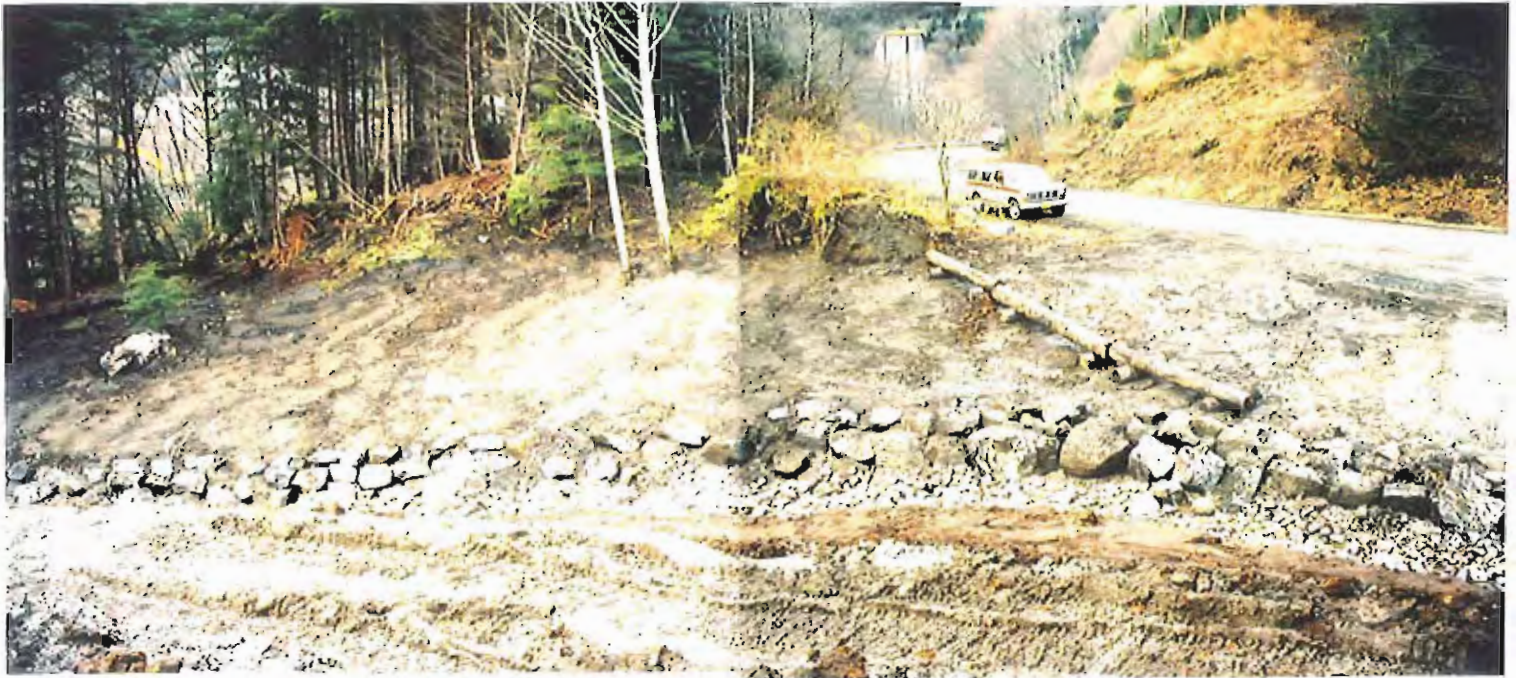
Photo #39: 11/11/99 view looking northwest and across the APC/Sitka drainage ditch, showing the completed landscaping and barrier logs placed along the Sawmill Creek Roadway.

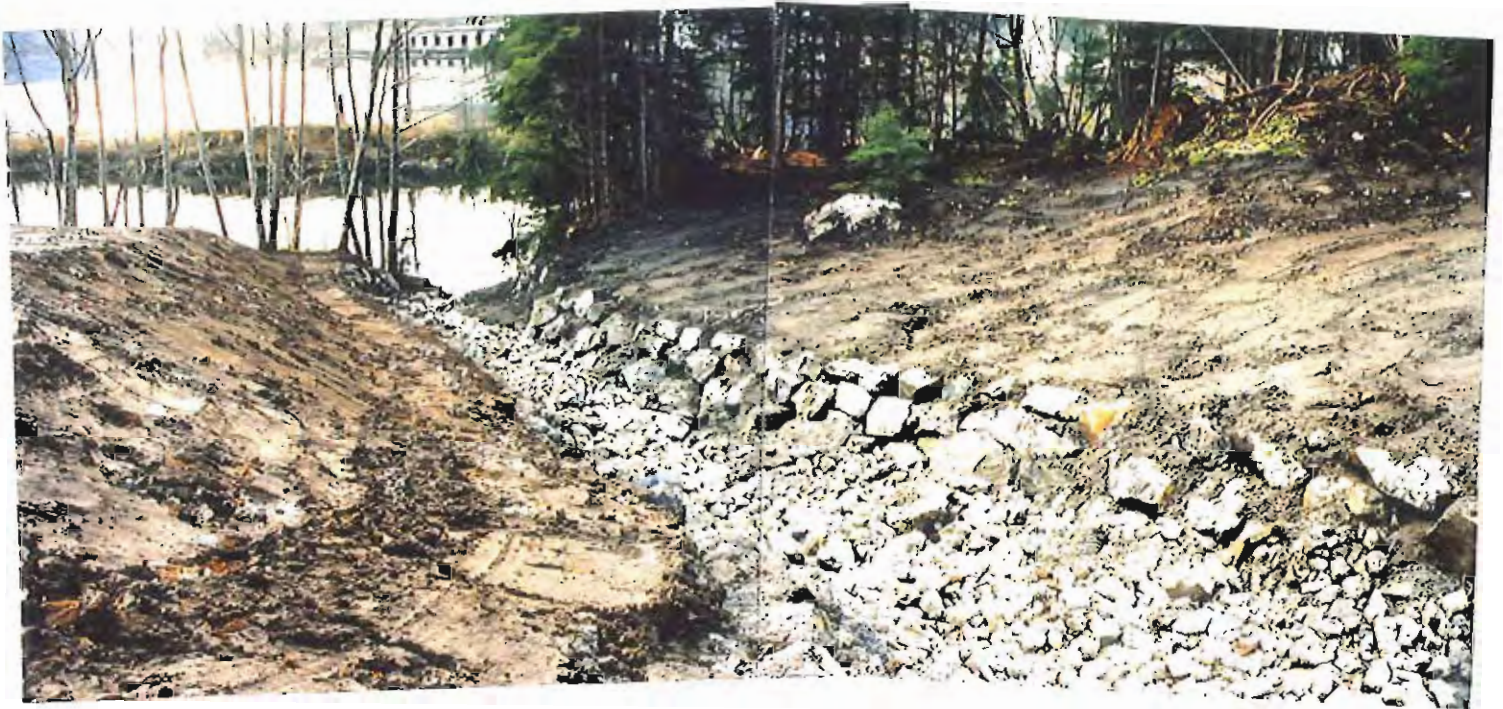
Photo #40: 11/11/99 view looking down the APC/Sitka landfill's northwestern ditchline, showing the completed soil placement and landscaping along both sides of the ditch. Also shown are the large armor rock along the sides of the ditch, and the 6"-8" rock completely covering the ditch bottom for erosion control.

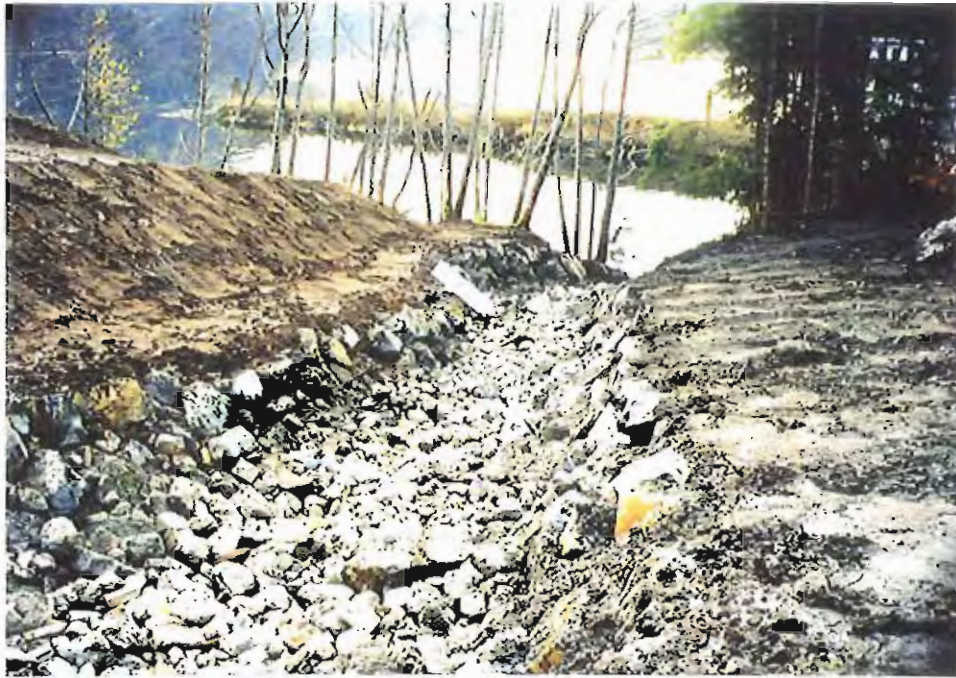
Photo #41: 11/11/99 view across the bottom area of the APC/Sitka landfill's northwestern drainage ditch. The 20'-wide by 30-mil membrane liner now is completely covered with 6"-8" rock to protect against erosion. The arrow shows where the membrane liner ends, after which hard rock makes up the bottom of the ditch.

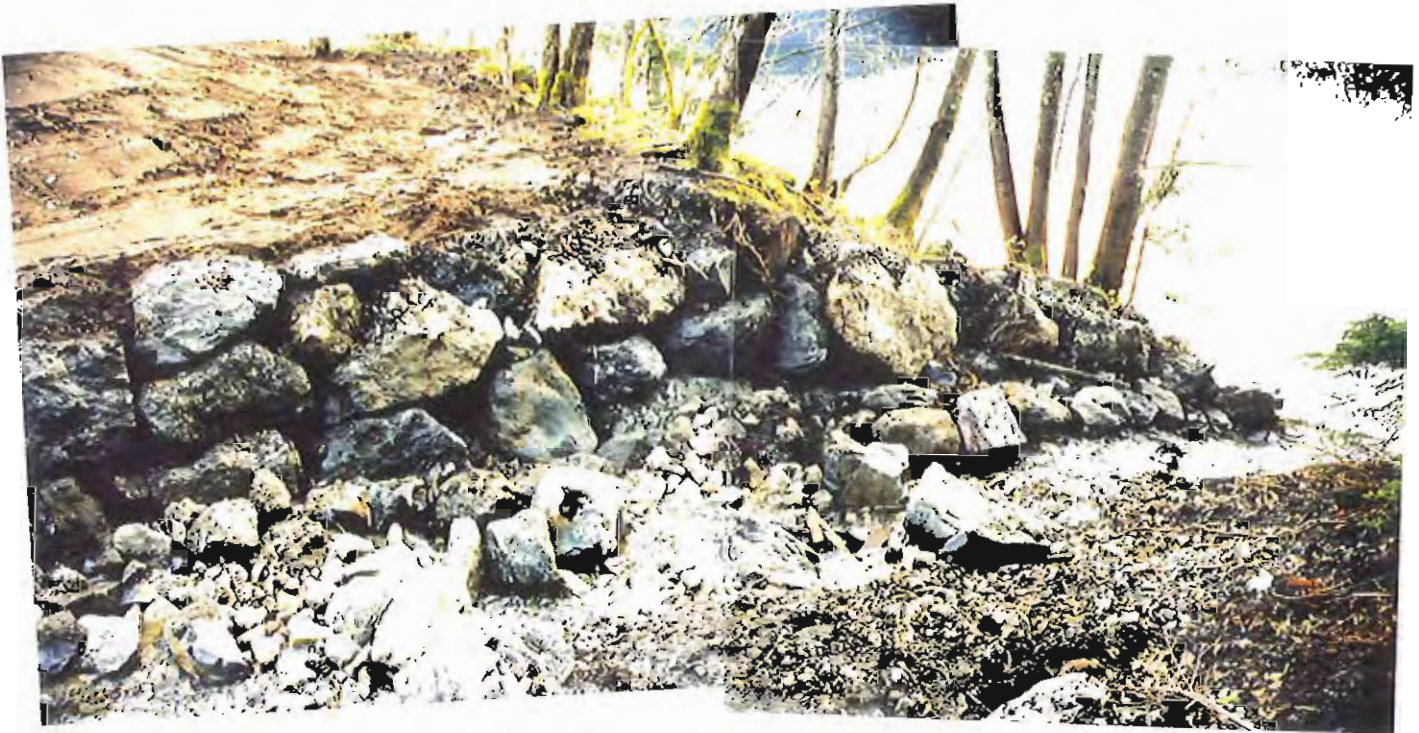
Photo #42: Closer 11/11/99 view near the end of the APC/Sitka landfill's northwestern surface water drainage ditch, showing the completed rockwork to protect against bank erosion.

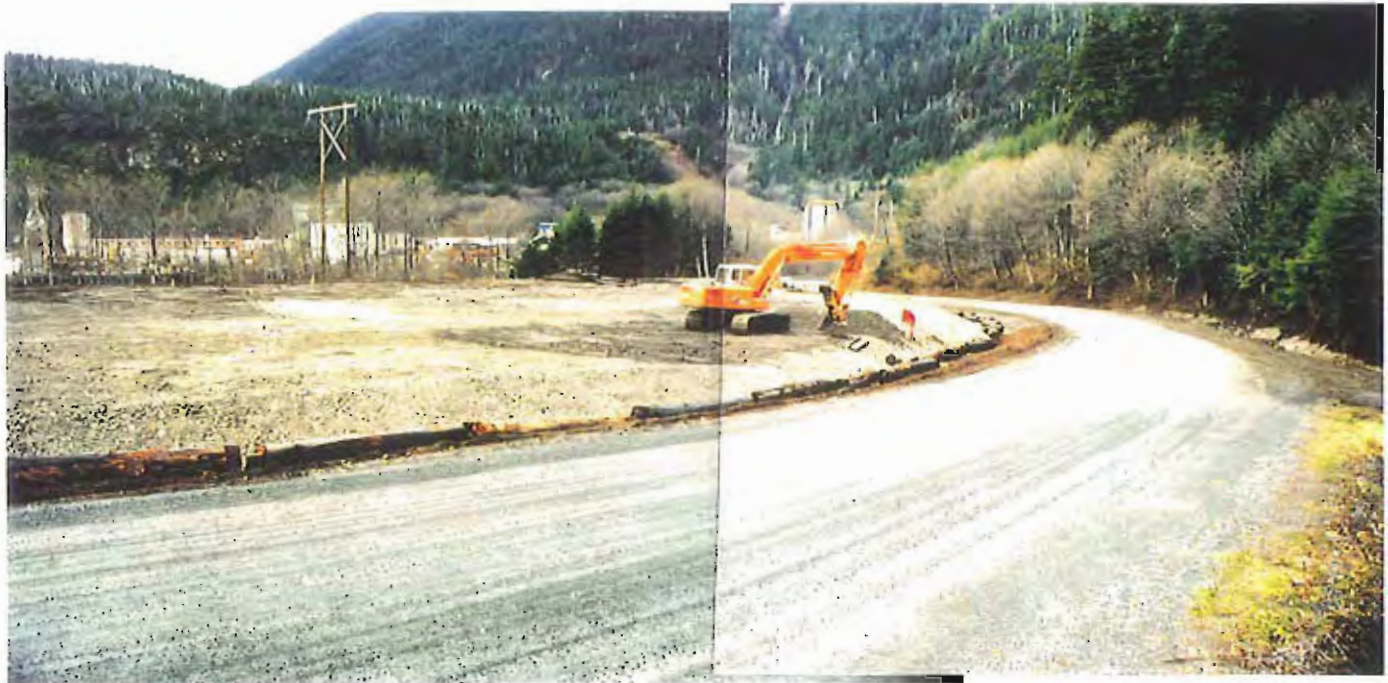
Photo #43: Looking northwest across the Sawmill Creek Road at the APC/Sitka landfill on 11/11/99, showing the spreading of crushed concrete over the top surface.

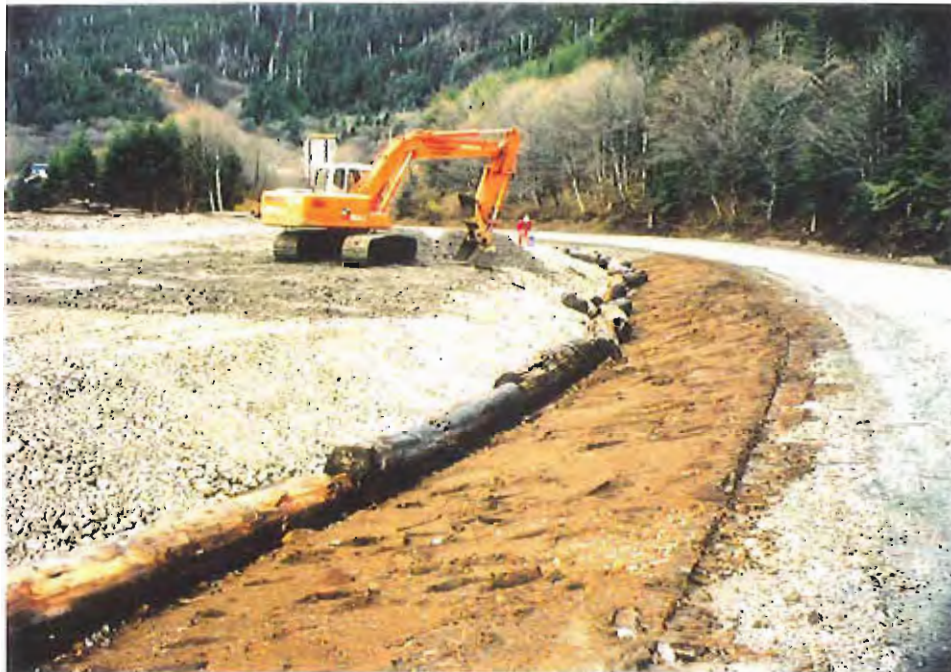
Photo #44: Closer view of the backhoe spreading the crushed concrete fill in thin layers along the APC/Sitka landfill's roadside ditch, 11/11/99. A laborer can be seen watching out for and picking up any remaining pieces of metal that might be seen in the fill material.

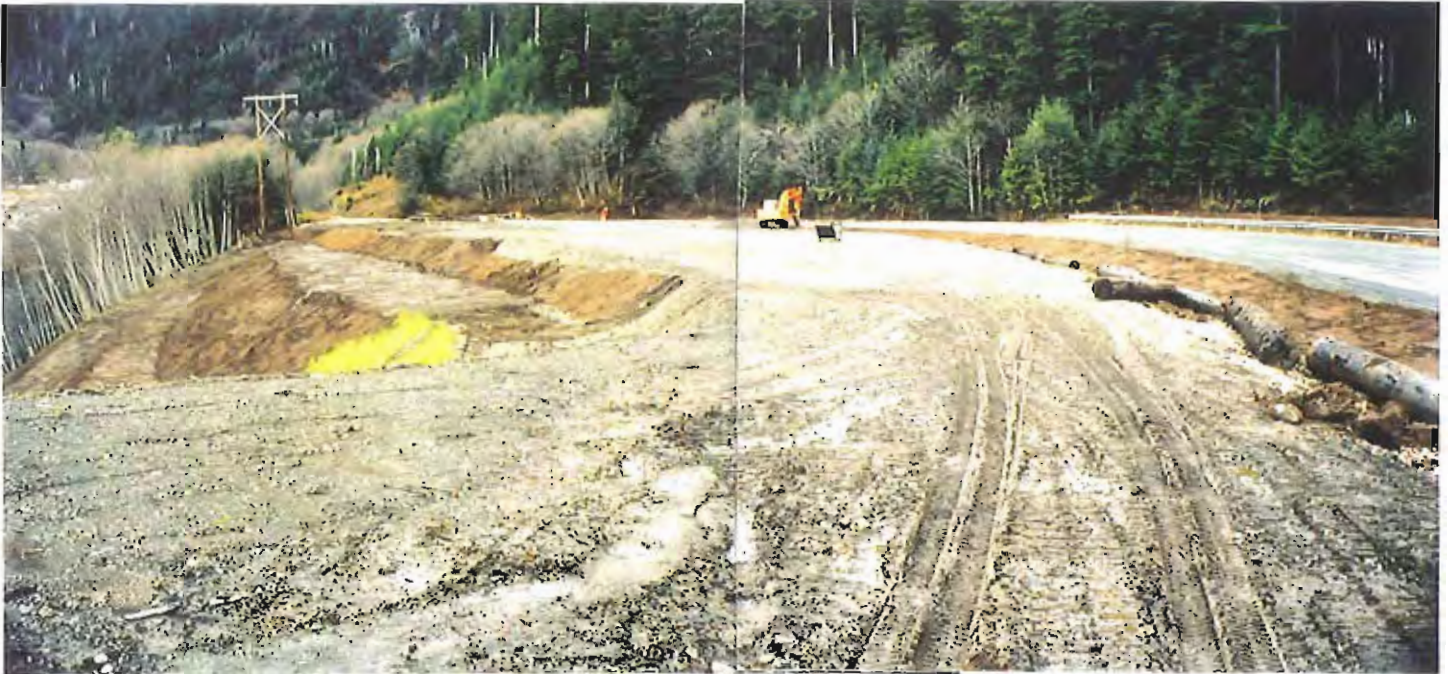
Photo #45: Looking northwest across the upper surface and embankment of the APC/Sitka landfill on 11/11/99. The crushed-concrete surfacing layer is completed throughout this area until just beyond the green hopper bin.

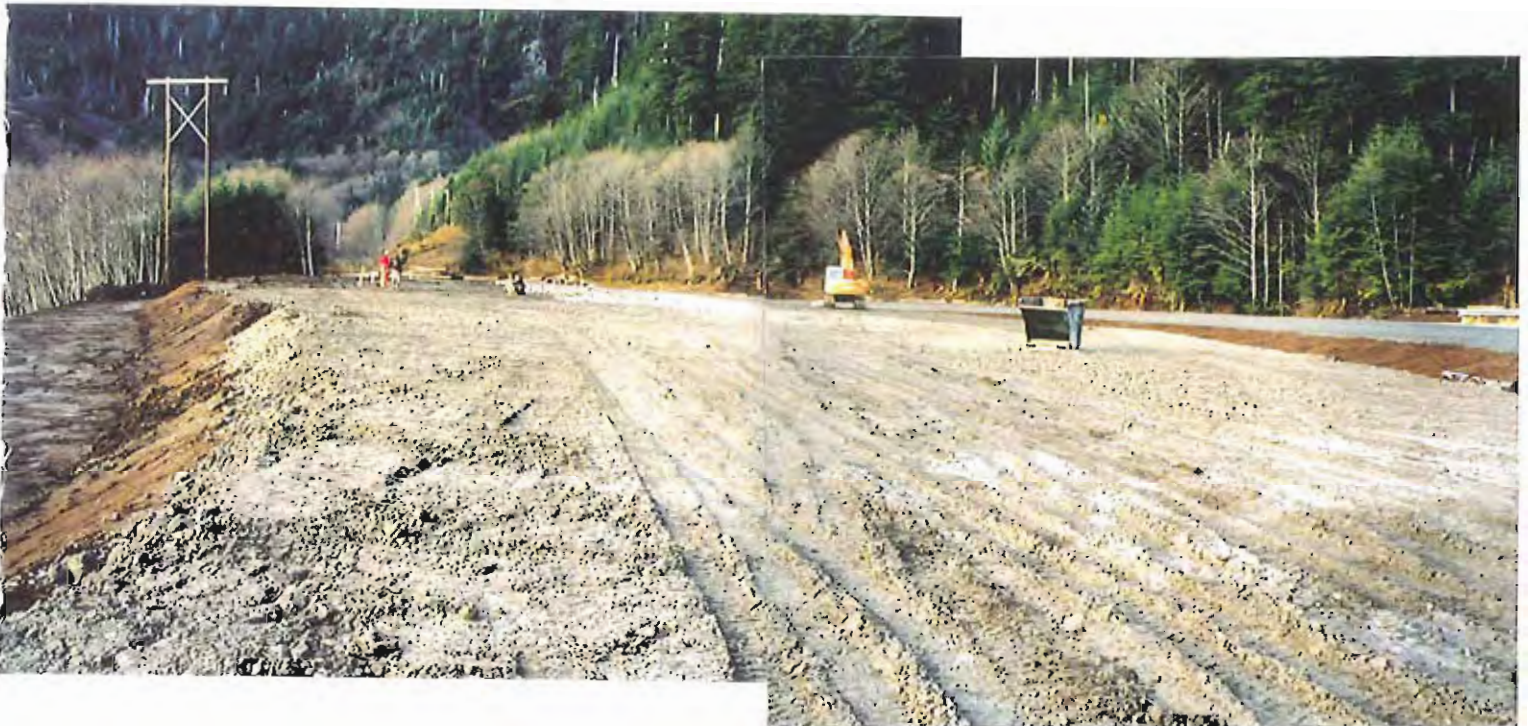
Photo #46: Closer view of the crushed-concrete fill already spread and levelled in preparation for the final 6"-thick covering of soil, 11/11/99. Crushed-concrete fill is continuing to be placed in the far background, where survey stakes are present to guide the final placement of fill.

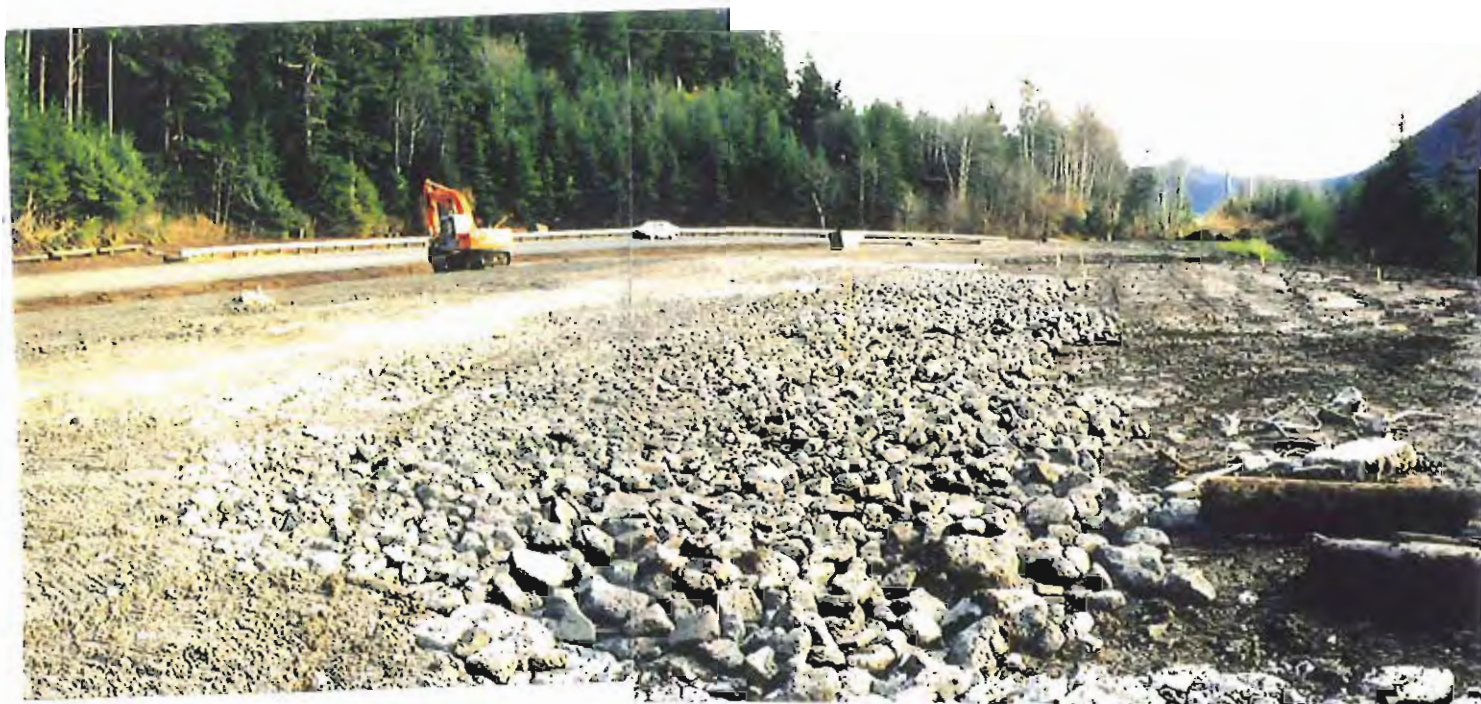
Photo #47: 11/11/99 view looking southeast across the upper surface of the APC/Sitka landfill site, showing the initial 6"-thick layer in the process of being placed. Survey stakes can be seen throughout the area being filled, to make certain that the 18"-thickness will be achieved throughout the area.

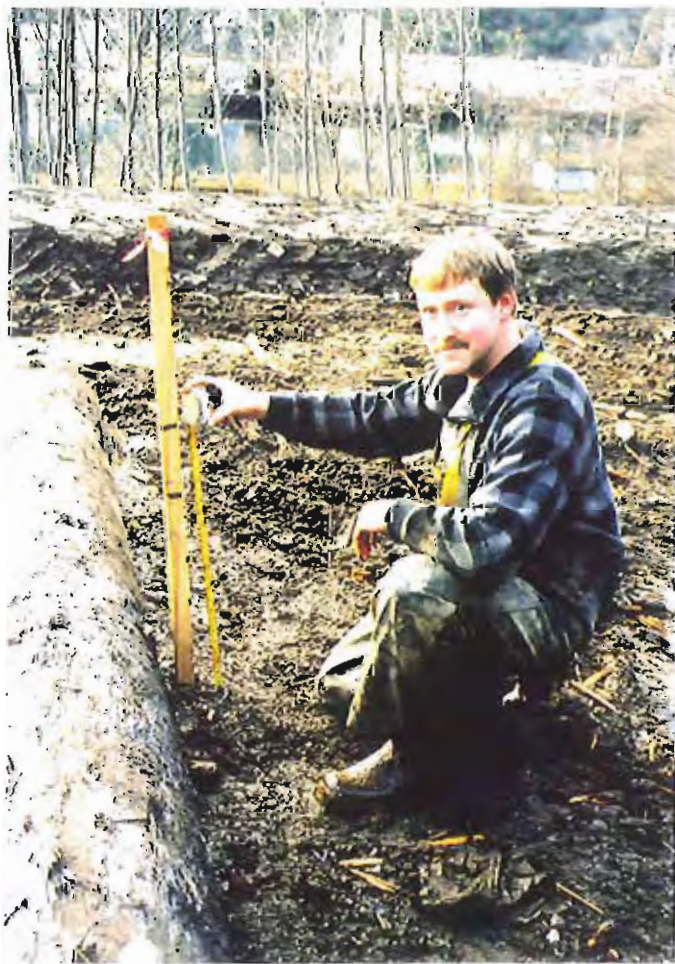
Photo #48: Close-up view of the survey stakes being marked to assure that the crushed-concrete fill is 18" thick throughout, followed by a 6"-thick layer of soil.

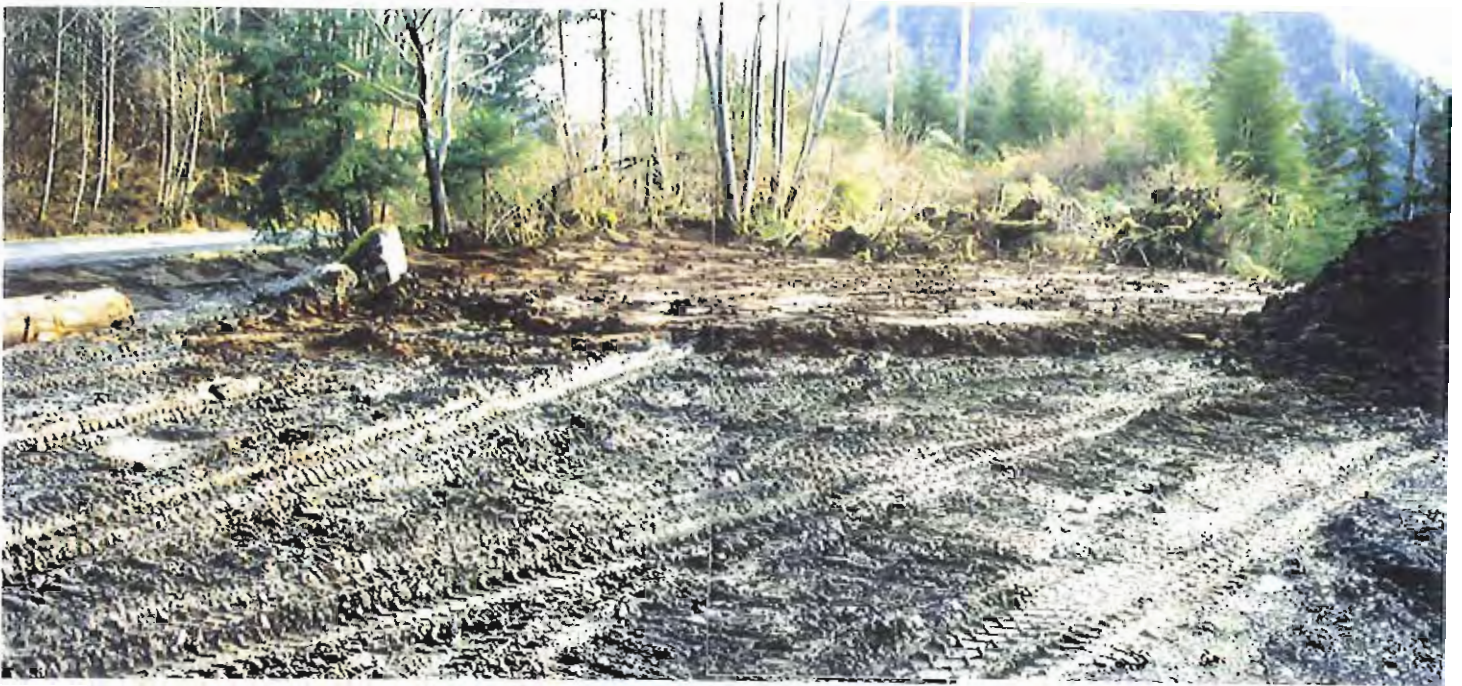
Photo #49: 11/11/99 view of the final 6"-thick surfacing layer of soil being placed along the south end of the APC/Sitka landfill.

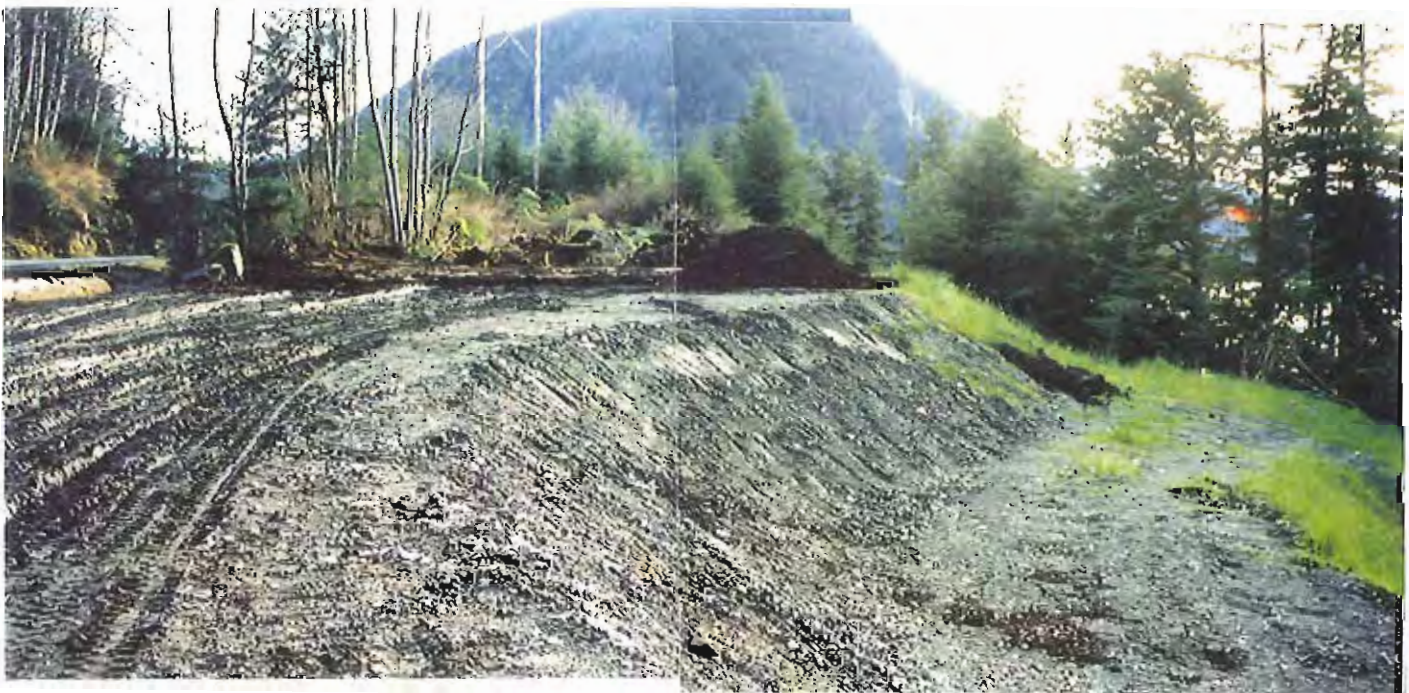
Photo #50: Closer view of the 6"-thick layer of surfacing soil being placed across the south end of the APC/Sitka landfill site on 11/11/99.

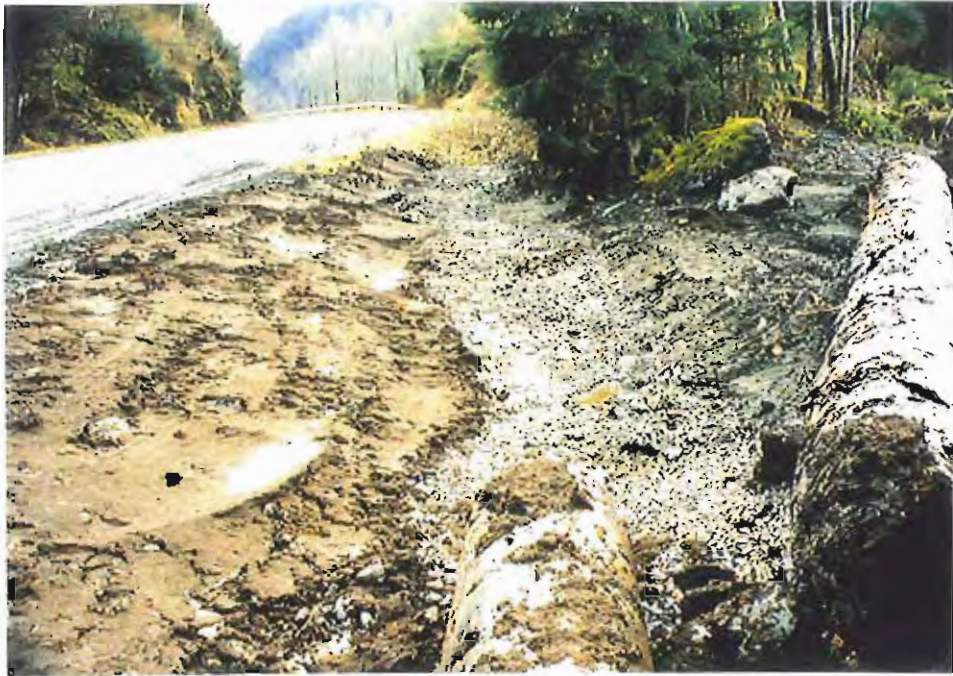
Photo #51: Looking southeast across the end of the Sawmill Creek Roadway's lower ditchline, now completed with its 10'-wide by 30-mil membrane liner completely covered with crushed concrete fill and a soil layer covering the roadside embankment (compare with Photo #8 on page A5).

Details of the final ditchline are shown in Cross-Section B-B on page C10. In addition, a 6"-thick layer of soil was added to the roadside bank and extended over the edges of the crushed-concrete layer as shown in Photo #25, page A14, and continued to the upslope end of the ditch (see Photo #51, page A27). As the project neared completion on 11/23/99, the 6"-thick soil layer along the fill embankment had been extended over the crushed-concrete sides of the ditchline as shown in Photo 80 on page A41.

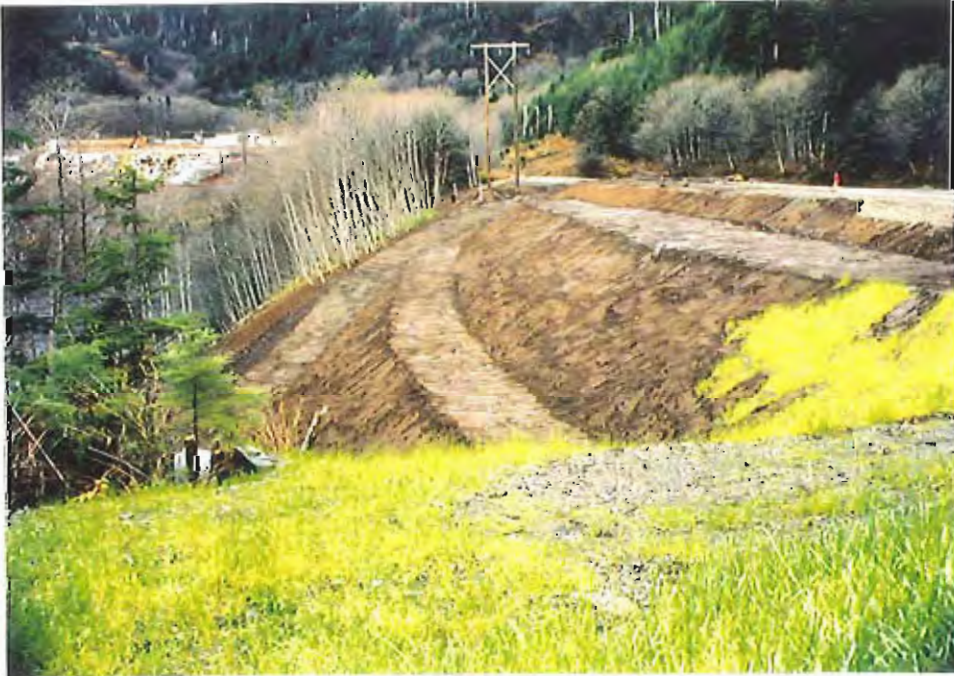
Photo #52: Looking northwest across much of the APC/Sitka landfill's main embankment area, showing the final 6"-thick layer of soil to be in place except for the far right-hand edge of the photo.
