BOARD OF DIRECTOR'S MEETING

Gary Paxton Industrial Park – Board of Directors Meeting
April 27, 2020 3:00pm – Zoom Meeting
DRAFT Meeting Minutes

II.A. Site Description & Initial Conditions

FIGURE IV:
APC-SITKA SOLID WASTE DISPOSAL FACILITY - 11/24/98 CONDITIONS
 Located along Sawmill Creek near Sitka, Alaska

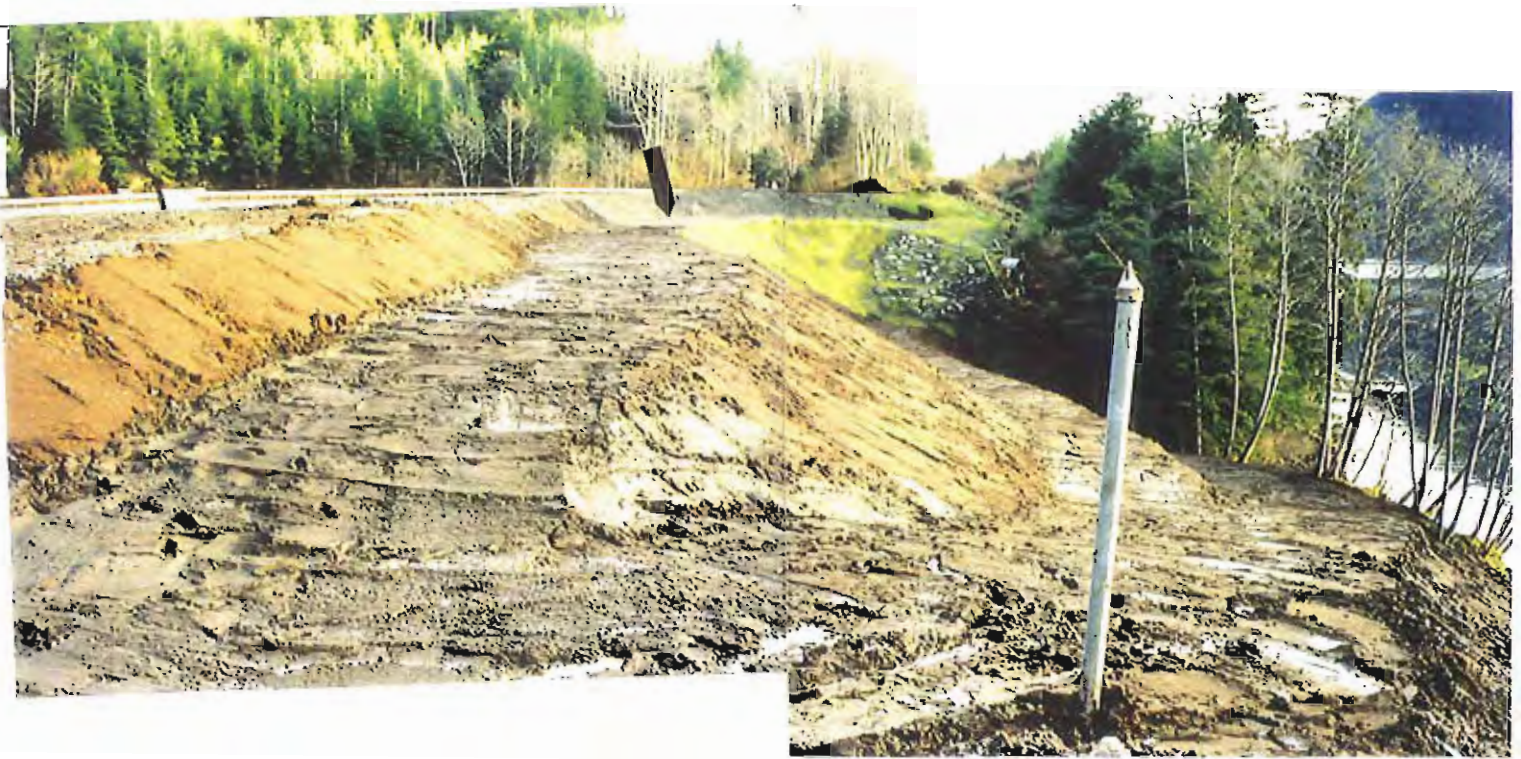
Photo #53: Looking southeast across the upper embankment of the APC/Sitka landfill on 11/11/99, showing it to be completely covered with a 6"-thick layer of soil. The only area still remaining to be covered is just beyond the arrow.

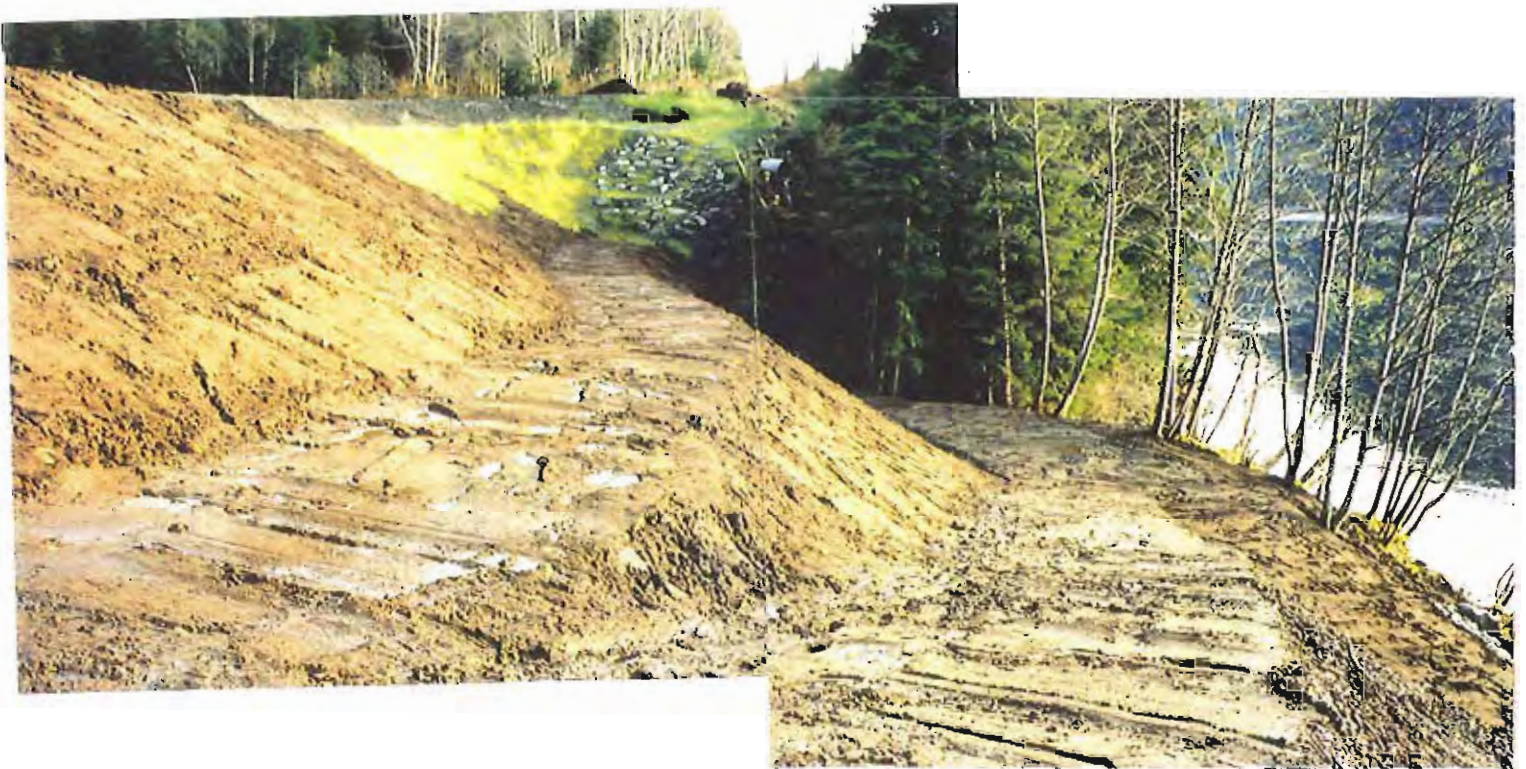
Photo #54: 11/11/99 view looking southeast across the mid-&-lower levels of the APC/Sitka landfill's embankment, showing the entire area to be covered with its final 6"-thick layer of soil.

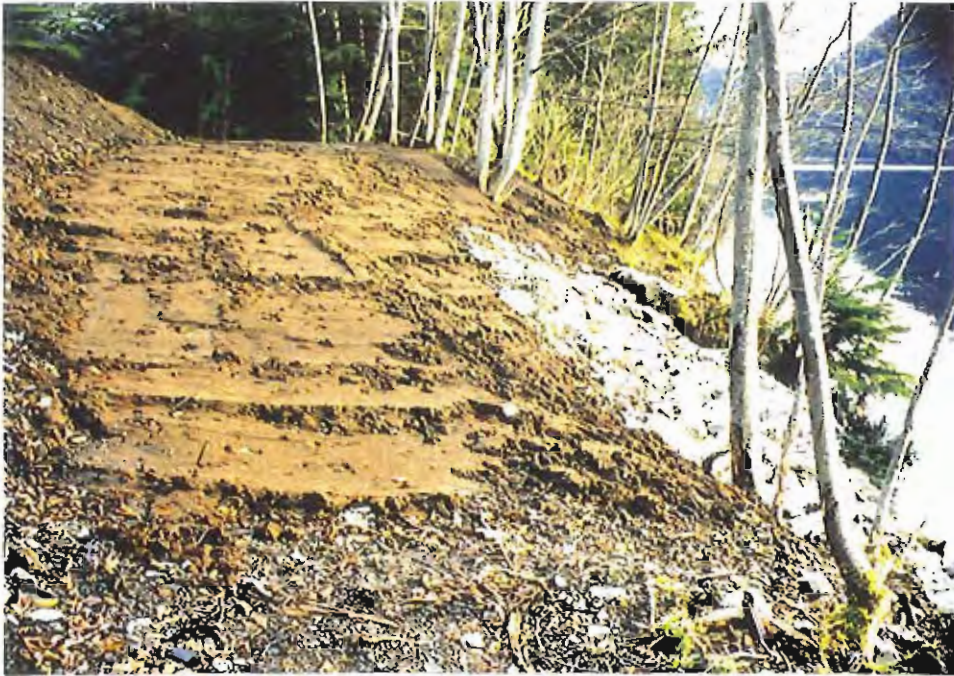
Photo #55: Looking southeast across the top of the tidelands stabilization rockwork at about Sta. 3+00', showing the completed 6"-thick soil layer to extend to the top of the rock and to the undisturbed embankment in the far right of the photo.

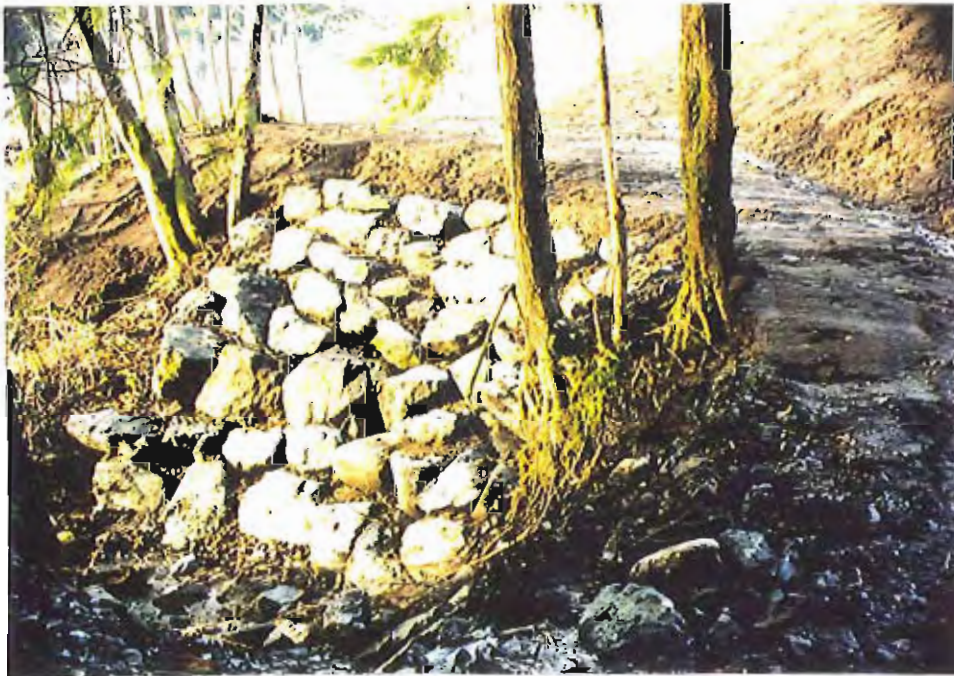
Photo #56: 11/11/99 view of the completed stabilization rockwork along the bottom toe of the APC/Sitka landfill embankment at about Sta. 1+30'. Also shown is the completed 6"-thick layer of soil over the upper pathway and along the lower embankment to the left side of the rockwork.

On 6/3/99 the initial lower embankment slope area along Sta. 1+30' – Sta. 2+10' was compacted into place by backhoe bucket, and armor rock was placed along the toe of the embankment where a small surface water drainage stream was present (see Photo #56 on page A29). By 6/14/99 the steep cliff area about halfway up the embankment near the southern culvert discharge was lined with armor rock, to make this rock-cliff transition area both safe and stable. The adjacent stepped-embankments then were completed at an overall 1.8:1 slope, and by 6/30/99 an initial portion of the embankments was covered with a 4"-thick layer of soil. By 8/18/99 the southeastern embankment excavations were completed, and were ready for soil covering.

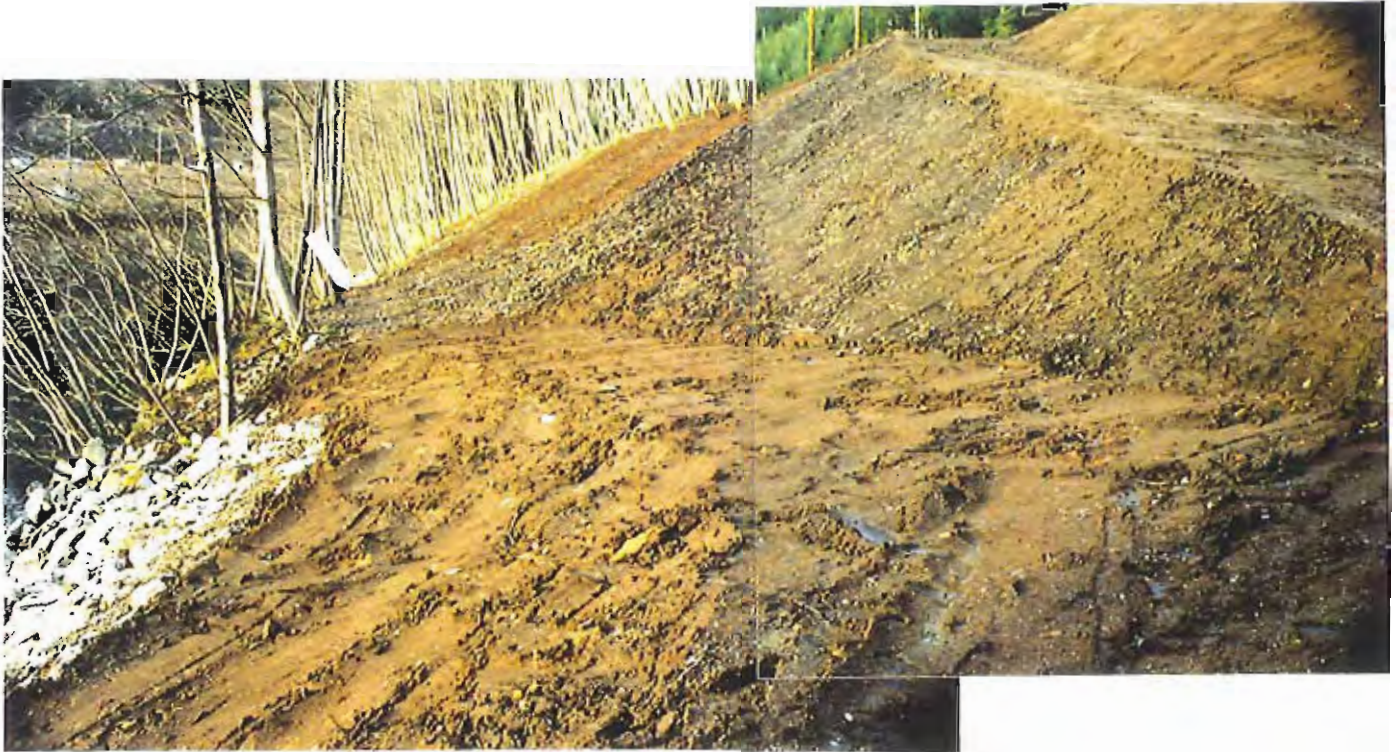
Photo #57: 11/11/99 view looking northwest from about Sta. 1+70' along the toe of the APC/Sitka landfill's embankment, showing the completed placement of the area's 6"-thick soil cover. Arrow points to the location of a very small water seep, refer to the photo below.

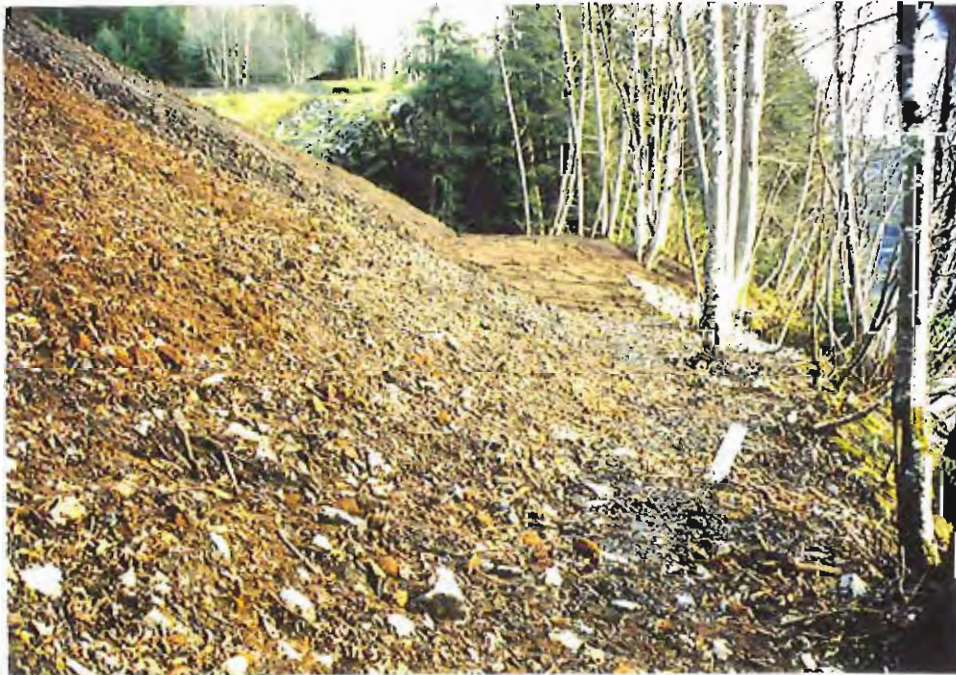
Photo #58: Closer 11/11/99 view of a damp soil area at about Sta. 3+50' along the APC/Sitka landfill's embankment toe, where a very small unmeasurable water seepage appears to be present.

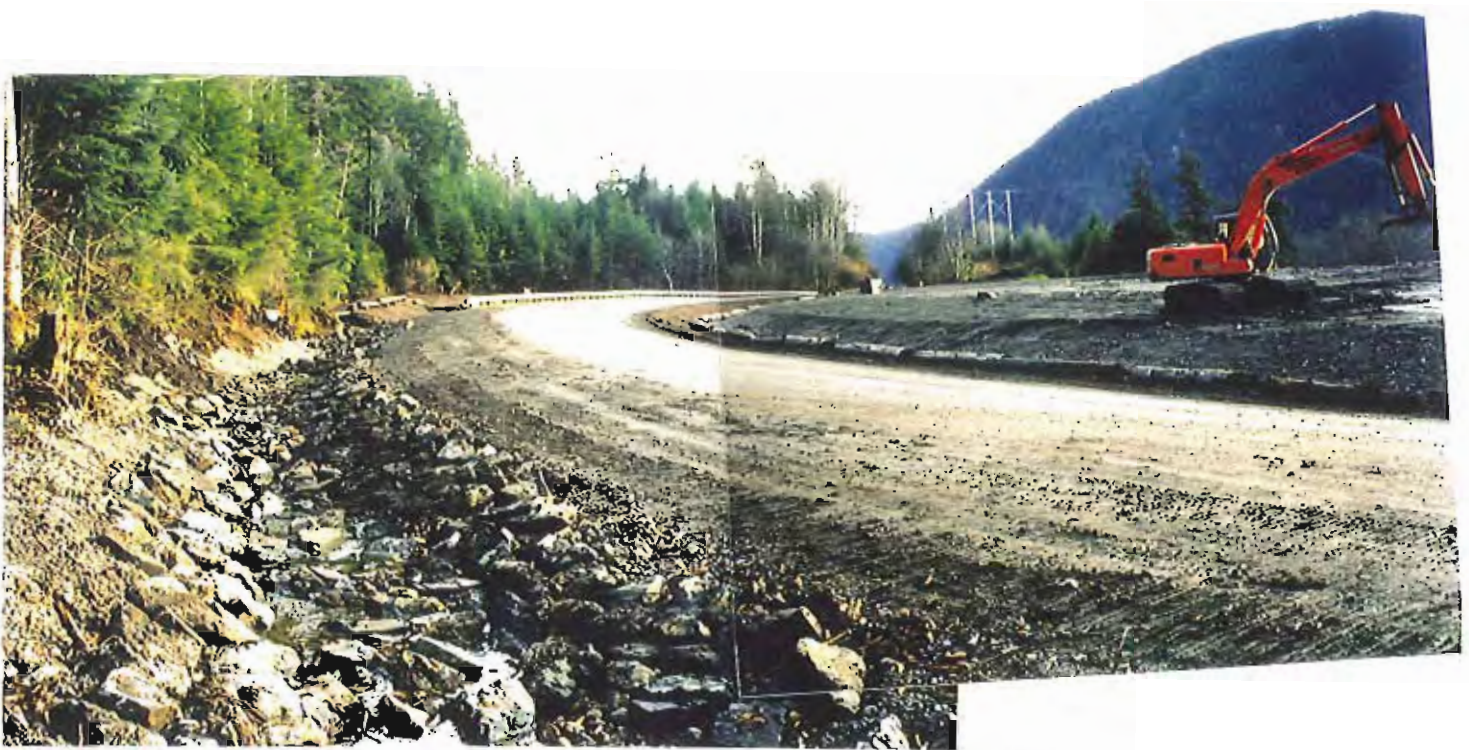
Photo #59: Looking south across the Sawmill Creek Road from about Sta. 3+50', showing the completed upslope ditchline including its armor rock on the right side of the photo, 11/11/99.

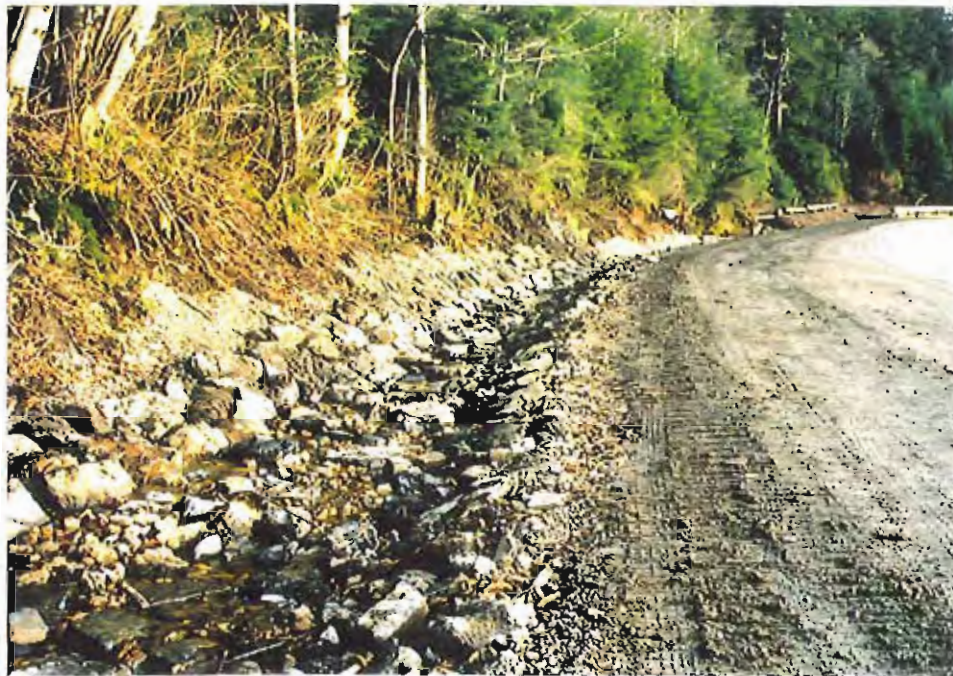
Photo #60: Closer 11/11/99 view of the upslope surface water drainage ditch along the Sawmill Creek road, showing the completed placement of armor rock along the sides of the ditch (compare with Photo #20, page A11).

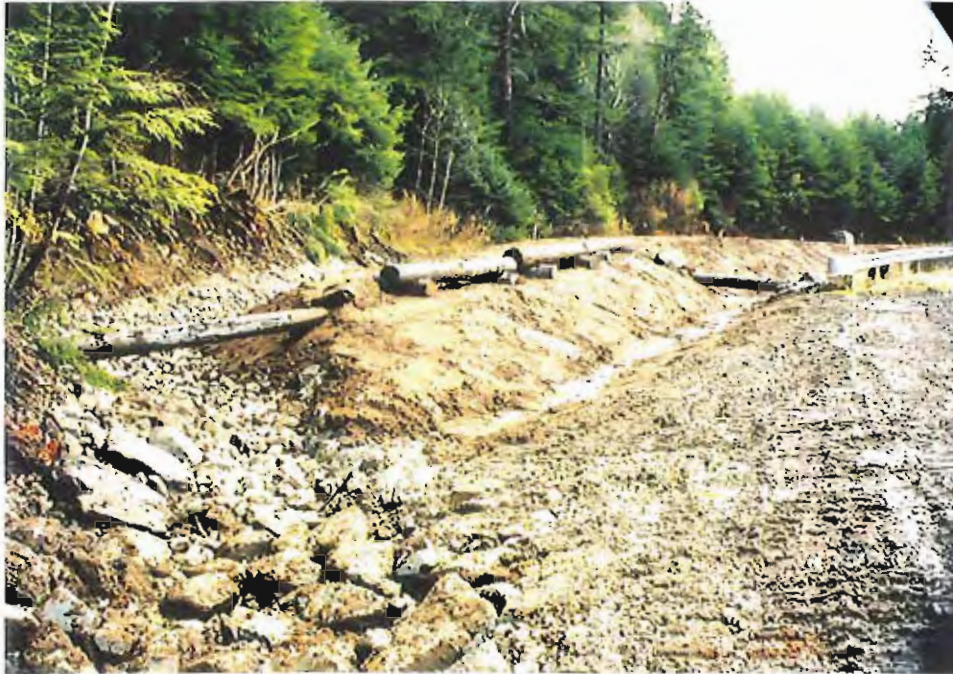
Photo #61: 11/11/99 view looking southeast across the lower end of the APC/Sitka landfill's northeastern disposal area, showing the completed ditchlines, final soil cover and roadside log barriers.

Photo #11, page A7, shows the care taken to make certain that the upper edges of the 30-mil membrane were definitely sealed into the ditchline's upper soil embankments. By 10/13/99 a 6"-thick layer of crushed-concrete fines were being placed over the membrane, and by 10/20/99 the entire membrane was covered with crushed-concrete (refer to Photo #12 on page A7, and Photo #18 on page A10). To help insure the crushed-concrete fines would not wash away, the entire ditchline then was covered with 4"-minus crushed-concrete to complete the ditch as shown in Photos #61 & #63, pages A32-A33.

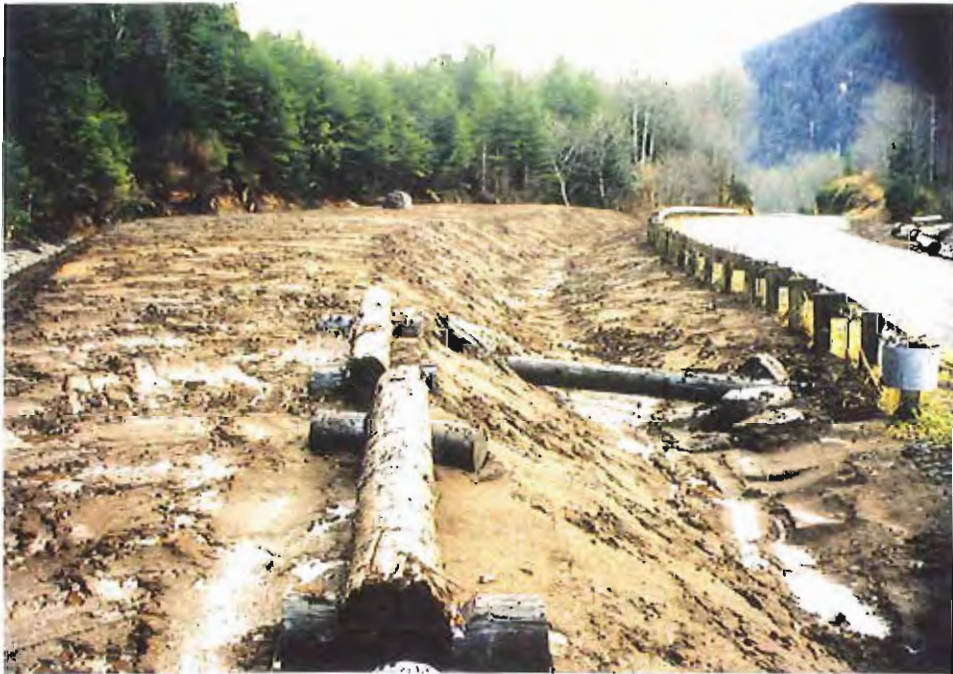
Photo #62: 11/11/99 looking up the completed roadside ditchline between the Sawmill Creek Roadway and the APC/Sitka landfill's northeastern fill area, and the area's now-completed layer of 6"-thick soil.

By 11/11/99 the entire ditchline was sealed with a 6"-thick layer of soil that extended to under the guardrail posts, as shown in Photos #62-#65, pages A32-A34. While this ditchline does not include a plastic membrane (refer to Cross-Section F-F on page C12), the thick soil cover appears to have created an effective seal because considerable surface water runoff is being observed during rainy periods.

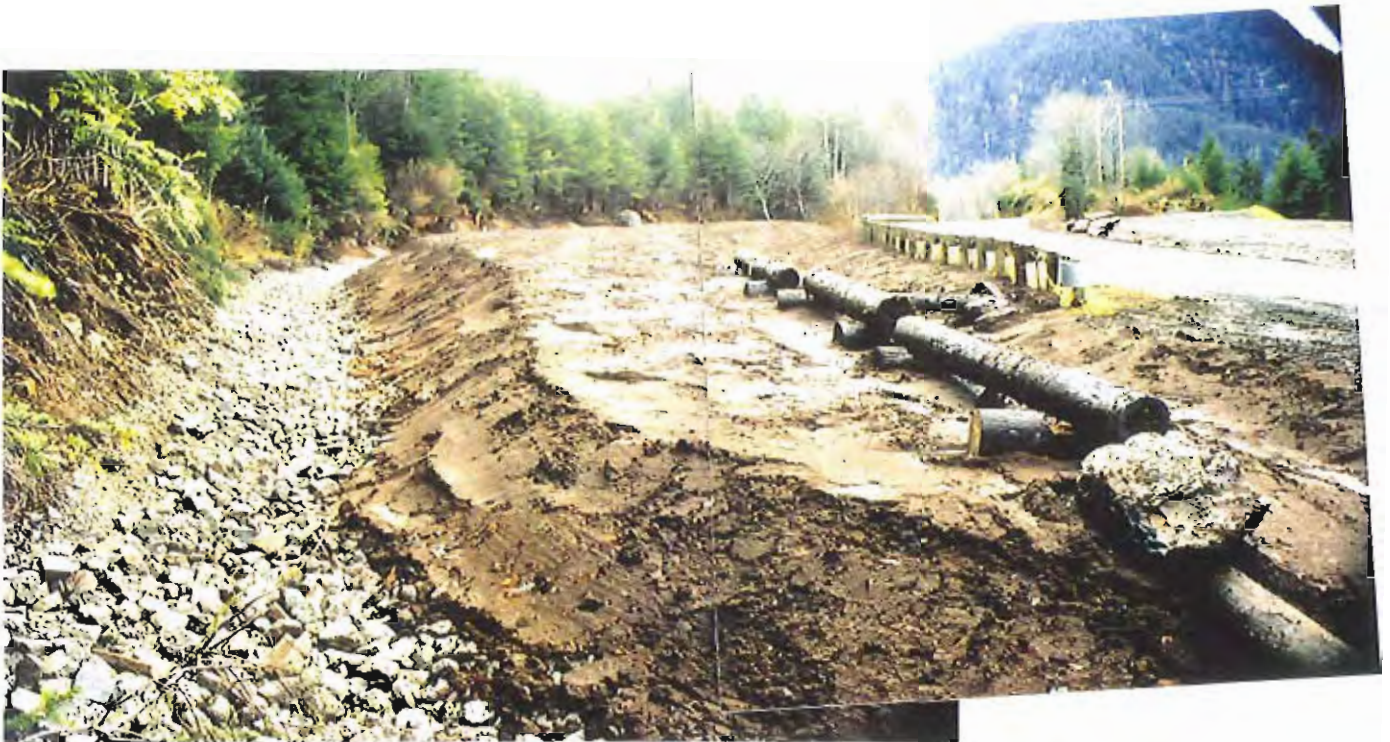
Photo #63: 11/11/99 view of the upslope surface water drainage ditchline around the APC/Sitka landfill's northeastern disposal area, showing the completed crushed-concrete rock now throughout the entire ditchline and the adjacent landfill's 6"-thick soil extending over the rock to the ditch bottom.

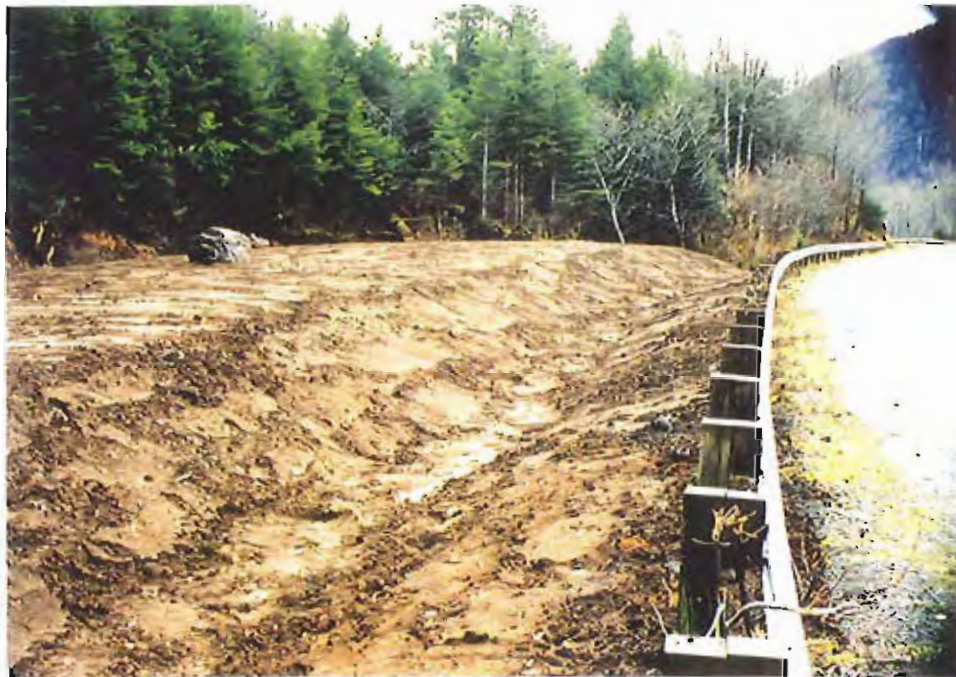
Photo #64: 11/11/99 view looking up the completed ditchline between the Sawmill Creek Road shoulder and the APC/Sitka landfill's northeastern disposal area, showing the area with its 6"-thick soil cover.

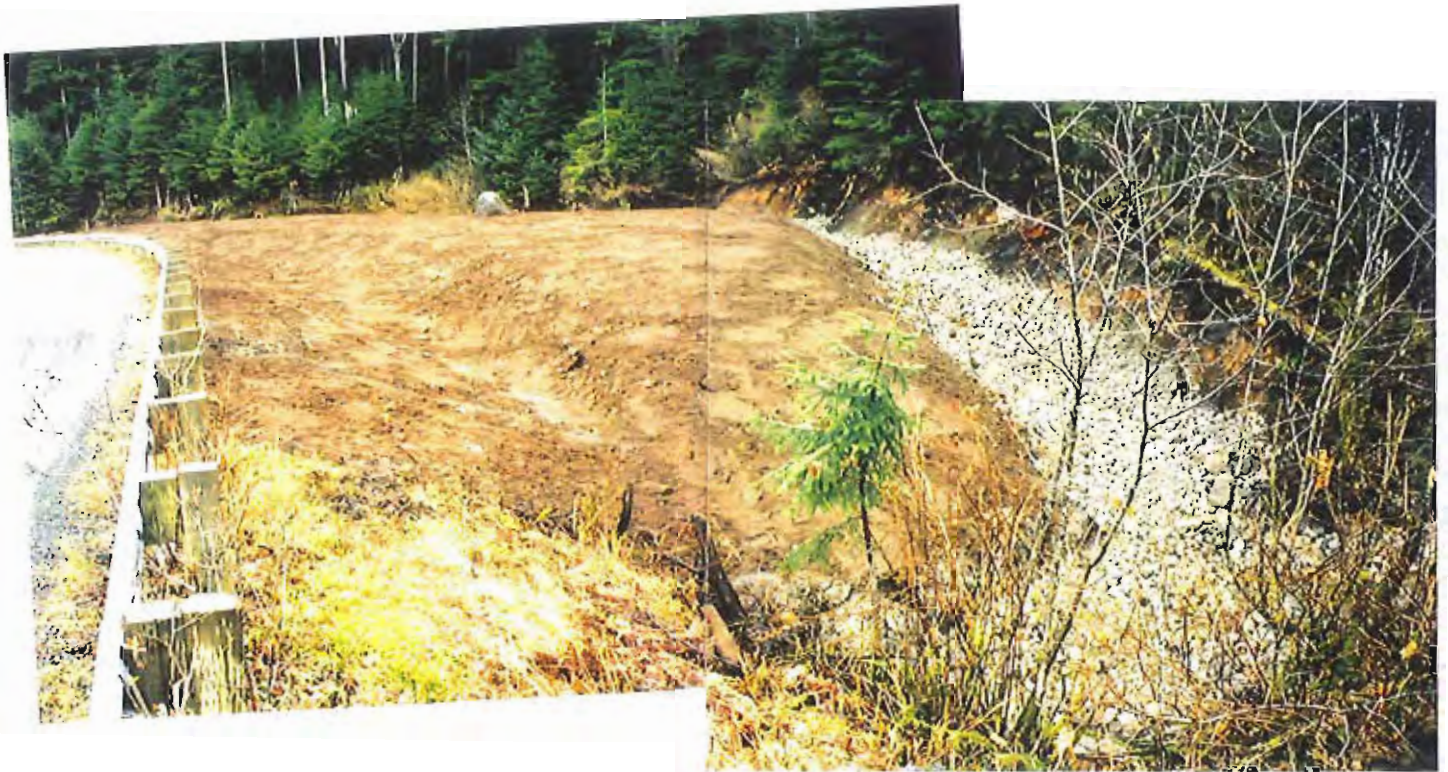
Photo #65: 11/11/99 view looking across the APC/Sitka landfill's northeastern area, showing its completed upslope ditchline and the 6"-thick covering of soil throughout the area which extends to the roadway's edge.

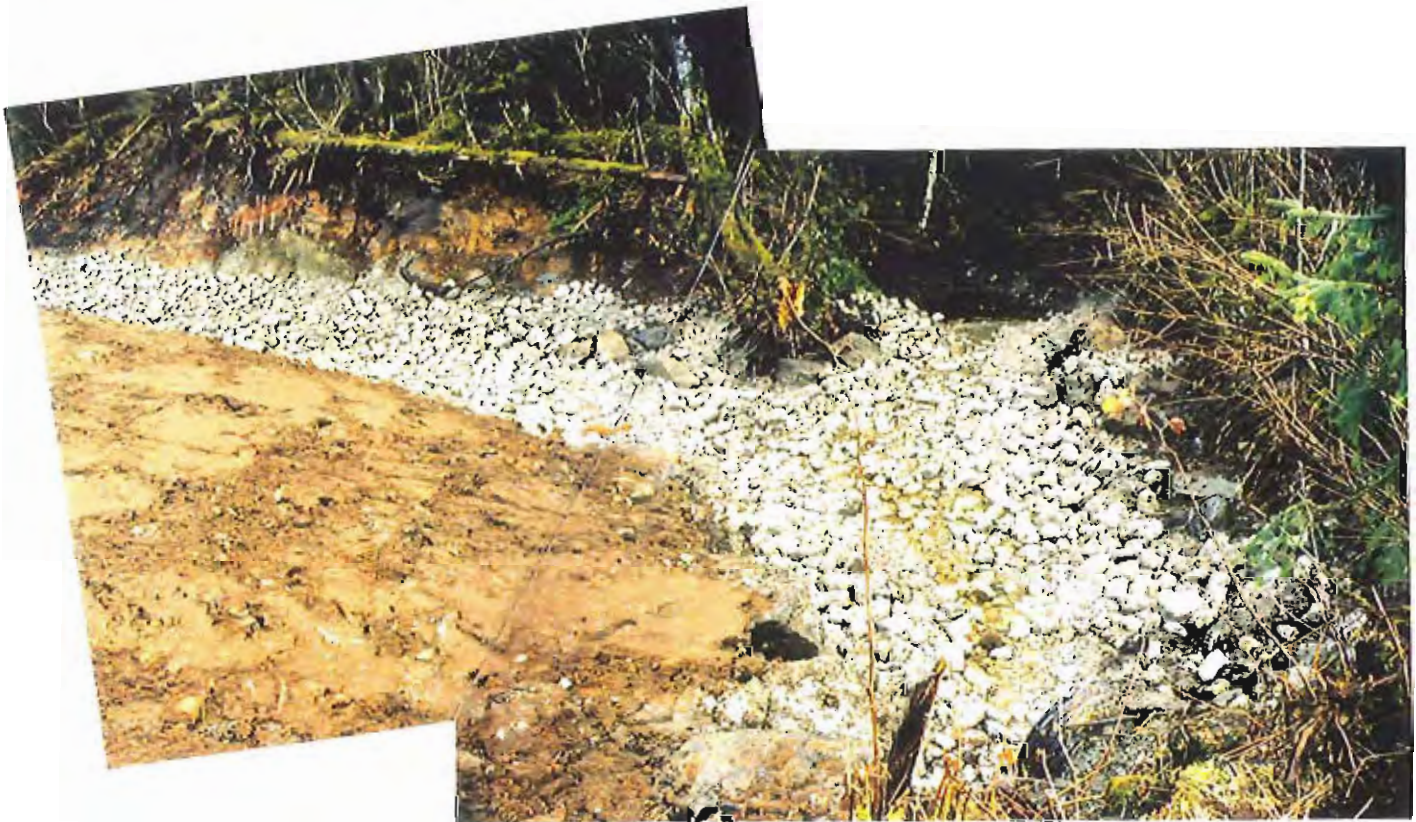
Photo #66: 11/11/99 view looking across the small creek entering the south-end culvert at the APC/Sitka landfill site, showing the crushed-concrete surfacing that completely covers the 30-mil liner that underlies the entire rocked area. The upslope drainage ditchline extending to the right is lined with four 6-mil plastic layers, followed by a 6"-thick layer of crushed concrete.

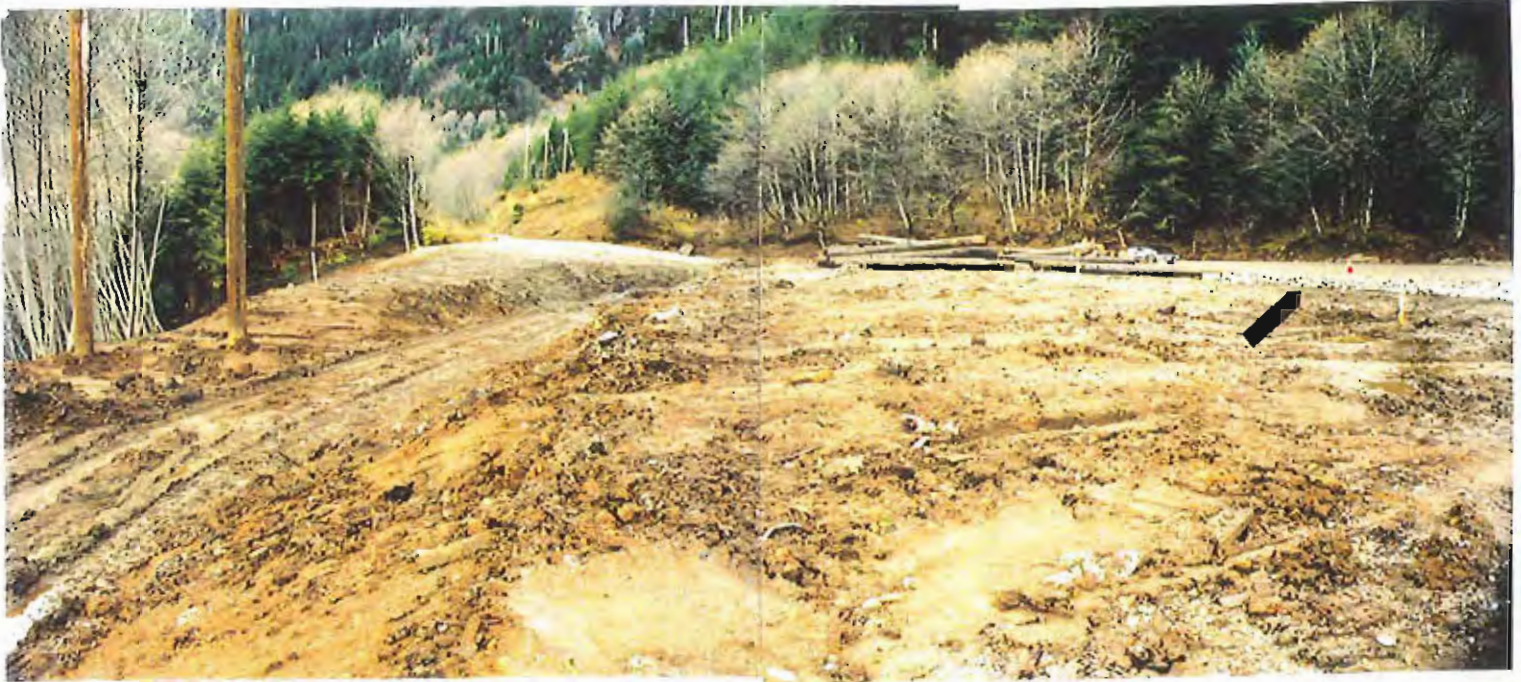
Photo #67: Looking north on 11/11/99 along the APC/Sitka landfill's top surface from about Sta. 3+50', showing the crushed-concrete surfacing fill beginning to be extended across the area (see arrow). Also shown in the far upper portion of the photo is the site's northwestern area, which still has to be covered with 18" of crushed rock and 6" of soil.

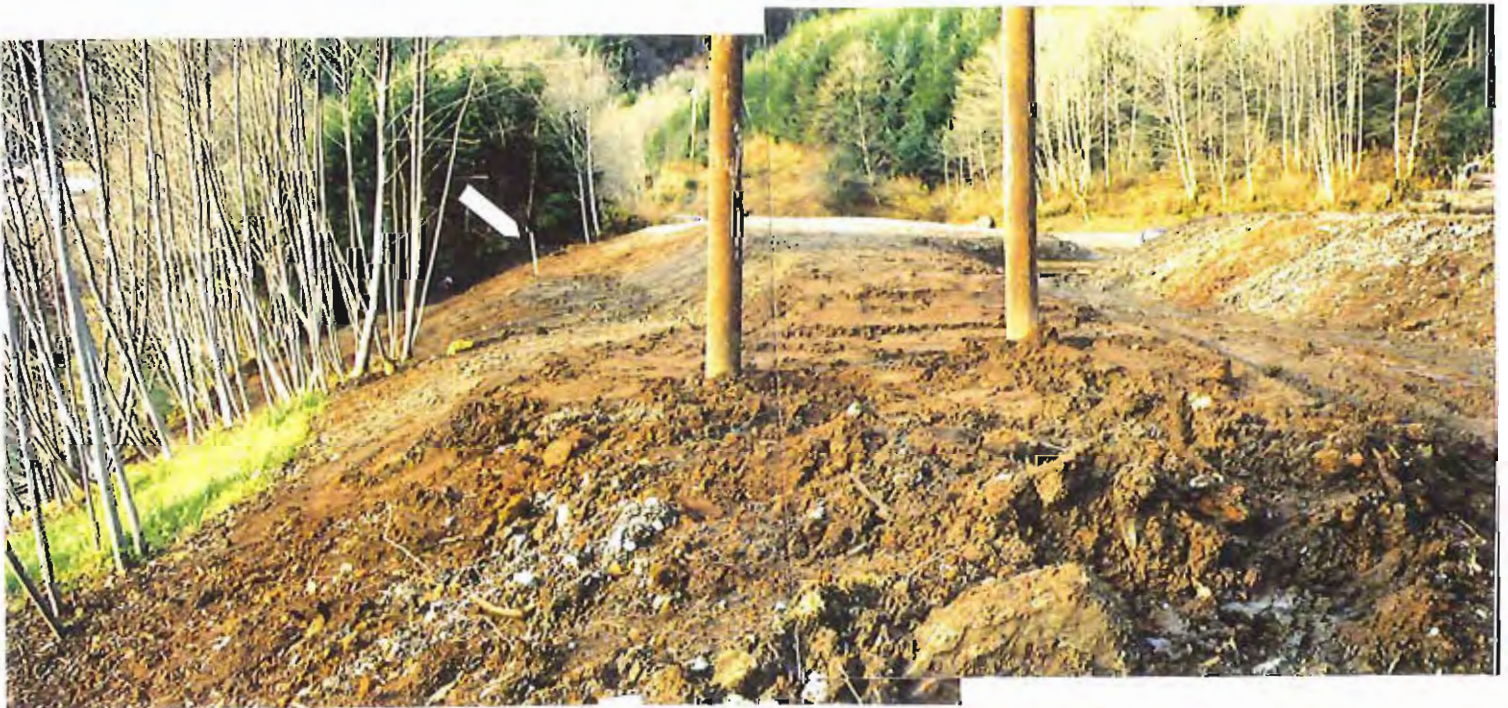
Photo #68: Looking across the APC/Sitka landfill's northwestern end, showing the final 6"-thick soil cover already in place across its outer embankment (arrow points to the former asbestos fence corner post that has been left in place for reference). Its upper surface still needs a 18" lift of crushed concrete and a final 6"-thick cover of soil before it is completed.

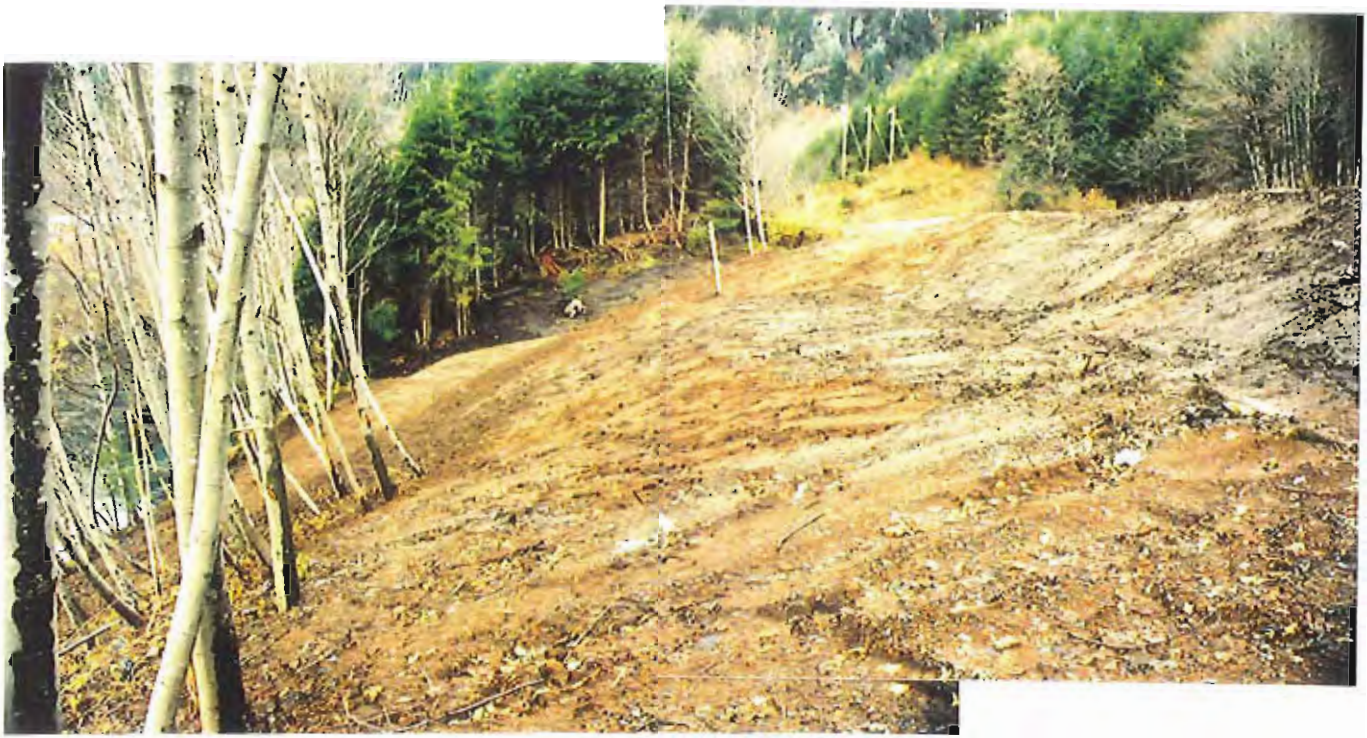
Photo #69: Closer view of the APC/Sitka landfill's northwestern embankment area on 11/11/99, showing the completed 6"-thick soil cover across the lower access path to the leachate sampling site (see next 5 photos).

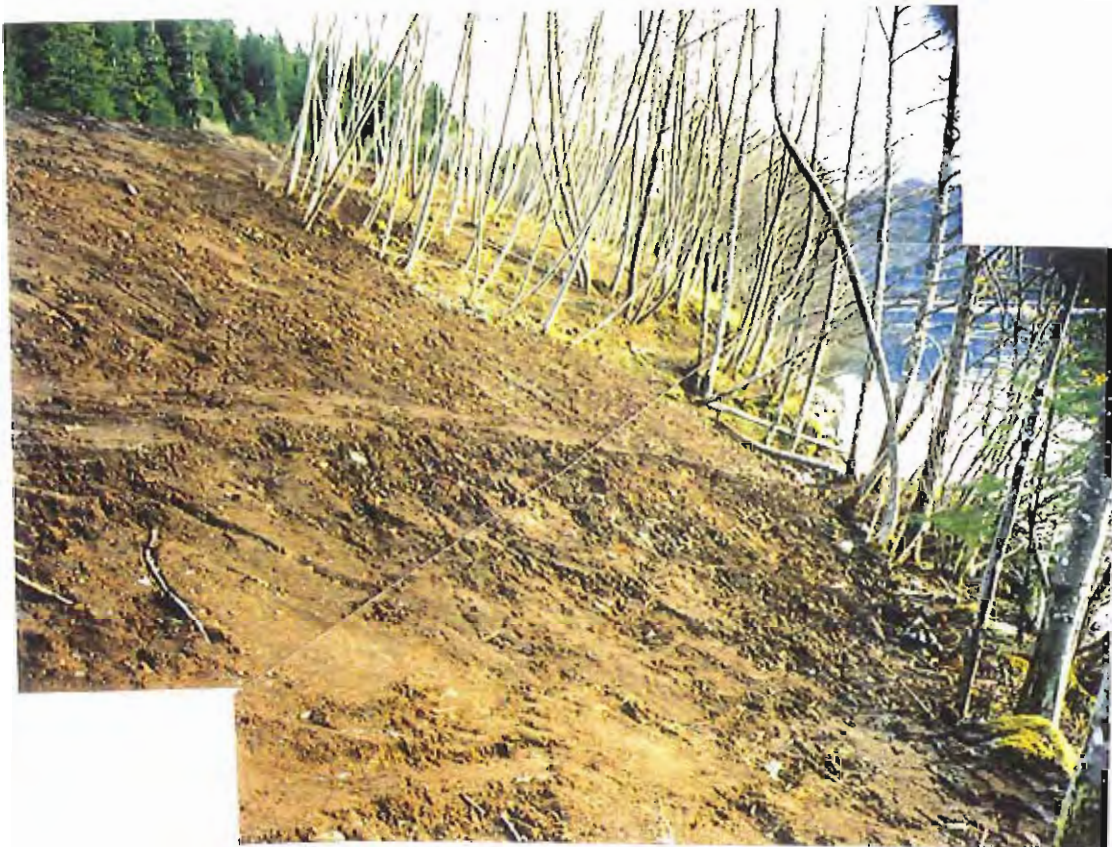
Photo #70: Looking across the lower portion of the APC/Sitka landfill's northwestern embankment area (photo taken from the embankment edge near the drainage ditch), showing the completed 6"-thick soil layer across the entire area and that has been merged into the undisturbed soil along its edge.

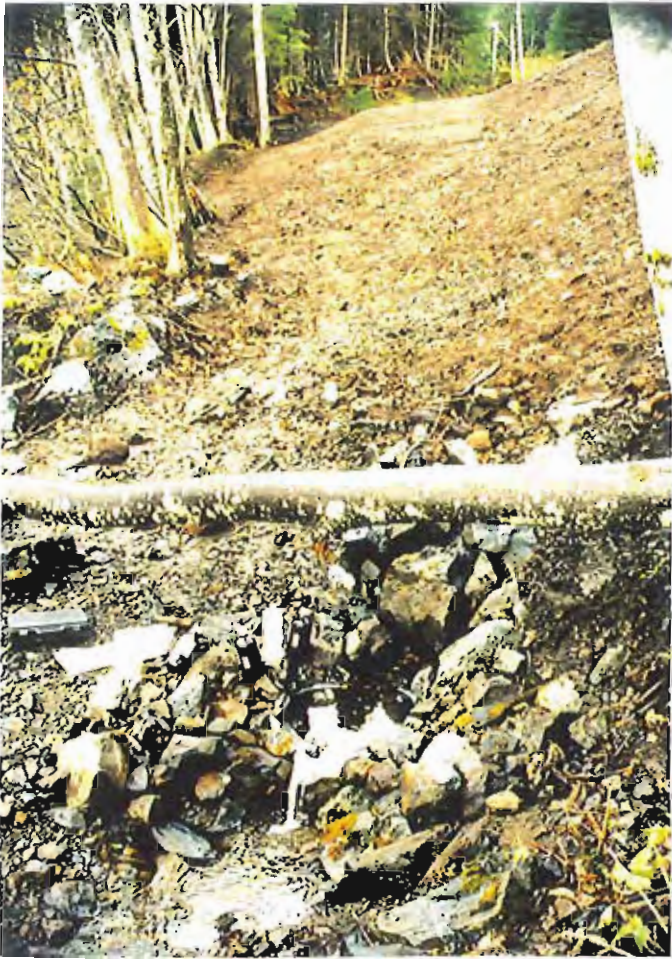
Photo #71: Looking up the access path around the APC/Sitka landfill's northwestern embankment corner, showing the leachate sampling site #1 (see next photo below).

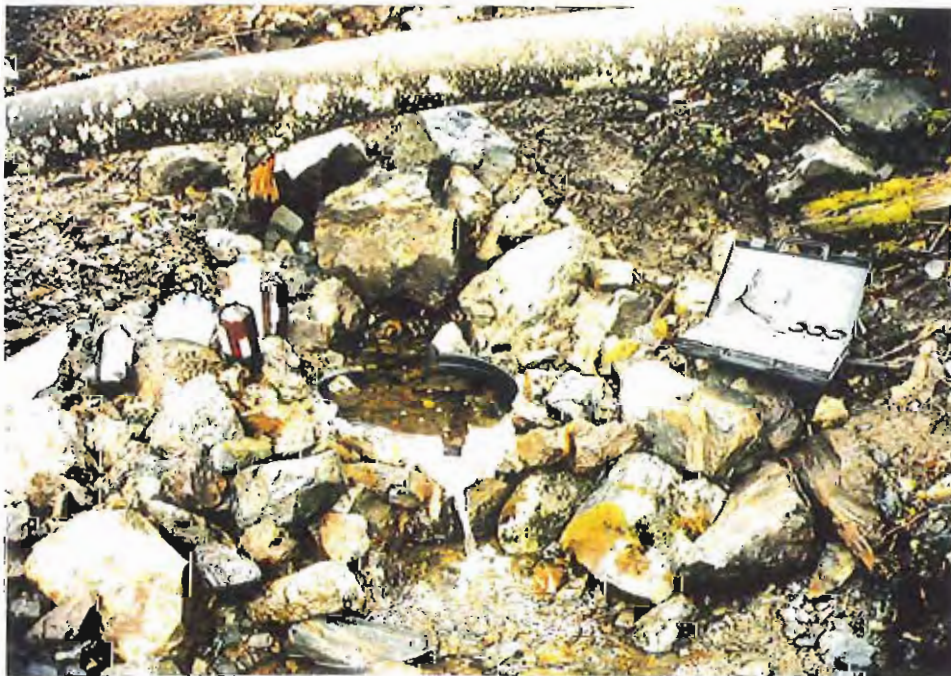
Photo #72: Closer 11/11/99 view of the APC/Sitka landfill's leachate sampling site #1 along its northwestern embankment toe. The sampling site consists of an 18"-dia. plastic pipe with a sampling depth of about 12" and an overflow notch to measure leachate flowrate.

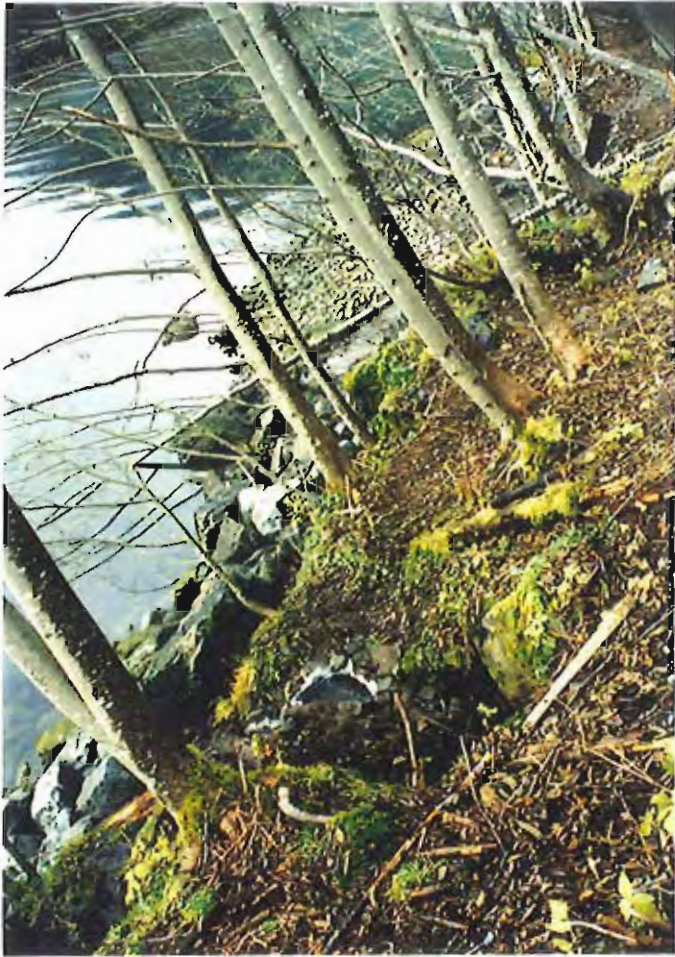
Photo #73: Looking northwest along the APC/Sitka landfill's northwestern embankment toe, showing the leachate sampling site #2 (see white arrow) perched just above tideline (see next photo below), 11/11/99. The leachate sampling site #1 is just out of view at about the location of the black arrow.

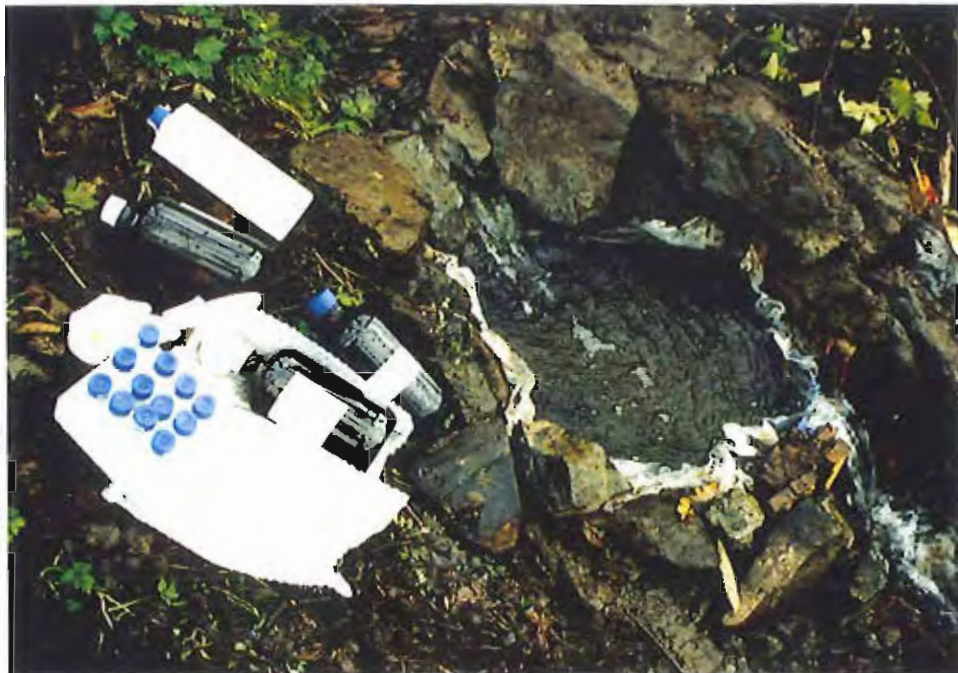
Photo #74: Closer 11/11/99 view looking down on the APC/Sitka landfill's leachate sampling site #2 located at about Sta. 5+20', showing its 18"-dia plastic pipe and its discharge notch.

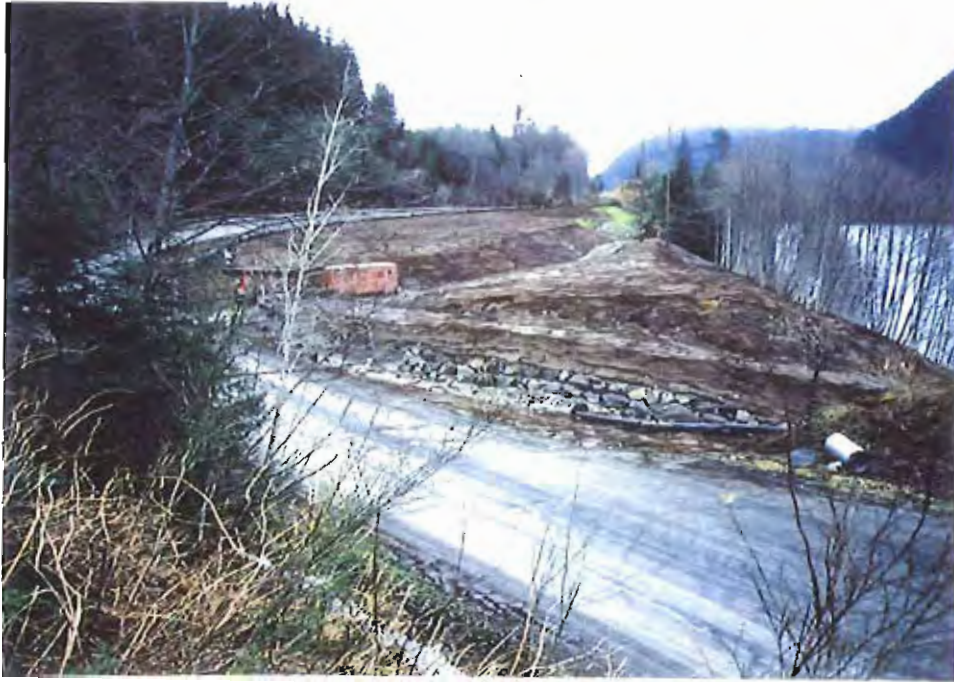
Photo #75: 11/23/99 view looking southeast across the APC/Sitka landfill, showing its entire top area and northwestern embankment to be completely covered with a 6"-thick soil layer.

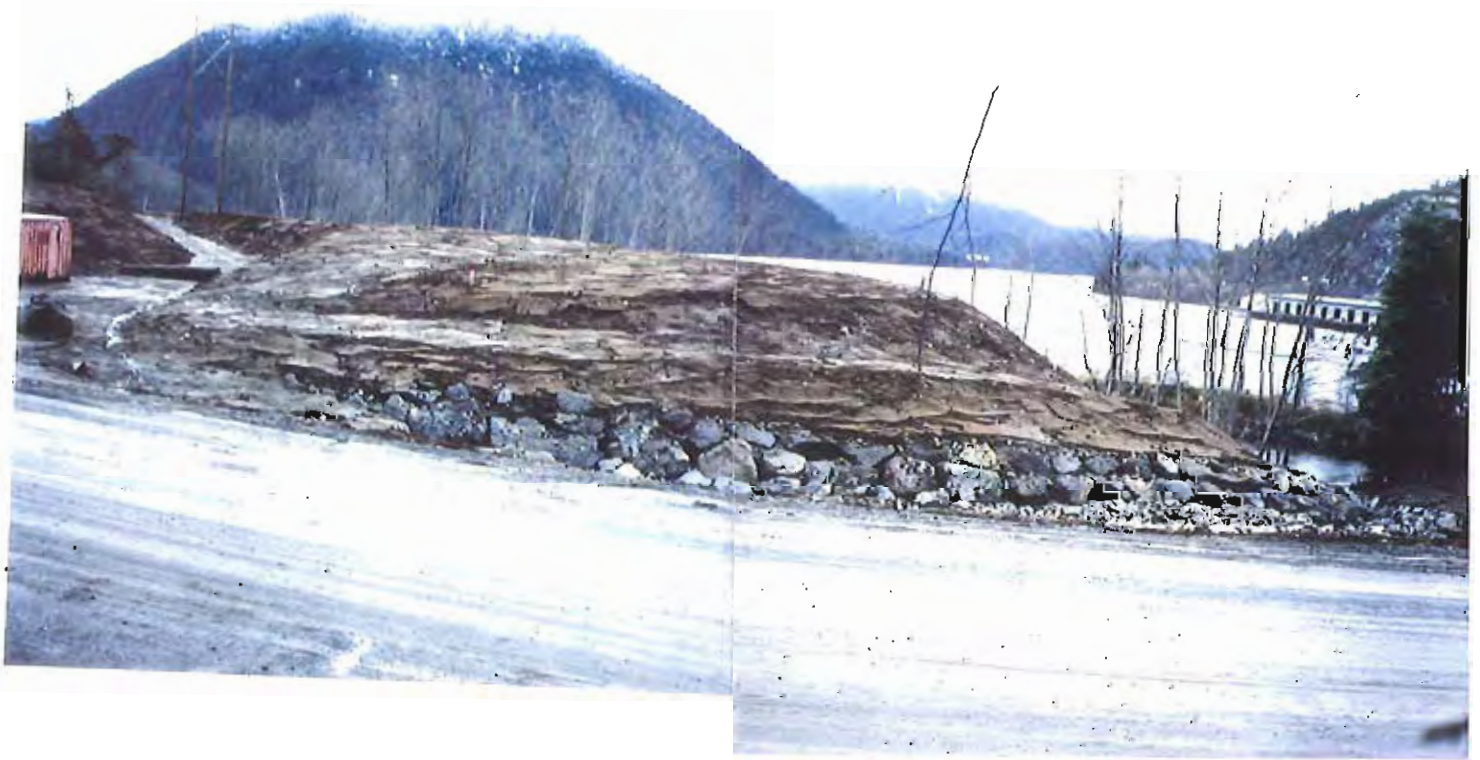
Photo #76: Closer view of the APC/Sitka landfill's northwestern end, showing the completed rockwork along the edge of the open drainage ditch and the final soil cover over the entire area.
