BOARD OF DIRECTOR'S MEETING

Gary Paxton Industrial Park – Board of Directors Meeting
April 27, 2020 3:00pm – Zoom Meeting
DRAFT Meeting Minutes

II.A. Site Description & Initial Conditions

FIGURE IV:
APC-SITKA SOLID WASTE DISPOSAL FACILITY - 11/24/98 CONDITIONS
 Located along Sawmill Creek near Sitka, Alaska

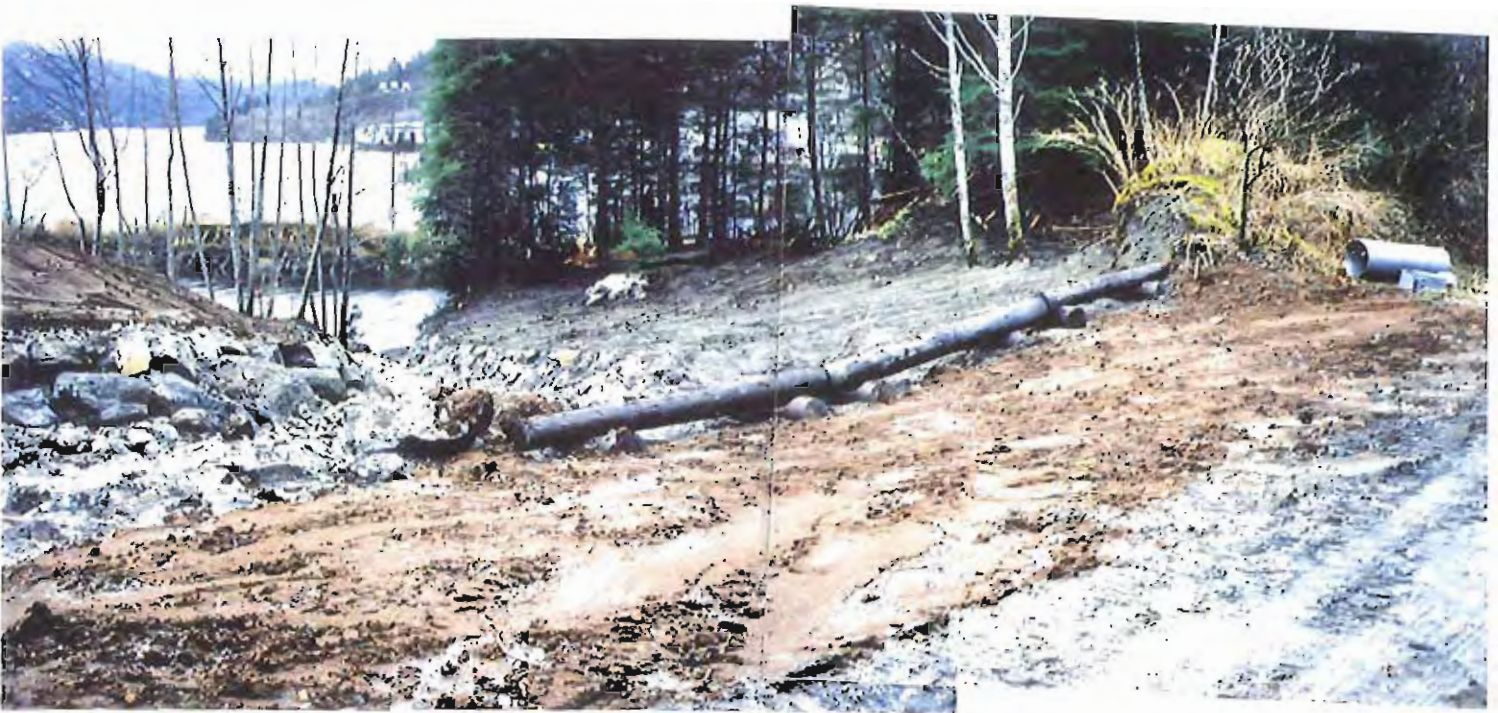
Photo #77: 11/23/99 view looking down the open ditch around the northwestern end of the APC/Sitka landfill, showing the rocked open drainage ditch and the landscaped area on its far side where the site meets the undisturbed forested area.

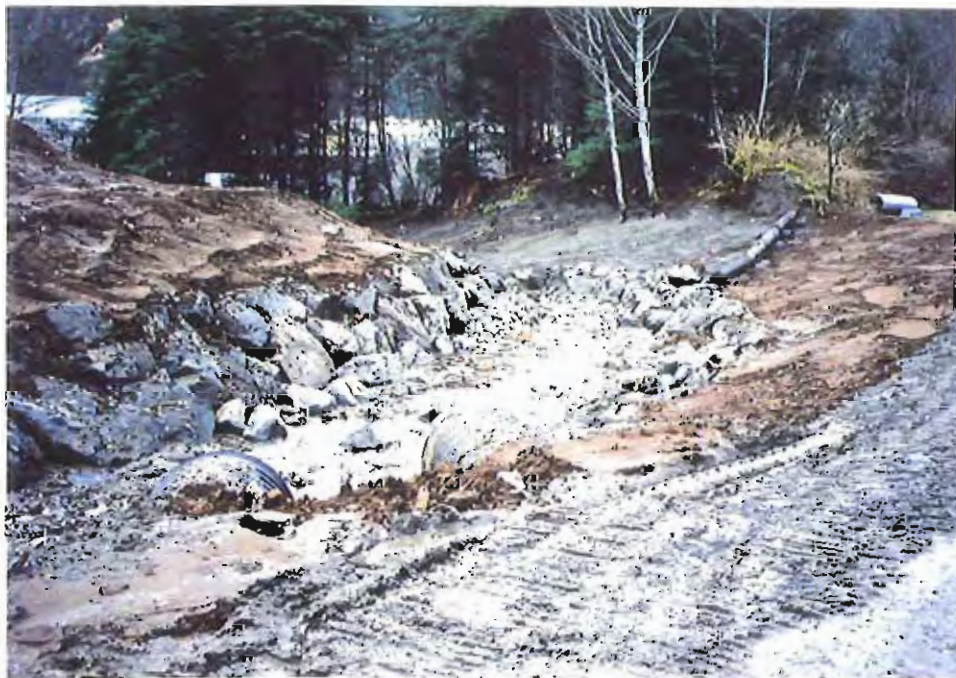
Photo #78: Looking down the open surface water ditch around the APC/Sitka landfill's northwestern end on 11/23/99, showing the roadside culverts and the large rock lining both sides of the ditch (compare with Photo #34 on page A18).

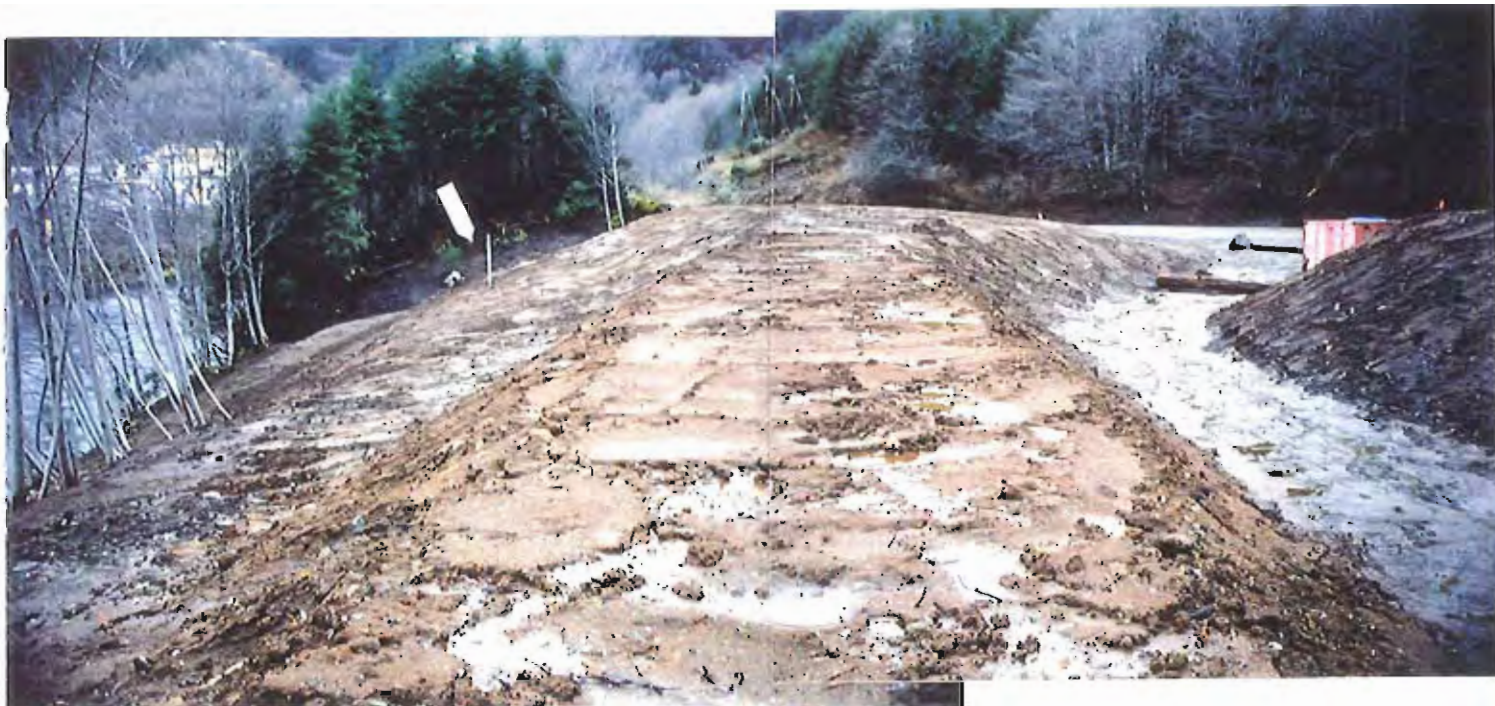
Photo #79: 11/23/99 view looking across the top area of the APC/Sitka landfill's northwestern end, showing the completed 6"-thick soil cover. Arrow points to the cornerpost still remaining as a reference point from the asbestos cyclone fencing taken down at the start of the post-closure improvements project. The post will be cut down once the as-built survey is completed.

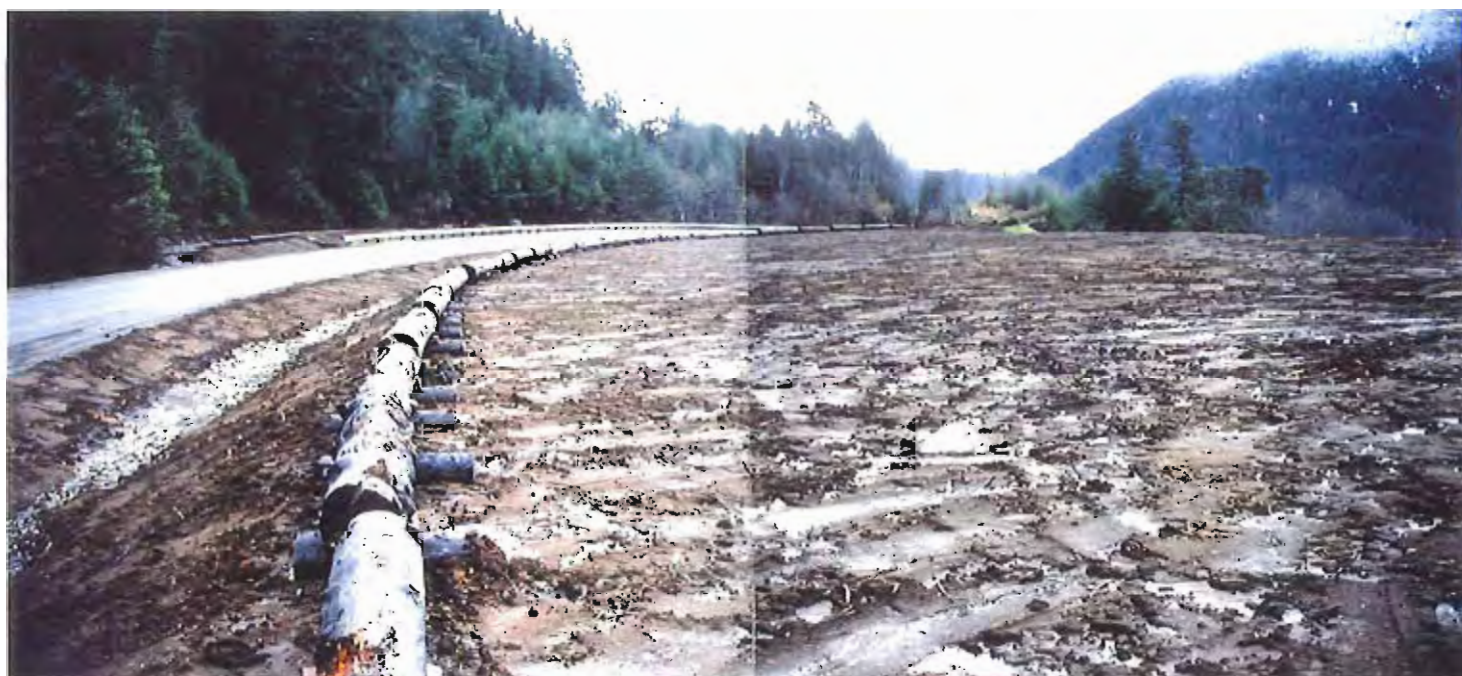
Photo #80: 11/23/99 view looking southeast along the new barrier logs separating the completed ditchline by the roadway from the main top surface of the APC/Sitka landfill site.

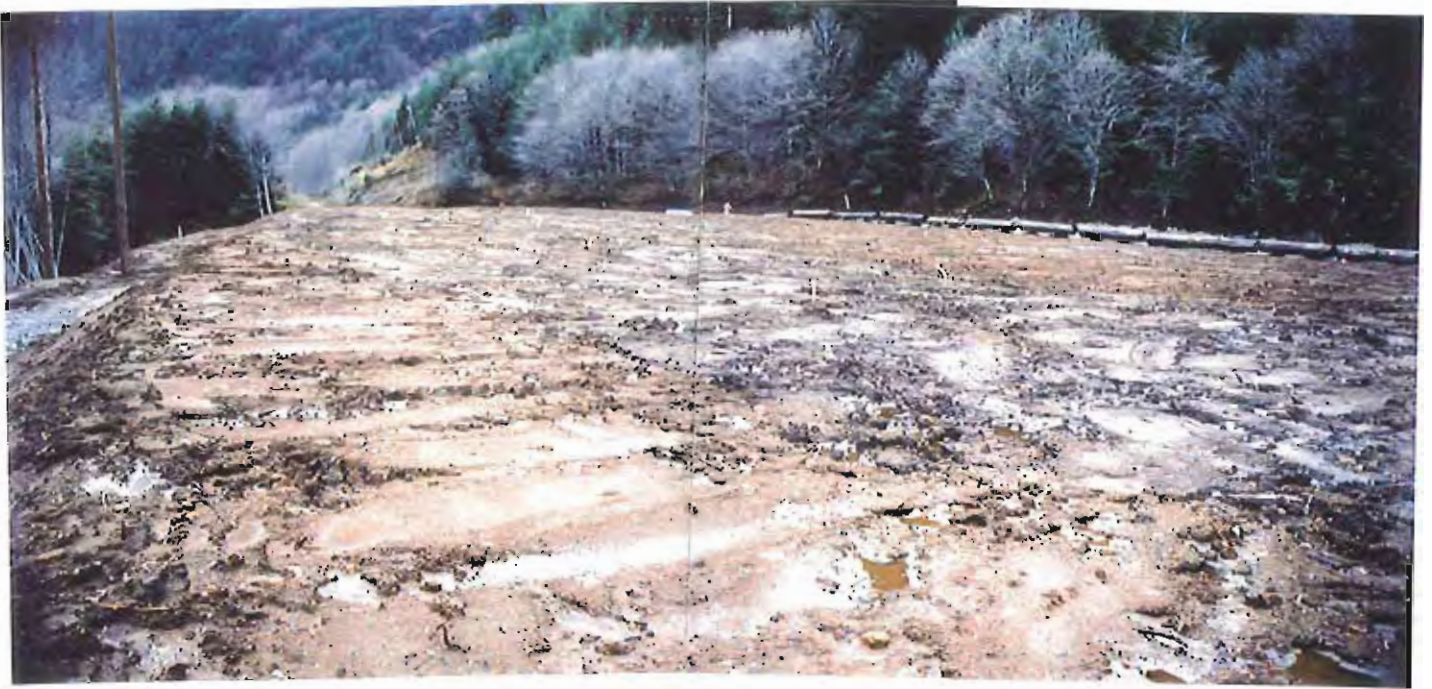
Photo #81: Looking northwest across the main top area of the APC/Sitka landfill site on 11/23/99, showing its smoothed-out surface and the fill stakes placed to confirm the needed depth of the underlying 18"-thick crushed concrete rock and the top 6"-thick soil cover (compare with photos on page A25).

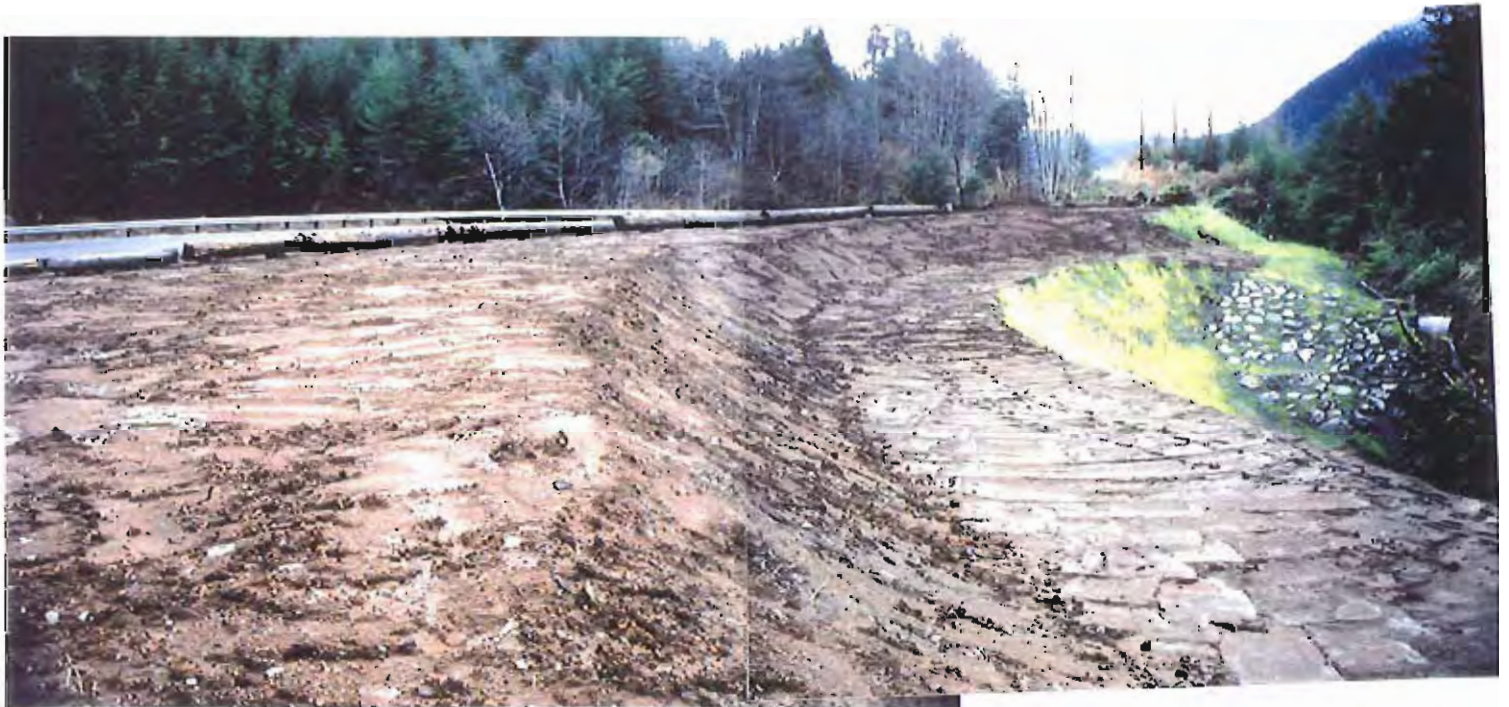
Photo #82: 11/23/99 view of the APC/Sitka landfill's southeastern end, showing its completed final soil cover along the top and upper embankment surfaces, and the barrier logs along the roadside edge of the site (compare with the photos on page A26 & A28).

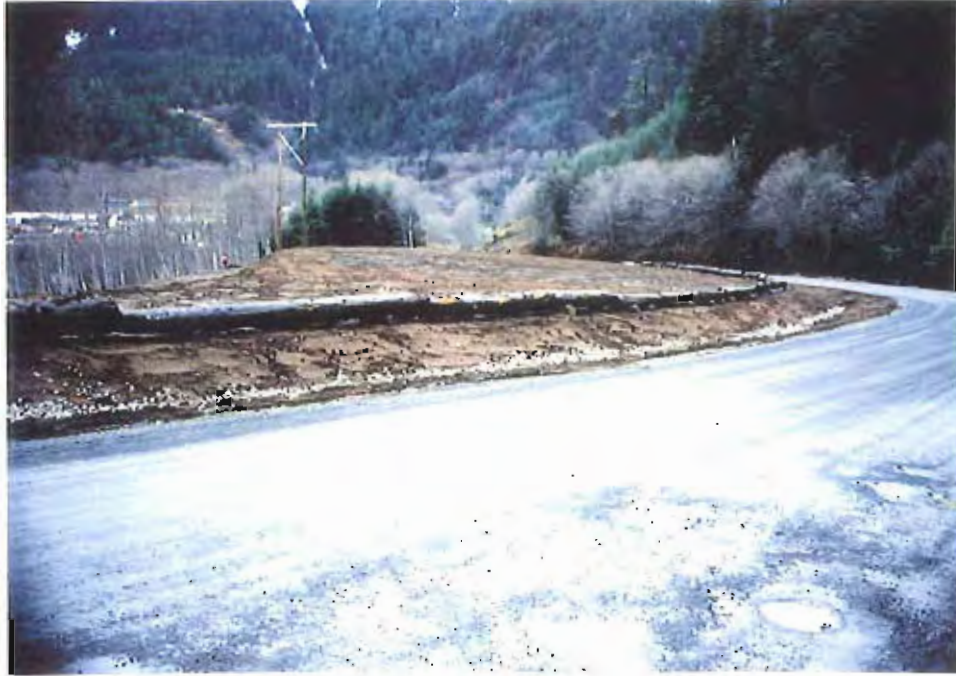
Photo #83: Looking northwest across the upper surface of the APC/Sitka landfill site on 11/23/99, showing its completed soil extending over the sides of the roadside ditchline, and the barrier logs along the top of the ditchline embankment (compare with the photos on page A23).

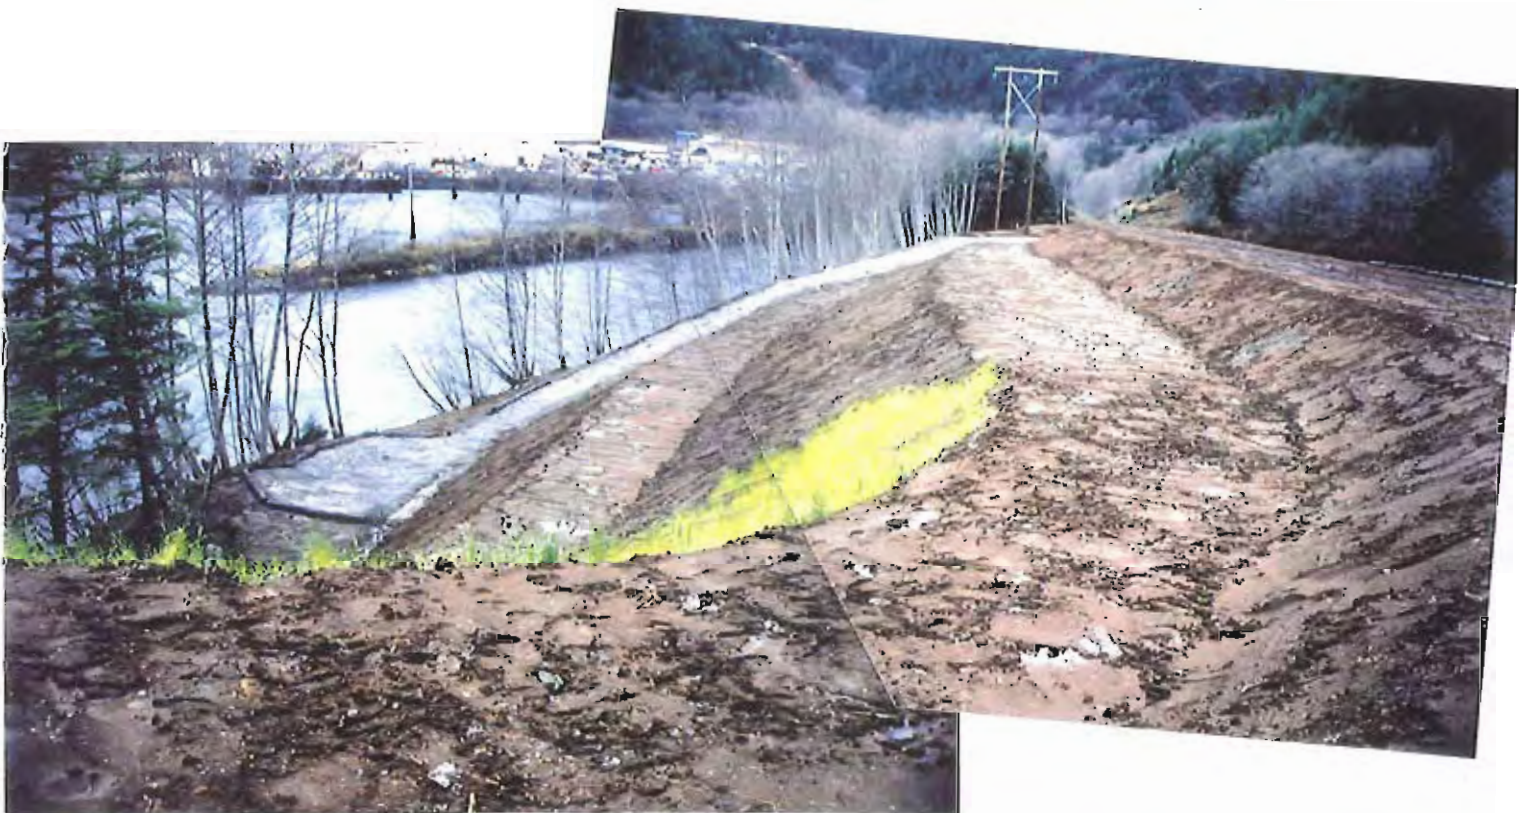
Photo #84: 11/23/99 view looking across the terraced outer embankment of the APC/Sitka landfill site, showing the final 6"-thick soil layer in place and the access road to the bottom of the embankment now surfaced with crushed concrete fill and lined with creosoted logs.

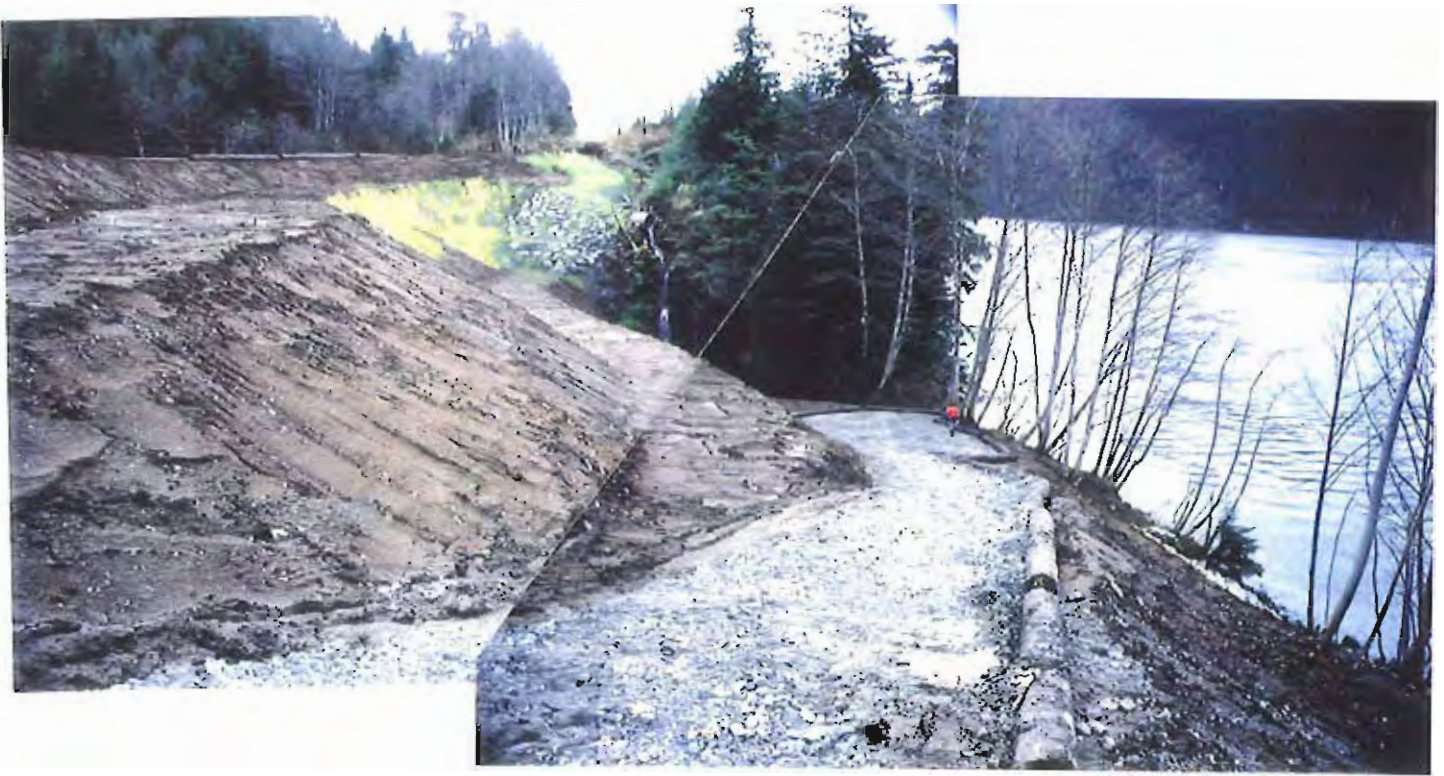
Photo #85: 11/23/99 view looking southeast along the APC/Sitka landfill's terraced embankment slopes, showing the completed soil layer and the access road with its lower turn-around area now surfaced with crushed-concrete fill and lined with creosoted logs.

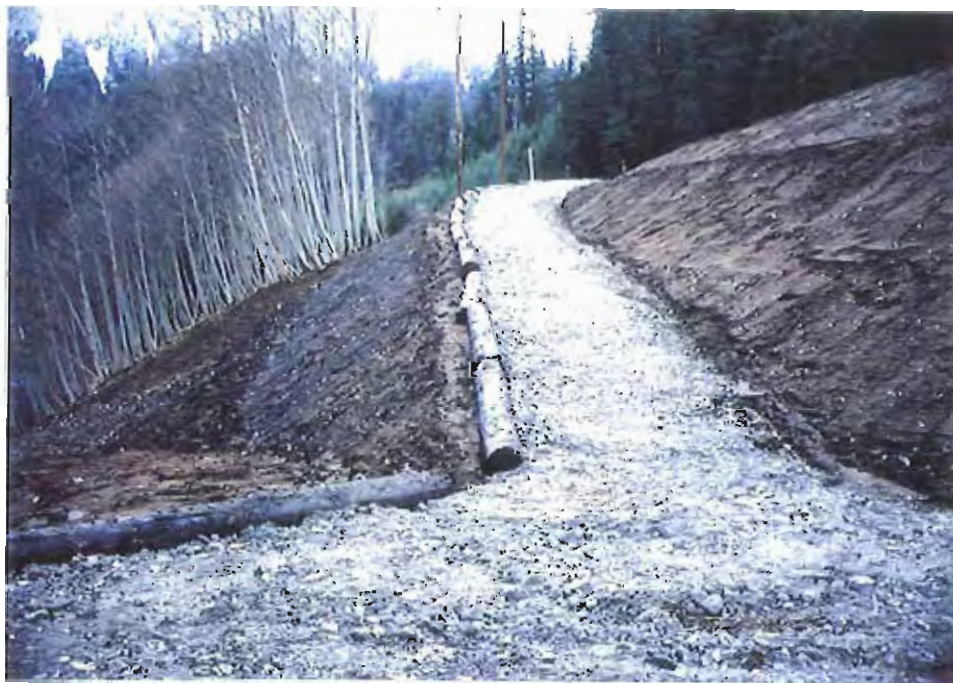
Photo #86: 11/23/99 view looking up the APC/Sitka landfill's embankment roadway, showing the creosoted logs lining the outside edge and the crushed-concrete fill now covering the entire roadway surface. A drainage ditch was created along its inside edge to keep surface water away from the lower embankment slope.

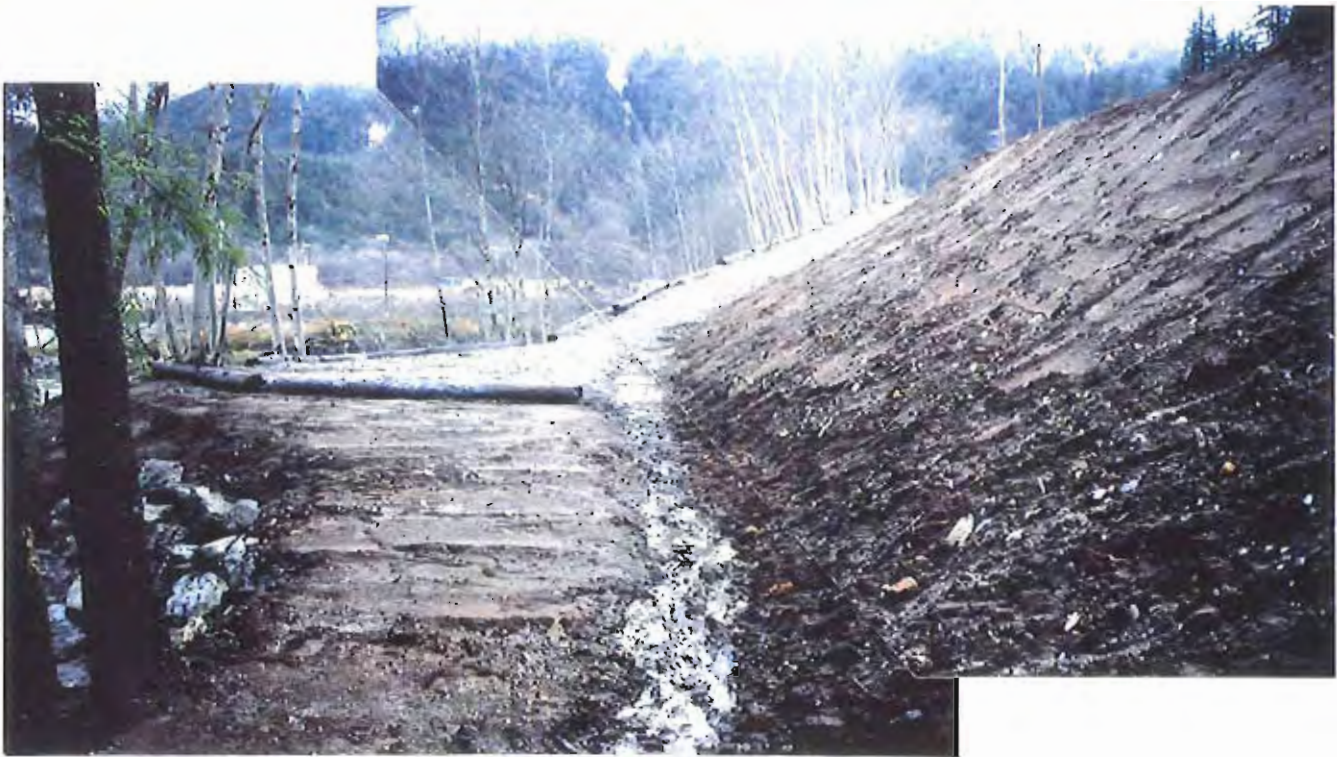
Photo #87: 11/23/99 view of the APC/Sitka landfill's embankment toe near its southern end, showing the drainage ditch for the surface water coming from the embankments and roadway.

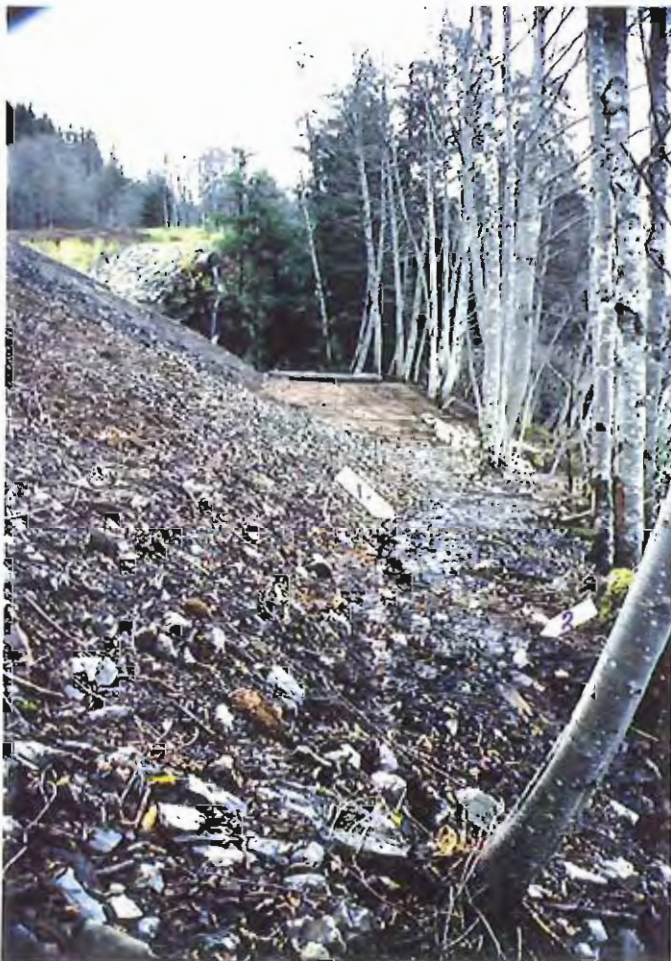
Photo #88: Looking southeast along the embankment toe of the APC/Sitka landfill from about Sta. 4+00', showing two very small water seepage areas (see next 3 photos)

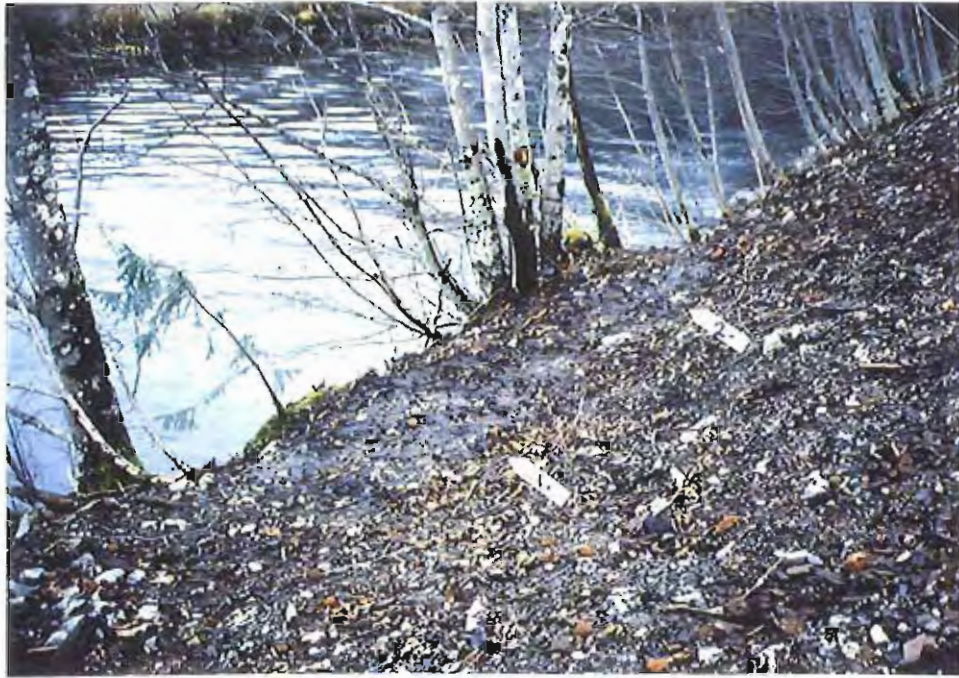
Photo #89: Another 11/23/99 view of the two very small water seepages along the APC/Sitka landfill's embankment toe at about Sta. 3+60' to 3+80' (see next two photos).

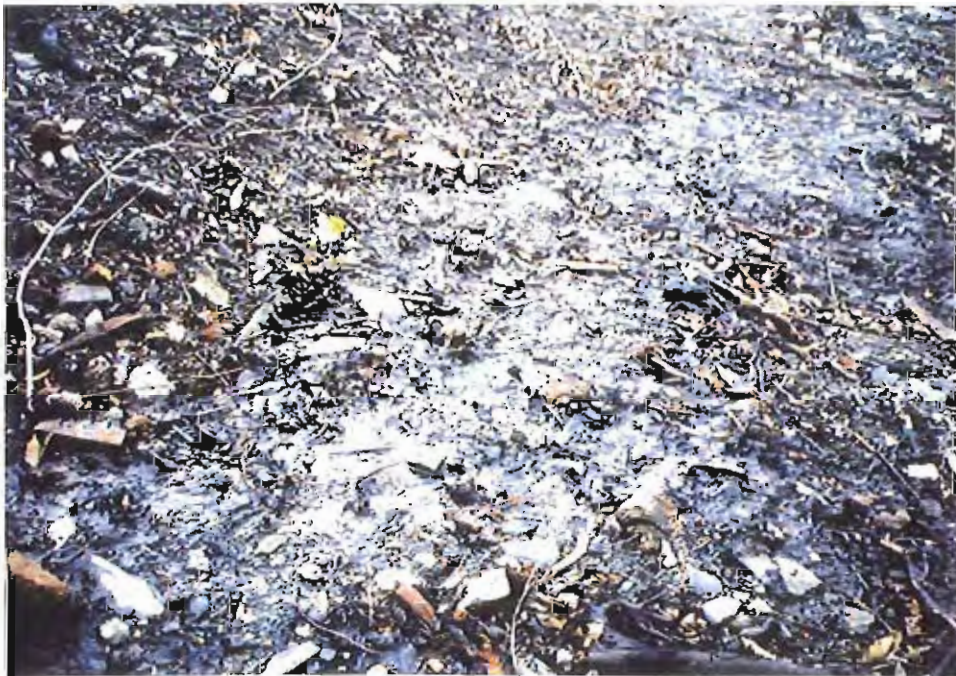
Photo #90: Closer 11/23/99 view of the very small water seepage #1 along the APC/Sitka landfill's embankment toe at about Sta. 3+60' (see previous 2 photos for location).

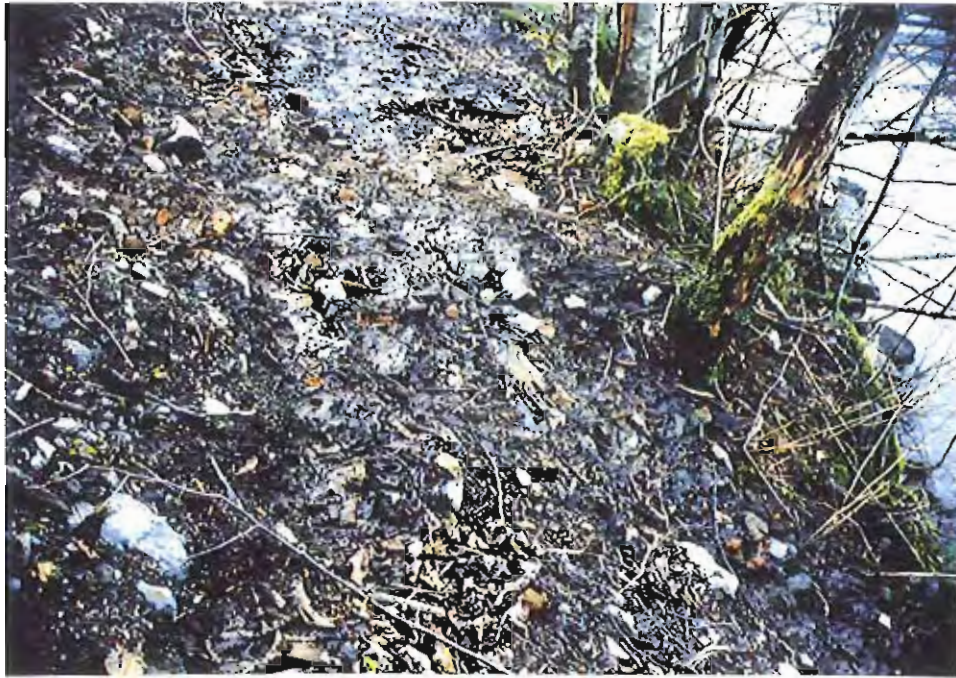
Photo #91: Closer 11/23/99 view of the very small water seepage #2 along the APC/Sitka landfill's embankment toe at about Sta. 3+60' (see Photos #88-#89 for location).

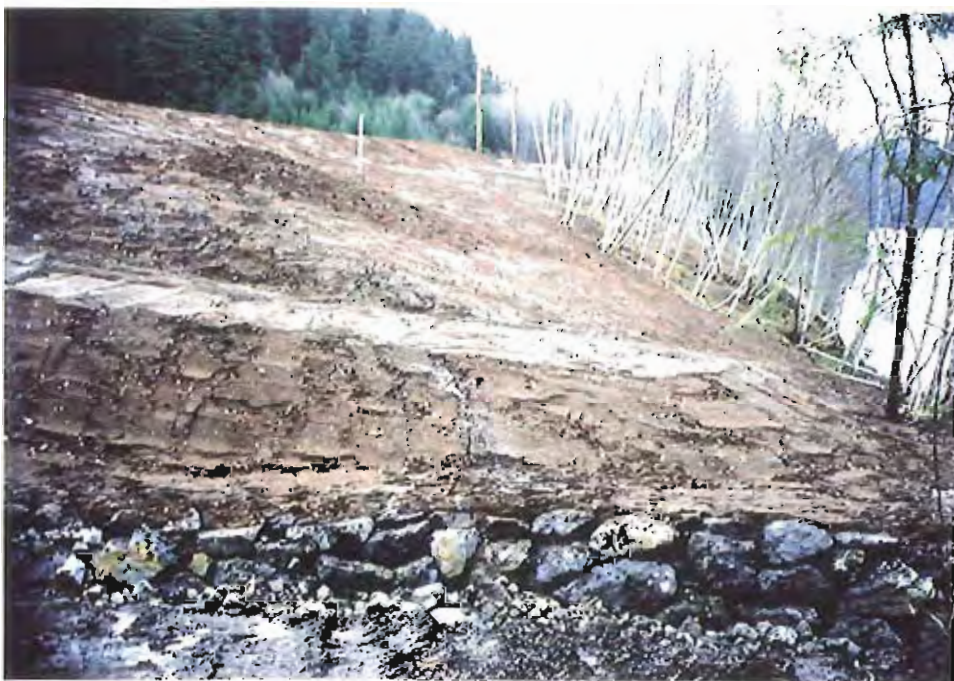
Photo #92: 11/23/99 view looking across the APC/Sitka landfill's northwestern lower embankment slopes, showing the protective rock along the surface water drainage ditch and the completed 6"-soil layer covering all slopes. Arrow points to the water sampling location #1, shown on the next photo).

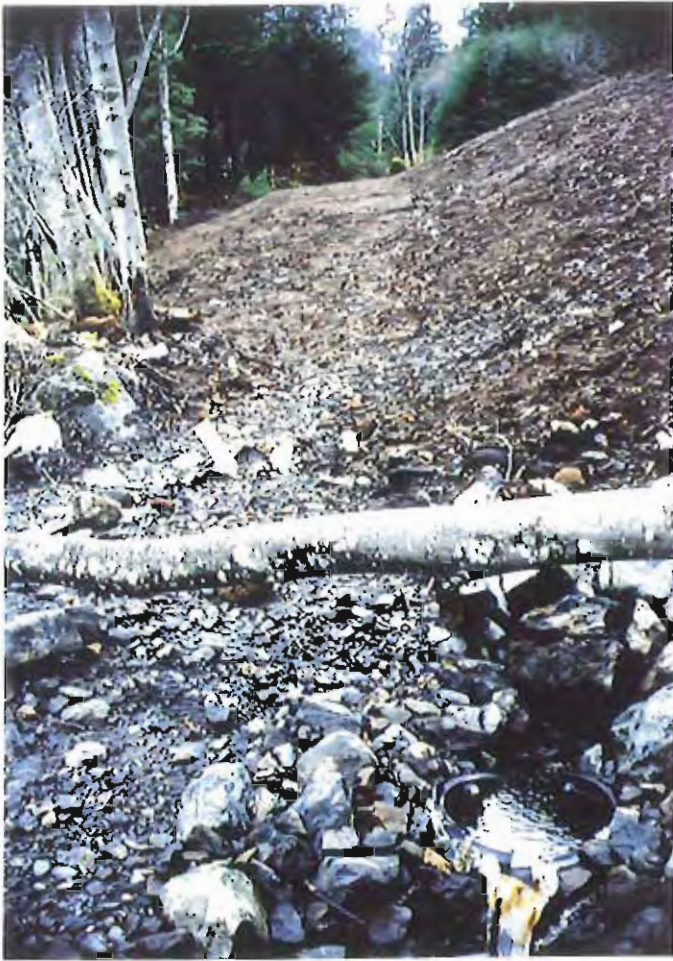
Photo #93: 11/23/99 view of a very small water seepage area (see arrow) just above the APC/Sitka landfill's water sampling site #1 which is in the lower right corner of the photo at about Sta. 5+50', refer to next photo.

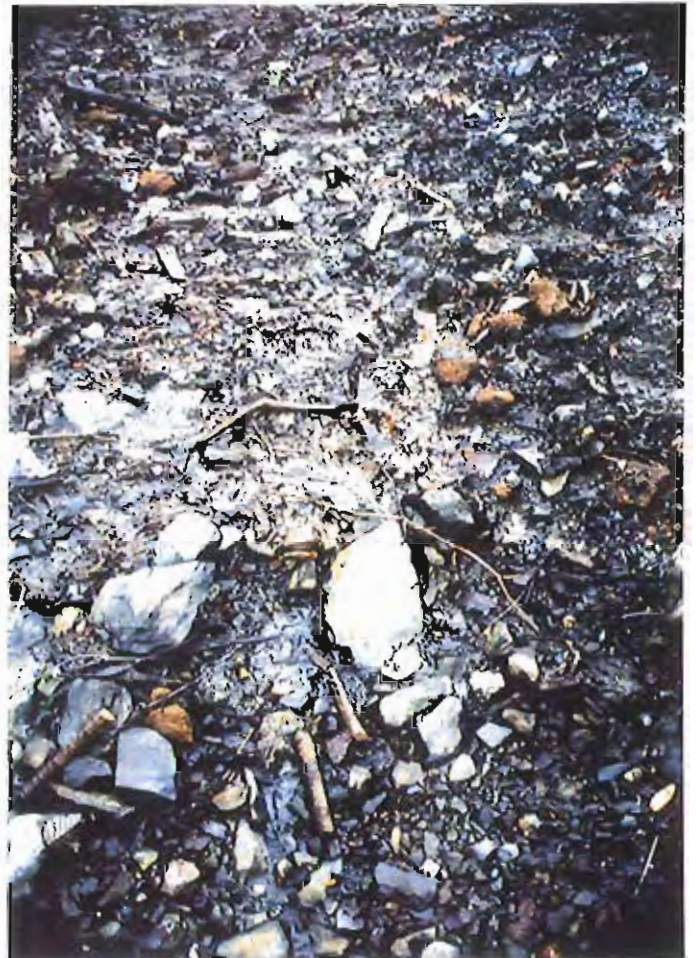
Photo #94: Closer view of the very small water seepage area shown in Photo #93, just above the APC/Sitka landfill's water sampling site #1 at about Sta. 3+60', 11/23/99.

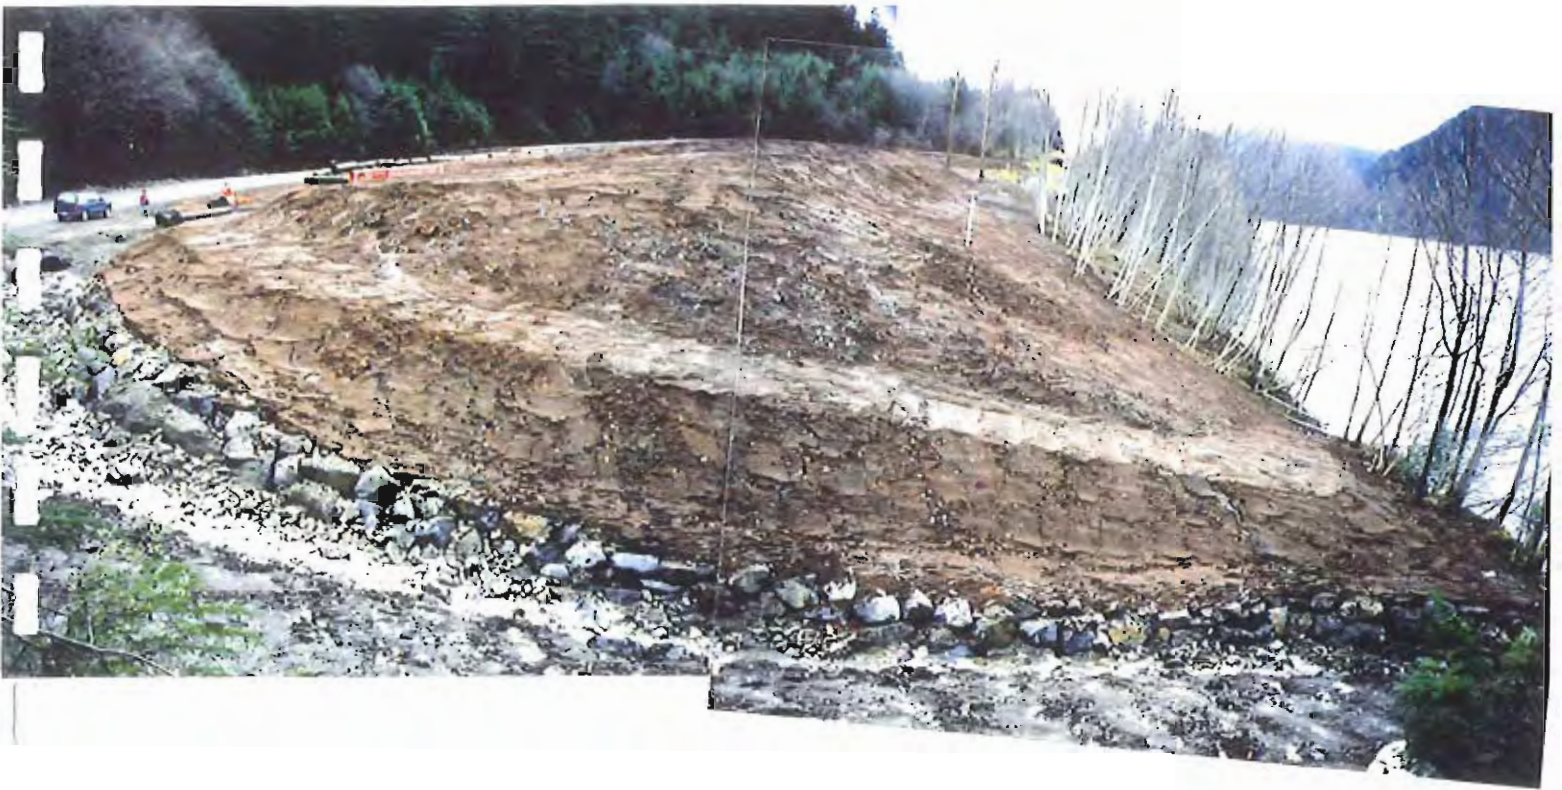
Photo #95: 11/23/99 view looking across the northwestern end of the APC/Sitka landfill, showing the final 6"-thick soil cover over the entire fill surface and the rock lining the surface water drainage ditch embankment (compare with Photo #38, page A20).

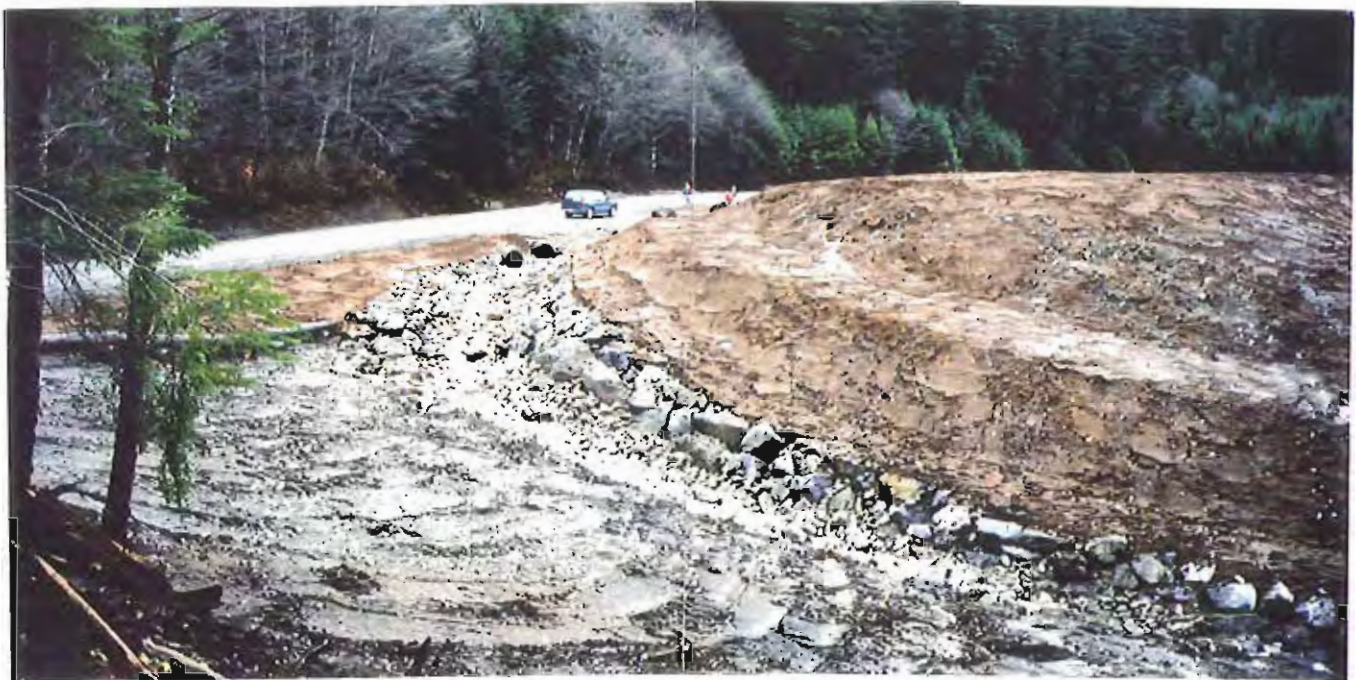
Photo #96: 11/23/99 view of the completed surface water drainage ditch around the APC/Sitka landfill's northwestern end, showing the gentle embankment slope along the roadside near the culverts, and the rock-lined ditch.

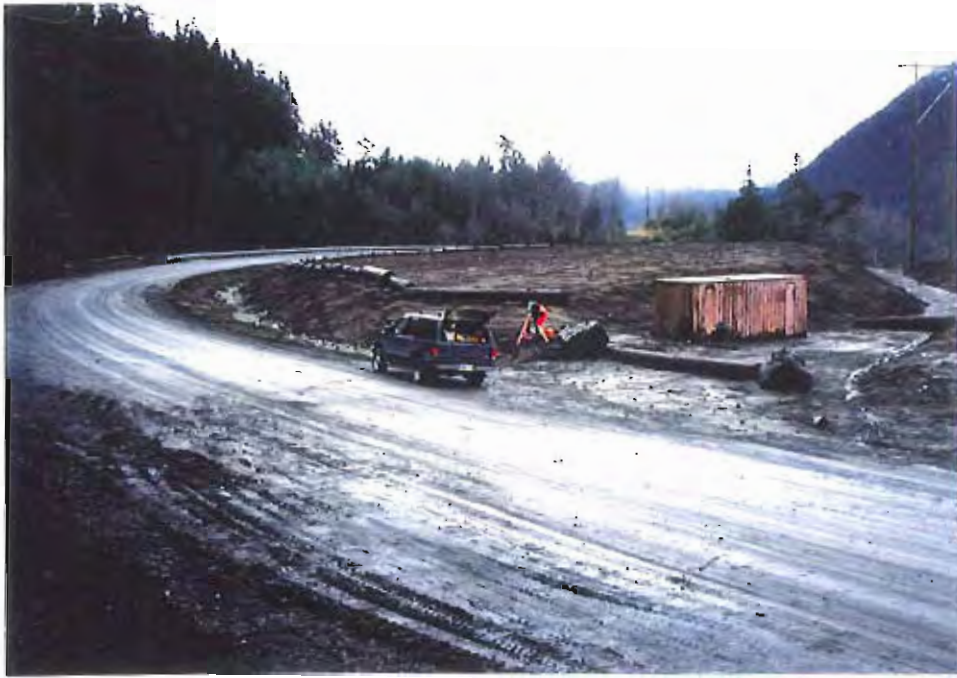
Photo #1: 11/23/99 view looking southeast across the main portion of the APC/Sitka landfill site, showing the Sawmill Creek Road and the completed downslope ditchline.

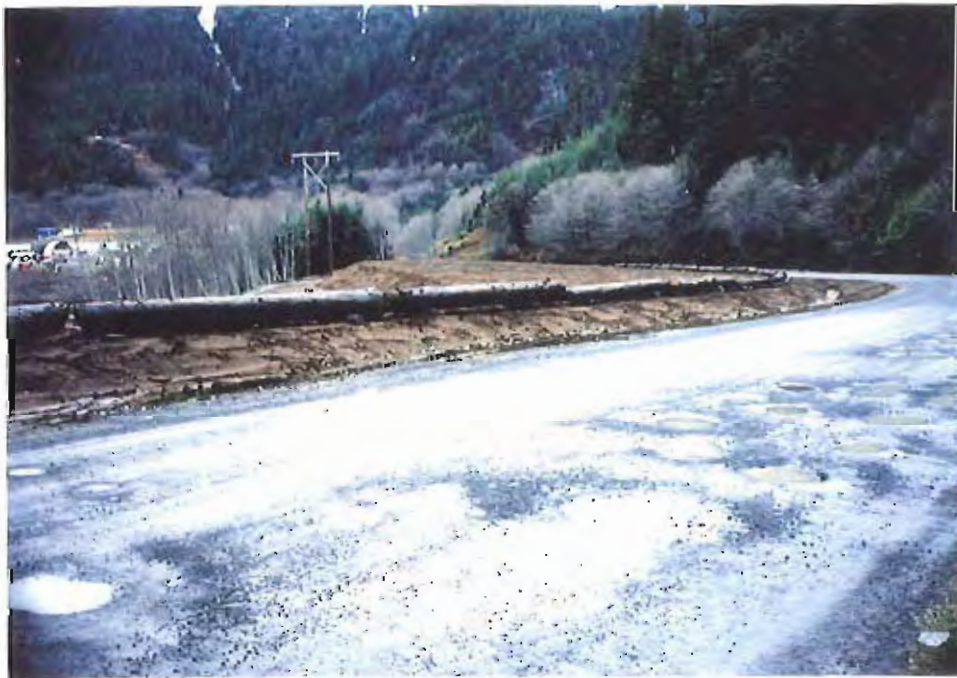
Photo #2: Looking northwest across the APC/Sitka landfill on 11/23/99, showing the roadside drainage ditch along Sawmill Creek Road and the access barrier logs placed around the landfill's periphery (compare with Photos #16 & #17).

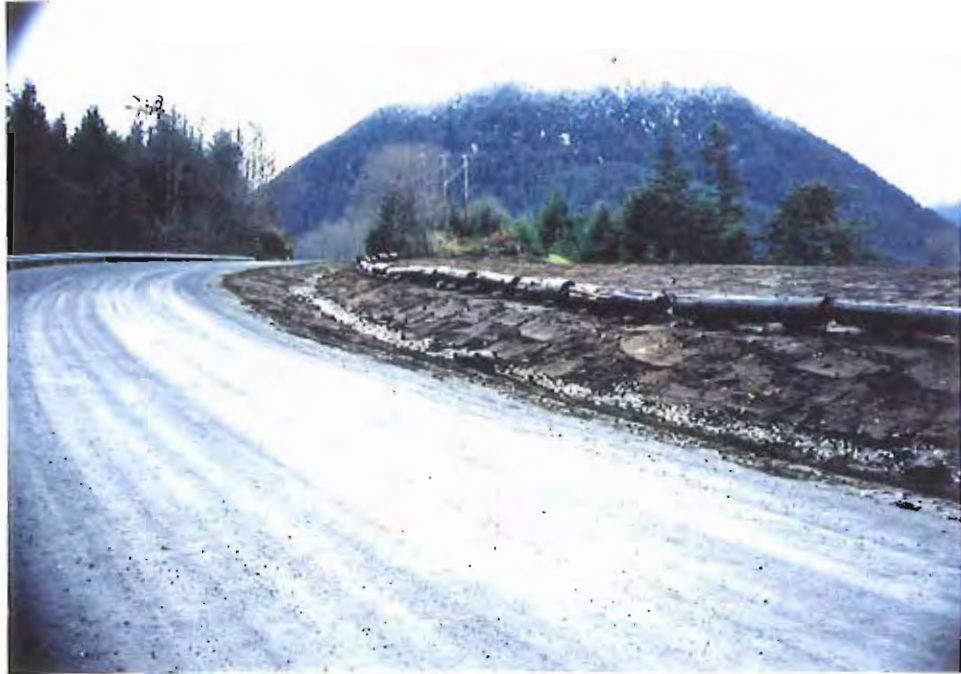
Photo #3: 11/23/99 view of the completed surface water drainage ditch along Sawmill Creek Road near the APC/Sitka landfill's southeastern end (compare with Photo #17).

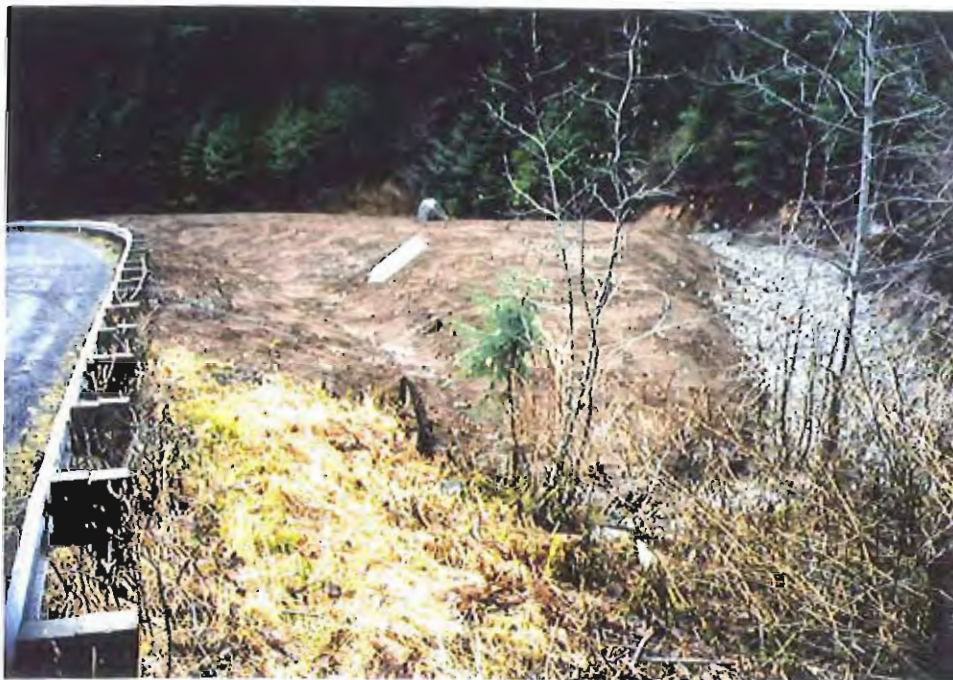
Photo #4: Looking across the end of the upper end of the APC/Sitka landfill's northeastern disposal area, showing the new roadside drainage ditch along Sawmill Creek Road (see arrow).

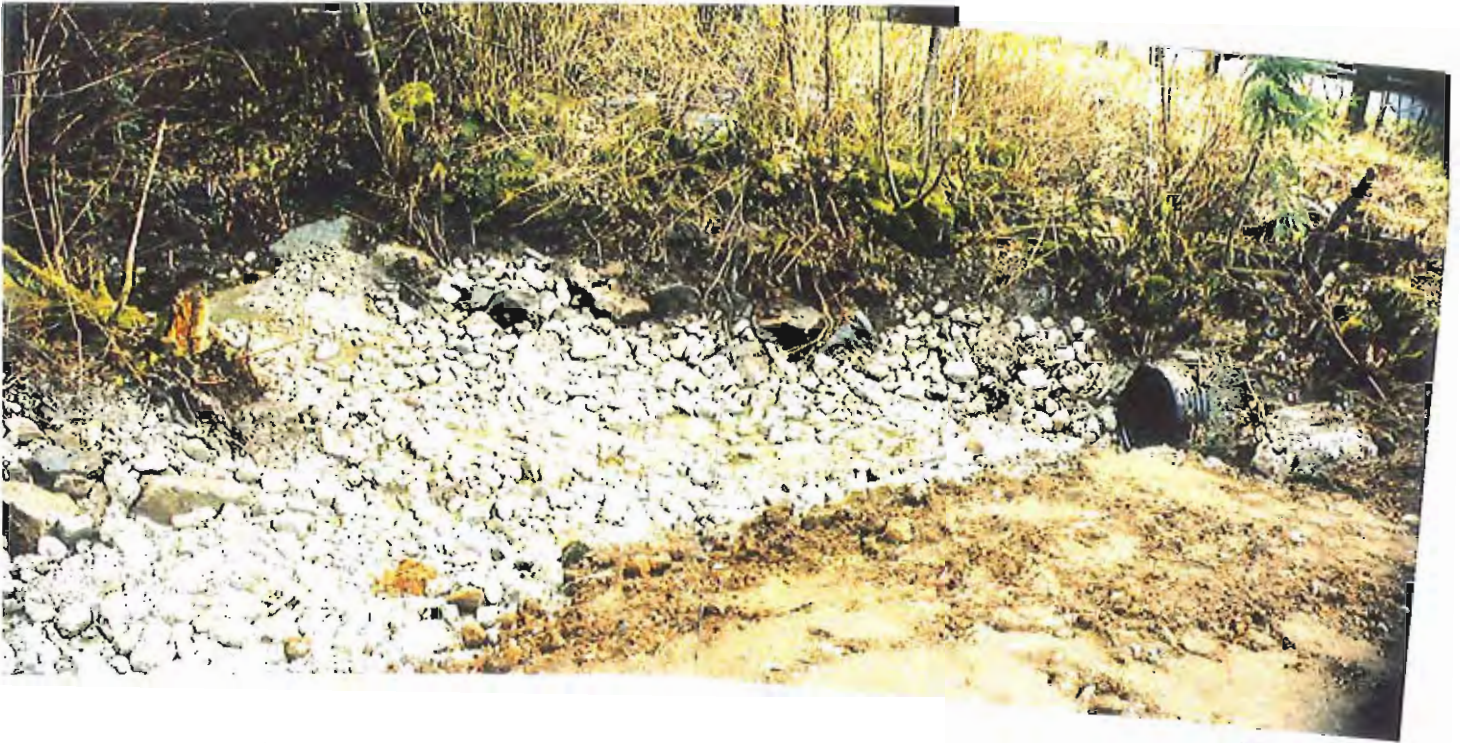
Photo #5: Looking down on the Sawmill Creek Road's culvert that goes through the APC/Sitka landfill's south end, showing the rock-lined creek which has a 30-mil membrane liner under the rock.
