BOARD OF DIRECTOR'S MEETING

Gary Paxton Industrial Park – Board of Directors Meeting
April 27, 2020 3:00pm – Zoom Meeting
DRAFT Meeting Minutes

II.A. Site Description & Initial Conditions

FIGURE IV:
APC-SITKA SOLID WASTE DISPOSAL FACILITY - 11/24/98 CONDITIONS
 Located along Sawmill Creek near Sitka, Alaska

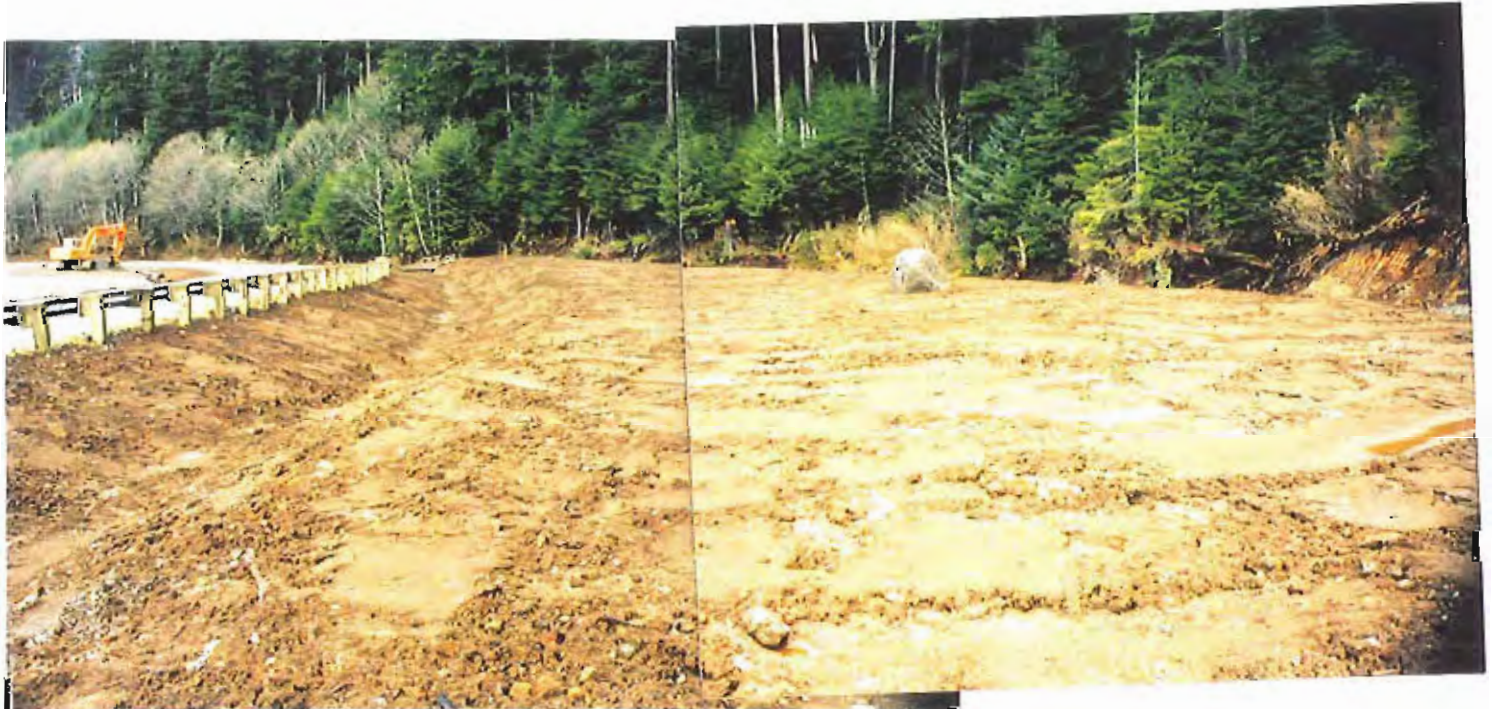
Photo #6: Looking across the middle portion of the APC/Sitka landfill's northeastern disposal area on 11/23/99, showing the newly created drainage ditch along Sawmill Creek Road.

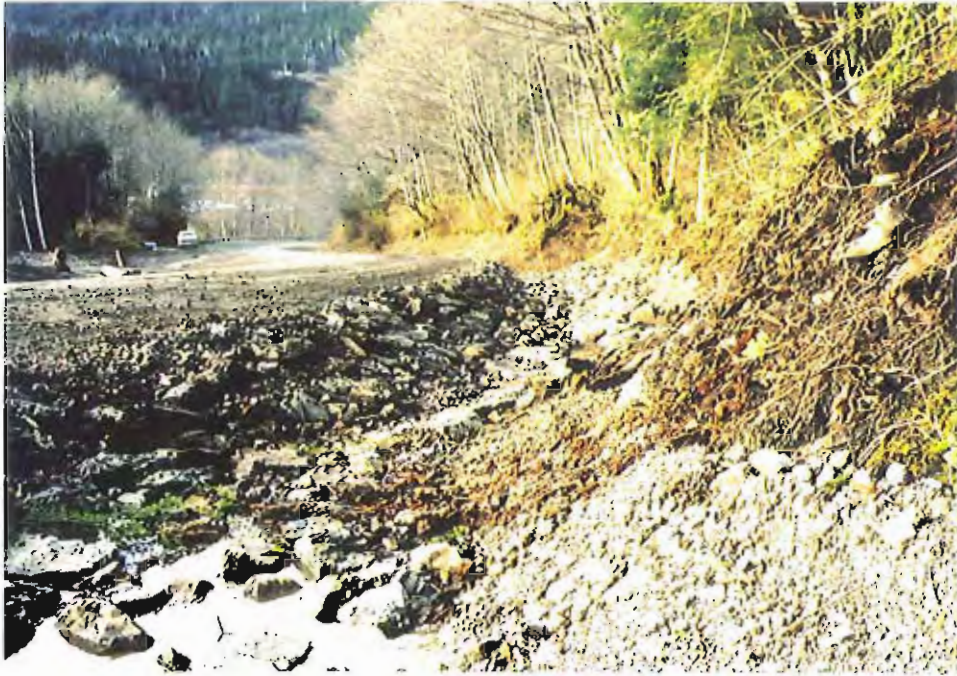
Photo #9: Looking down the Sawmill Creek Road's upslope surface water drainage ditch from about Sta. 3+80', showing the large rock placed in the ditchline to prevent erosion of the protective rock cover over the underlying 30-mil membrane liner, 11/11/99.

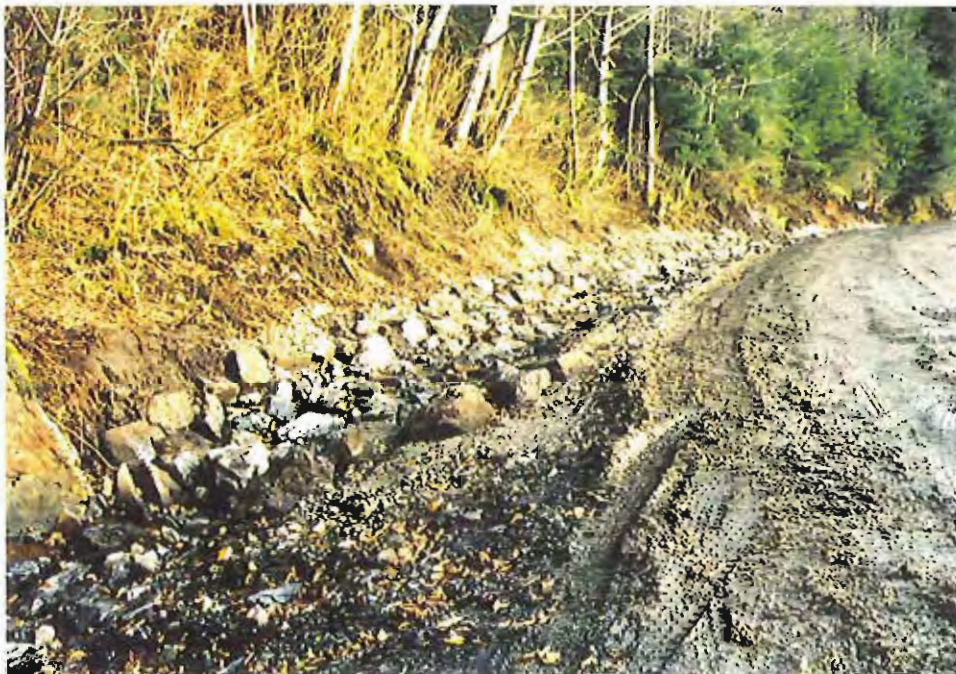
Photo #10: 11/11/99 view looking up the APC/Sitka landfill's upslope drainage ditch along Sawmill Creek Road taken from about Sta. 6+50', showing the large rock placed over the underlying 30-mil membrane liner to prevent surface water erosion.

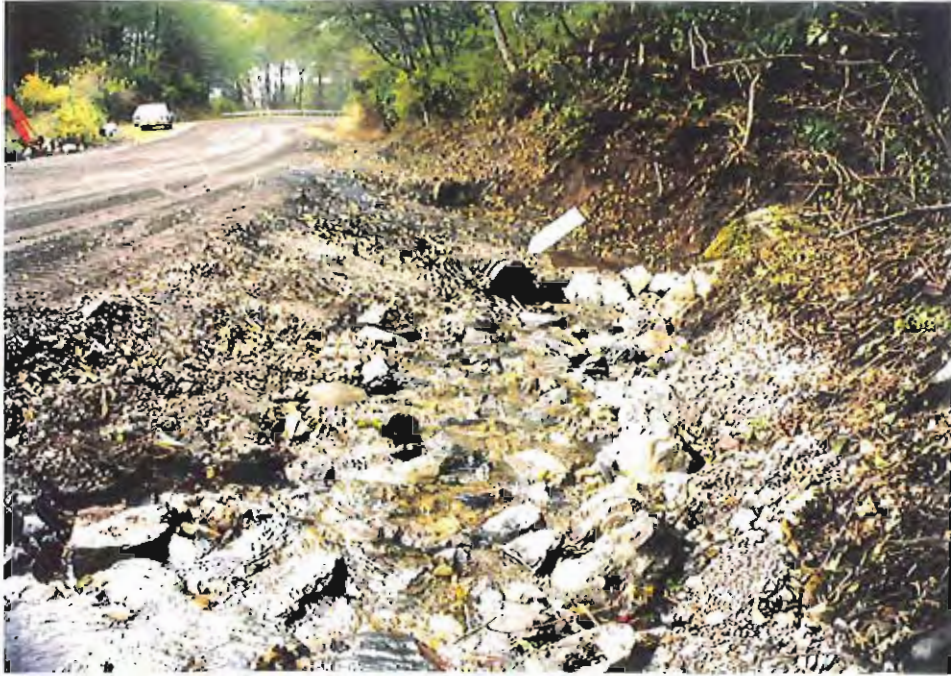
Photo #11: 11/11/99 view of the 3'-dia. culvert inlets going diagonally across Sawmill Creek road near the northwestern end of the APC/Sitka landfill. The new culvert (see arrow) takes all of the water flow, and the old culvert in the background is unlikely to experience any water except during extreme-flood conditions.

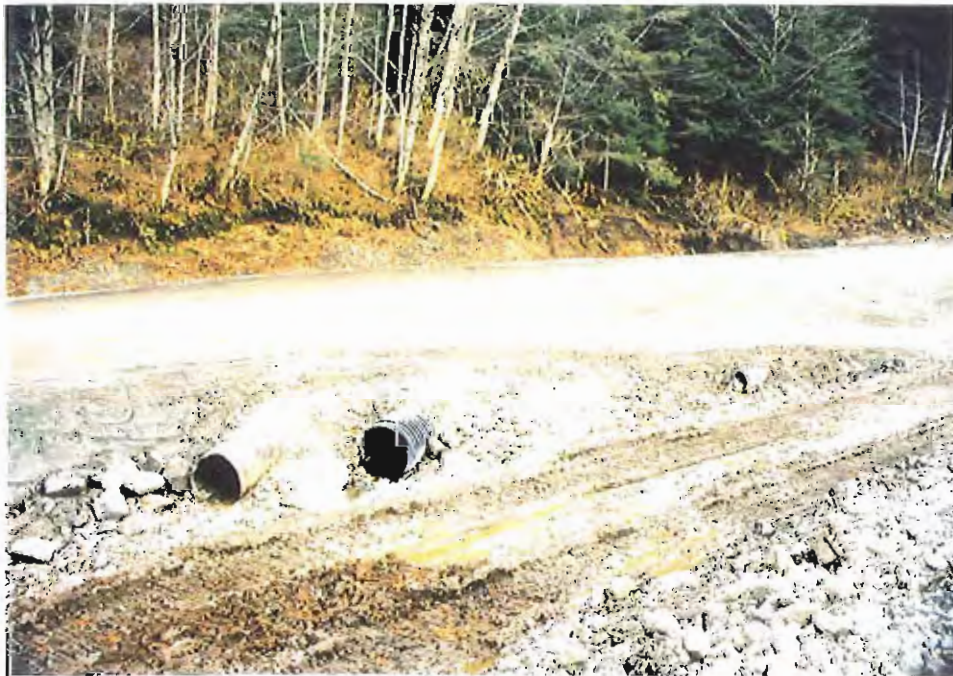
Photo #12: 11/11/99 view of the 3'-dia culvert discharges along the northwestern end of the APC/Sitka landfill. The new culvert is on the right site (see next two photos).

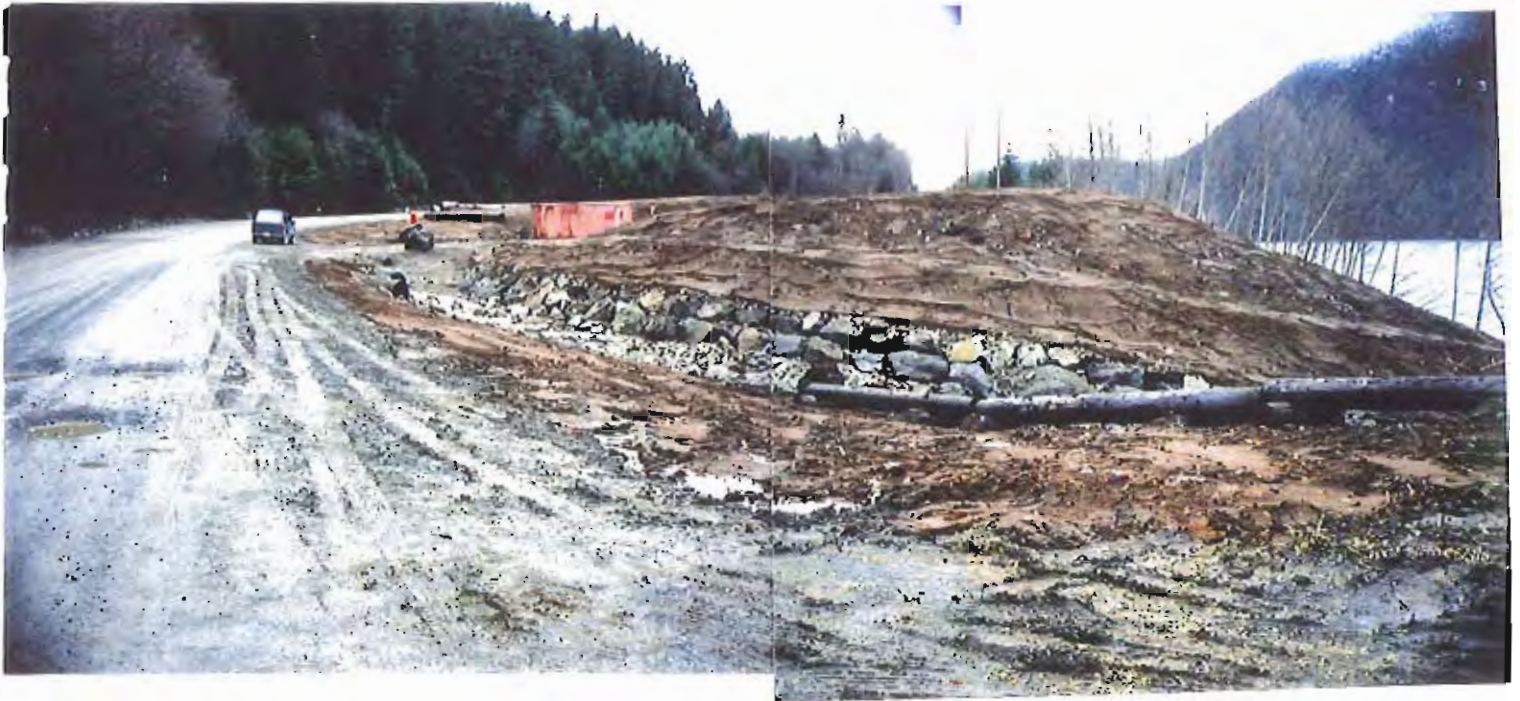
Photo #13: Looking across the northwestern end of the APC/Sitka landfill, showing the gentle banks of the surface water drainage ditchlines along Sawmill Creek road (see next photo).

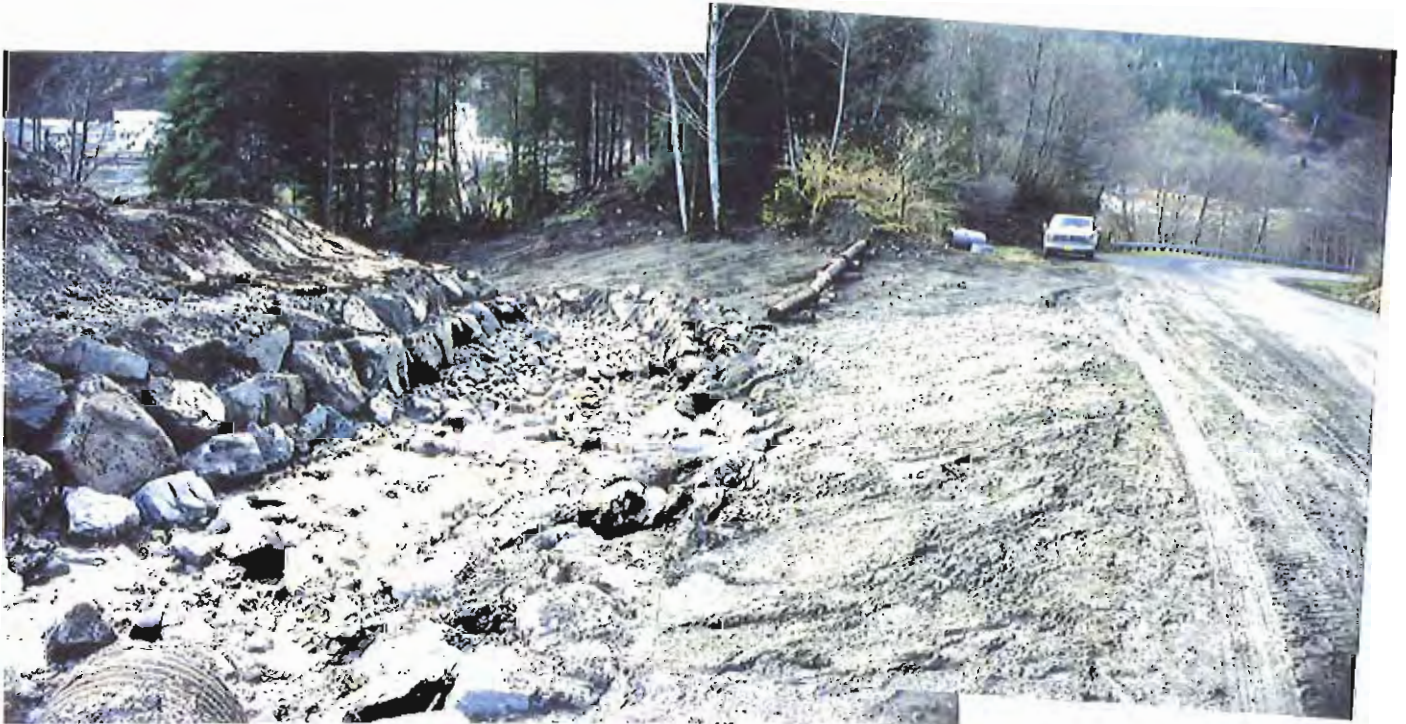
Photo #14: 11/11/99 view looking down the APC/Sitka landfill's surface water drainage ditch just beyond the Sawmill Creek Road's culvert discharge, showing the gentle roadside embankment and barrier logs placed well away from the road (refer to Photo #15).

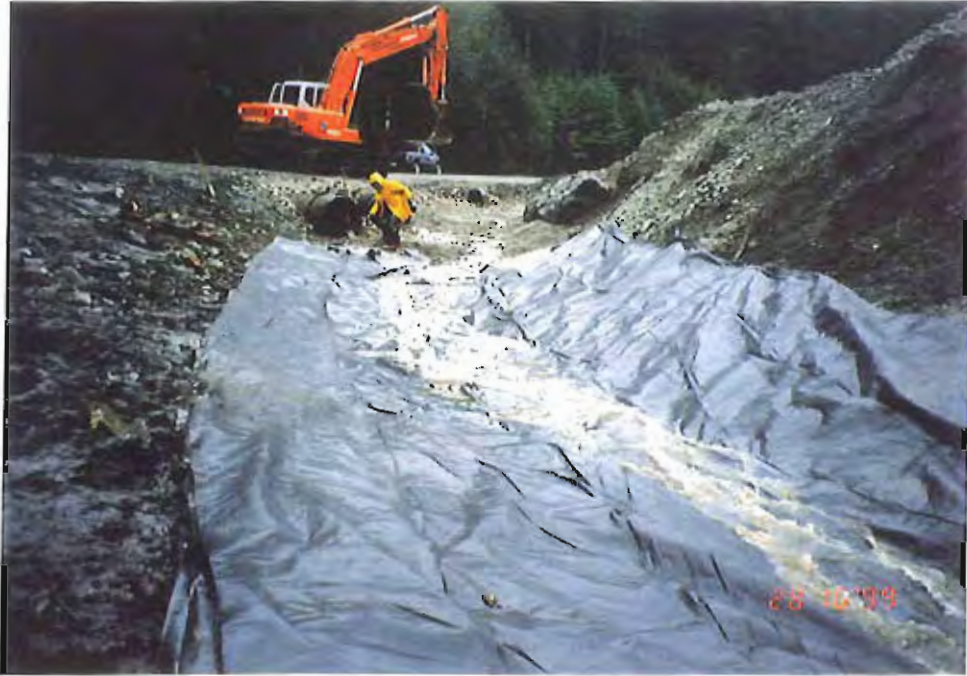
Photo #15: Earlier 10/28/99 view of placing the 20'-wide by 30-mil membrane liner in the surface water drainage ditch just below the Sawmill Creek Road's culvert at the APC/Sitka landfill's northwestern end (compare with Photo #14).

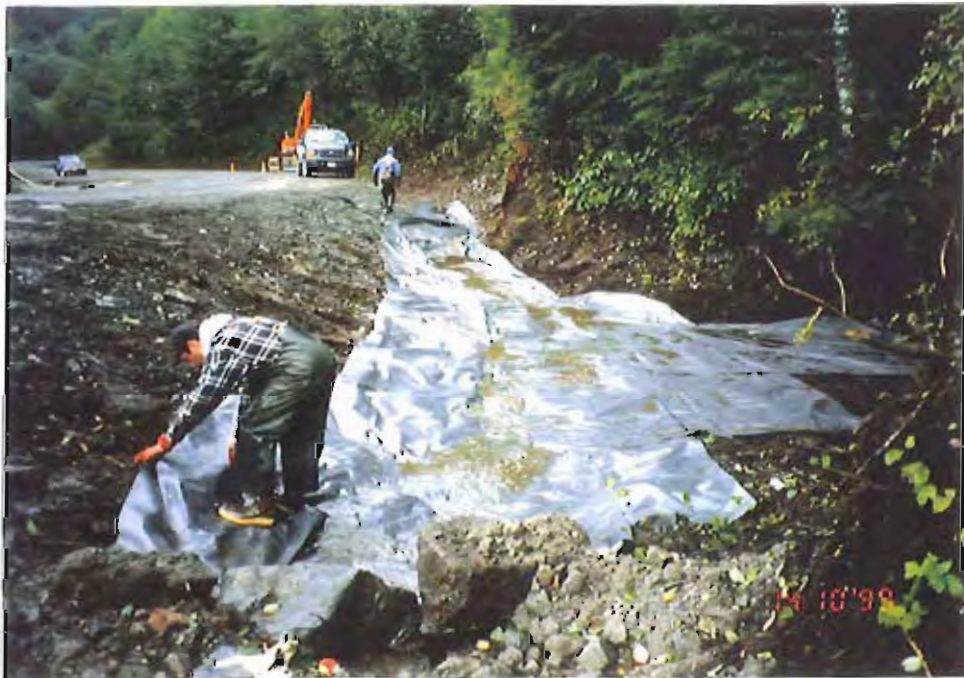
Photo #16: Earlier 10/14/99 view of the 10'-wide by 30-mil membrane liner being placed along the Sawmill Creek Roadway's upslope drainage ditch (compare with Photo #9).

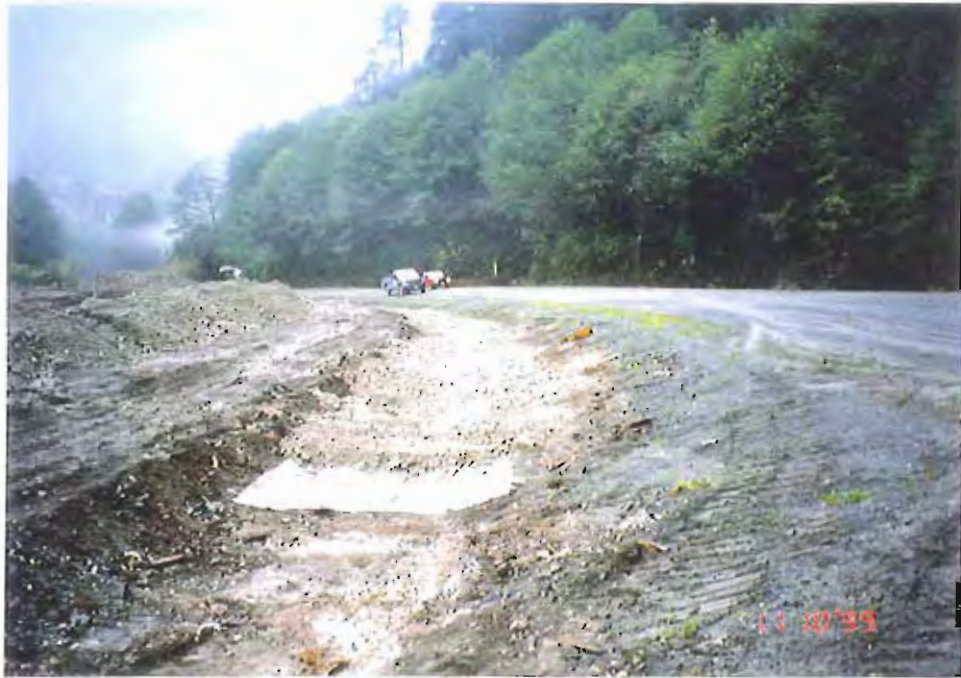
Photo #17: Earlier 10/11/99 view of the 10'-wide by 30-mil liner having been placed in the downslope surface water drainage ditch along Sawmill Creek Road, with a 6"-thick layer of rock over the membrane for protection against erosion (compare with Photo #2).

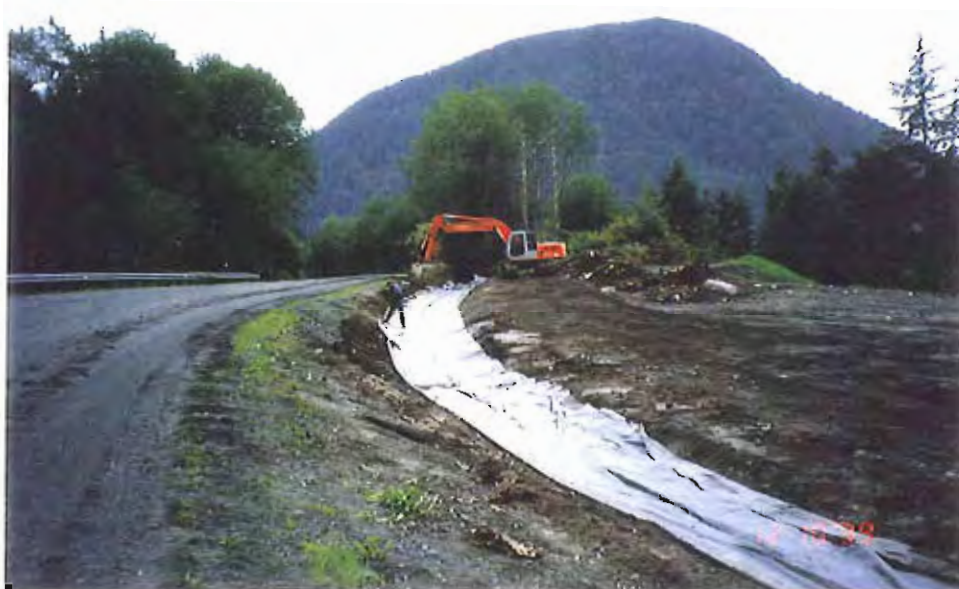
Photo #18: Earlier 10/12/99 view of the 10'-wide by 30-mil membrane liner being laid to the end of the downslope surface water ditch along the Sawmill Creek Road, near the southeastern end of the APC/Sitka landfill site (compare with Photo #3).
